A+ HOME INSPECTIONS

12345 Anywhere Street
Houston, TX 77000

Date: 9/13/2016

Re: Pre-Drywall inspection at 12345 Anywhere Street

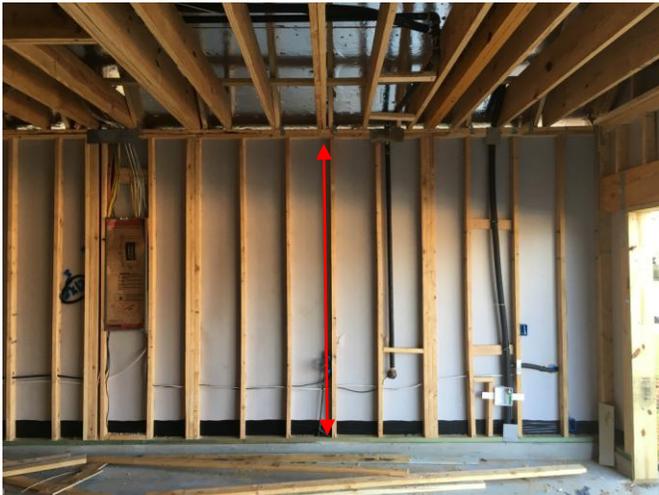
2. Nail plates missing where Romex wiring is within 1 1/4" of the stud face at the following locations: garage right wall; upstairs game room right, rear and front walls; right master bedroom rear, right and left walls; left master bedroom rear and left walls; study left wall.

Nail plates missing Romex right garage wall

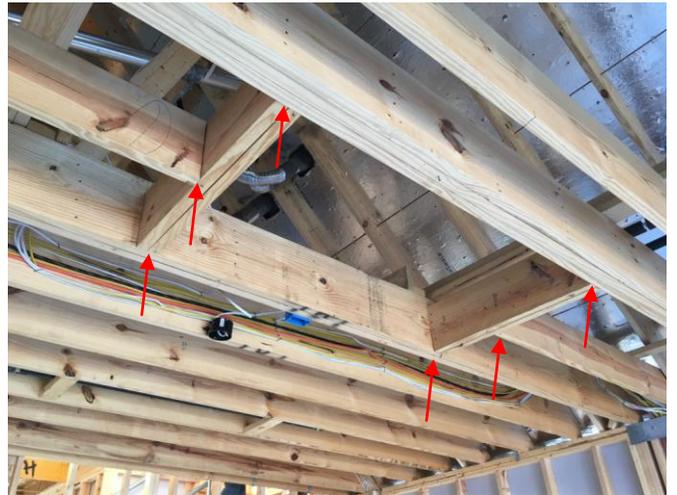
7. Wall studs missing under beams to properly transfer loads to the slab at the following locations: right garage wall under the beam, left family room wall under the beam, left master bedroom closet beam at the right and left wall, upstairs game room beams at the front and rear walls.

Stud not doubled under garage beam right wall

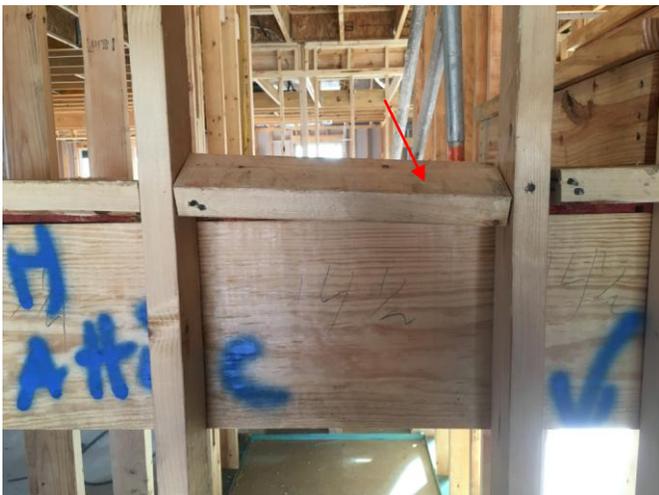
8. Joist hangers missing at the following locations: garage ceiling at the attic access framing, garage entry hall ceiling, utility room ceiling, stair landings, closet ceiling under the stairs, right master bedroom ceiling, entry hallway ceiling, entry closet ceiling, kitchen ceiling at the garage entry hallway, dining room ceiling at the left beam, second story floor joists at the top of the stairs.

Joist hangers missing garage ceiling

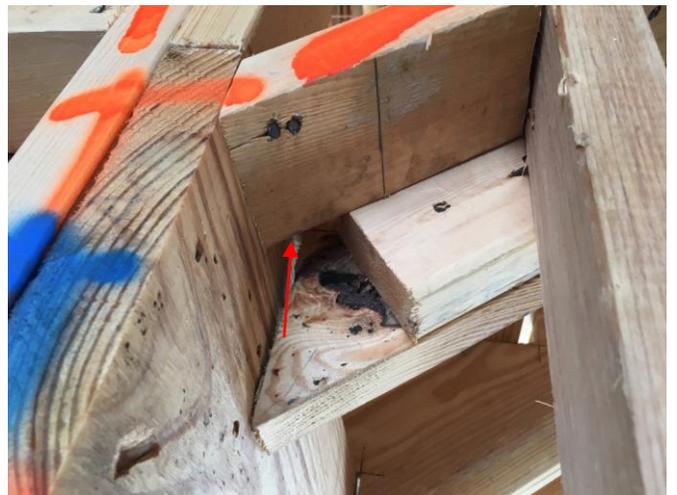
13. Fire blocking loose at the stairs at the following locations: first landing at the garage wall.
14. Lower cabinet blocking loose at the kitchen front wall at the garage entry hallway passage.

Loose stair fire block at garage wall

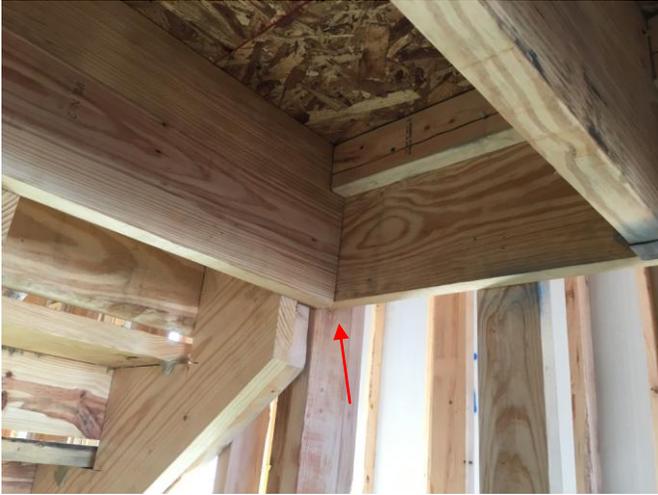
Gaps stair fire block at garage wall

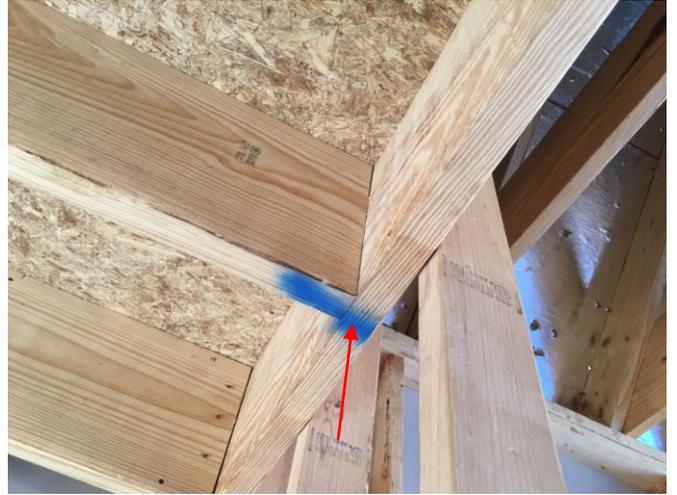
Joist hanger missing stair landing

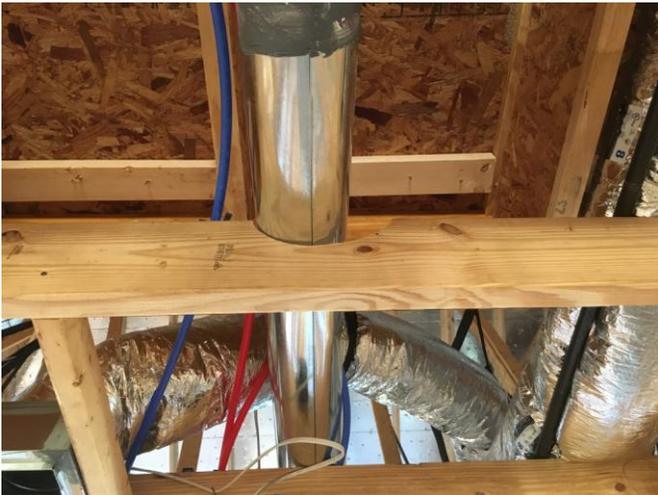
Joist hanger missing utility room ceiling

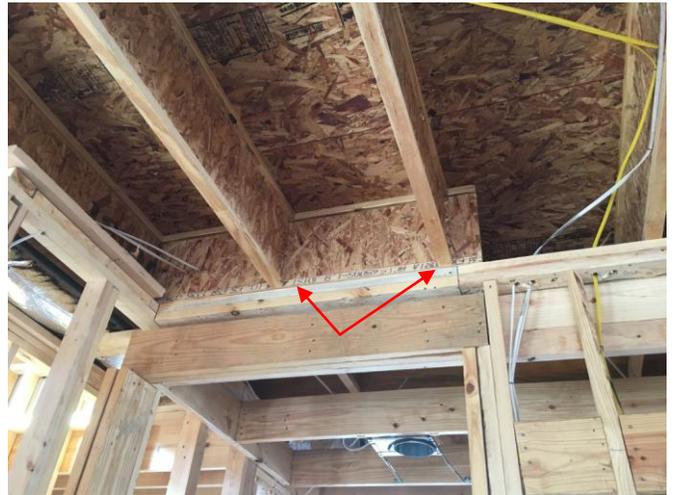
10. Ceiling joist notching exceeds allowable percentage at the utility room ceiling where the range hood exhaust vent pipe crosses.

Ceiling joist notch excessive utility room

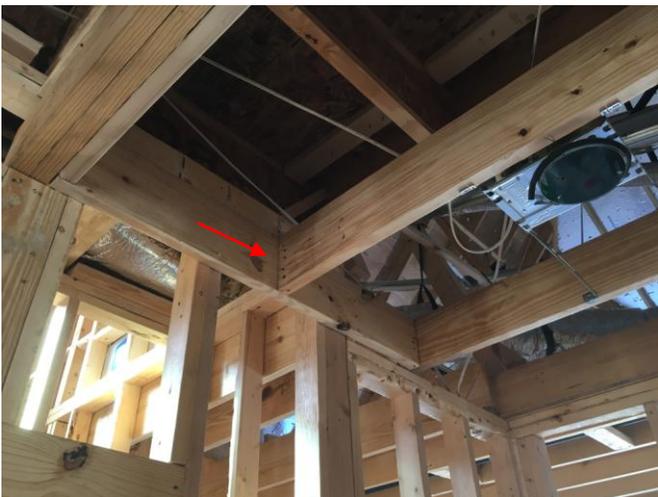
Joist hanger missing kitchen ceiling

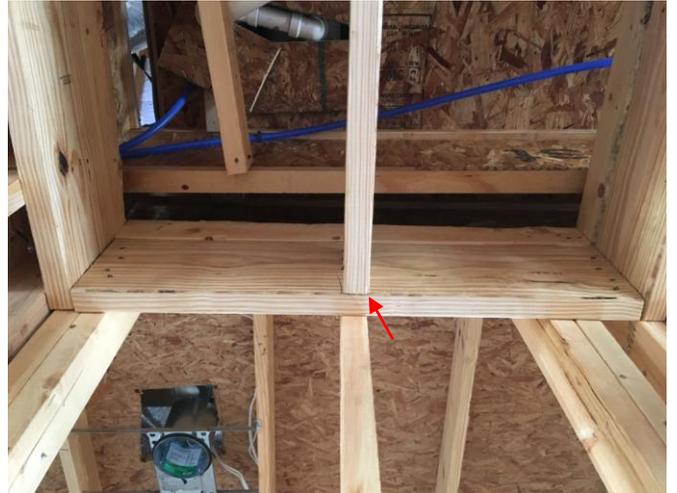
Joist hangers missing at entry hall ceiling

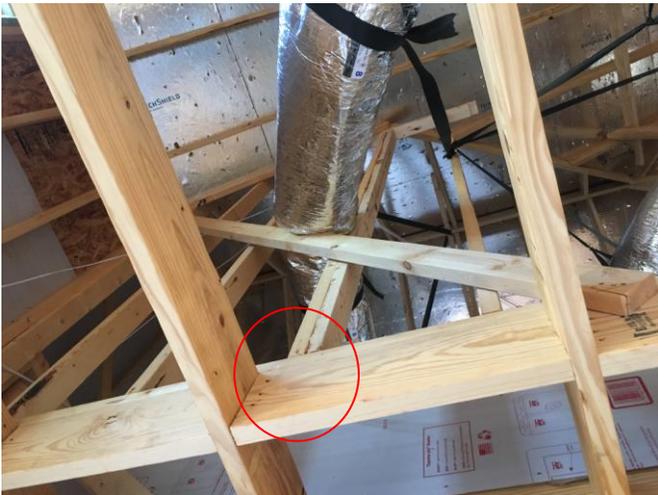
Joist hangers missing at entry hall closet

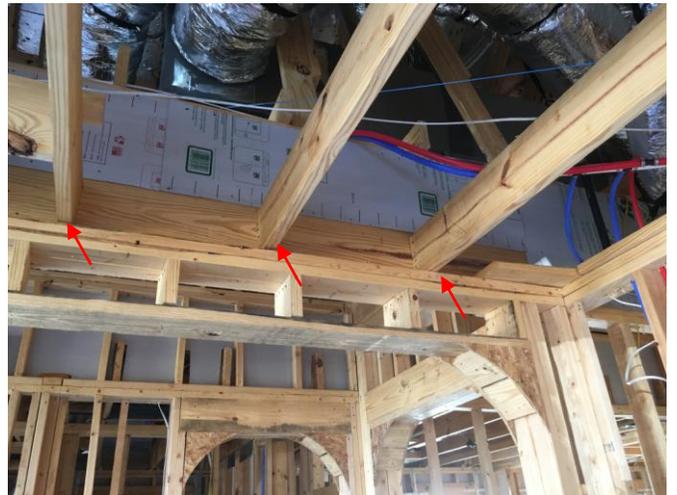
19. Double stud under the valley beam above the dining room terminates on a single ceiling joist. Point loads should terminate on a load bearing wall or beam. An engineer should verify if the loads are properly transferred to the slab if not specified in the plan set.

Valley beam load terminates at dining room ceiling

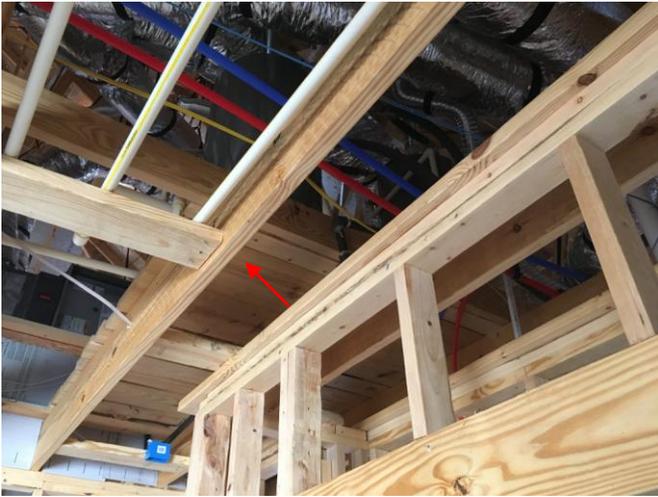
Joist hangers missing at entry hall ceiling

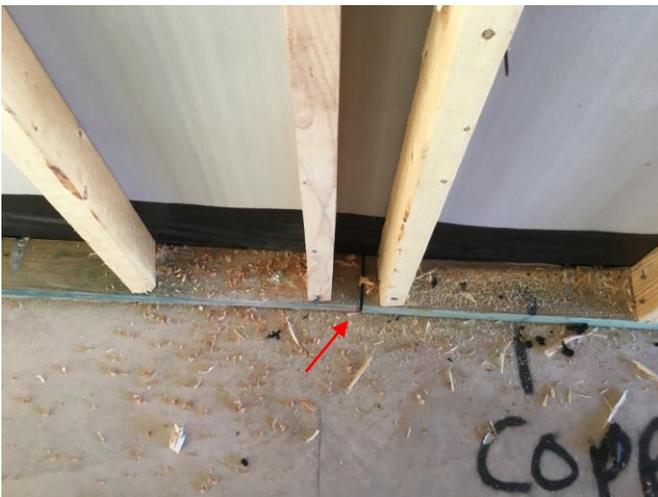
20. Block joints in the toe plate where not covered by a wall stud at the following locations: right breakfast room wall, closet under the stairs at the right wall, left master bedroom rear wall.

Joint toe plate not blocked right breakfast wall

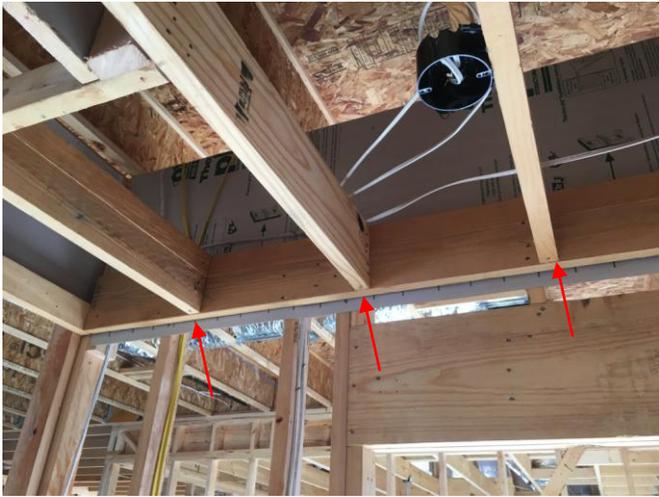
Joist hanger missing 2nd story floor at stairs

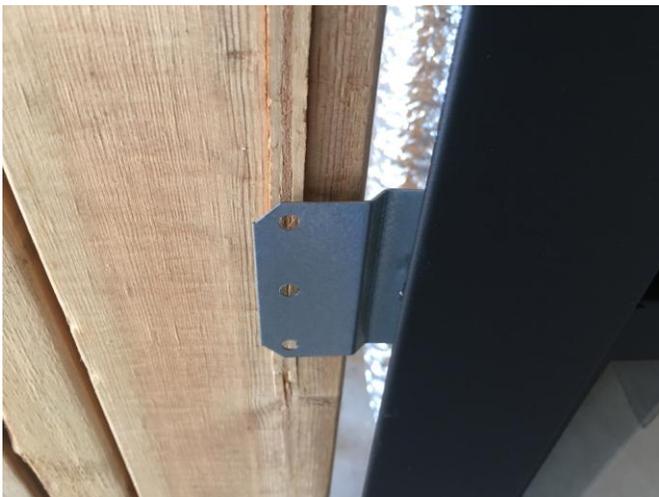
21. Right side of the family room fireplace not installed with proper clearance from combustibles.
22. The fireplace framing clips are missing fasteners.

Wood clearance at right side family room fireplace

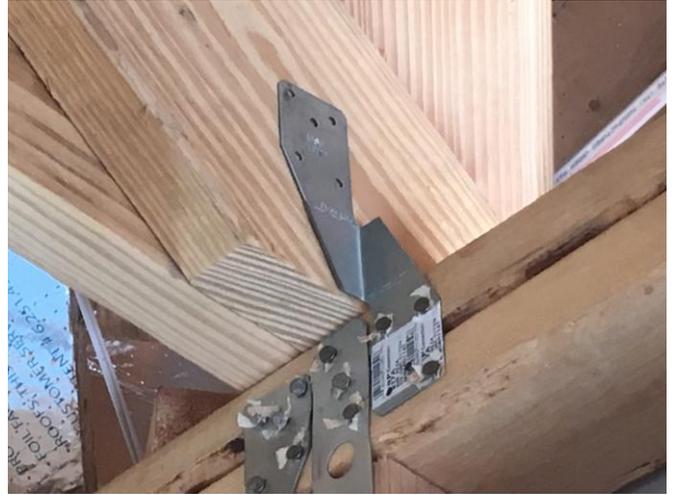
23. Rafter wind brackets missing at the following locations: rear family room wall at two of the roof rafters.
24. Rafter wind brackets missing fasteners at the following locations: rear family room wall at the left corner roof rafter.

Rafter clip missing rear family room

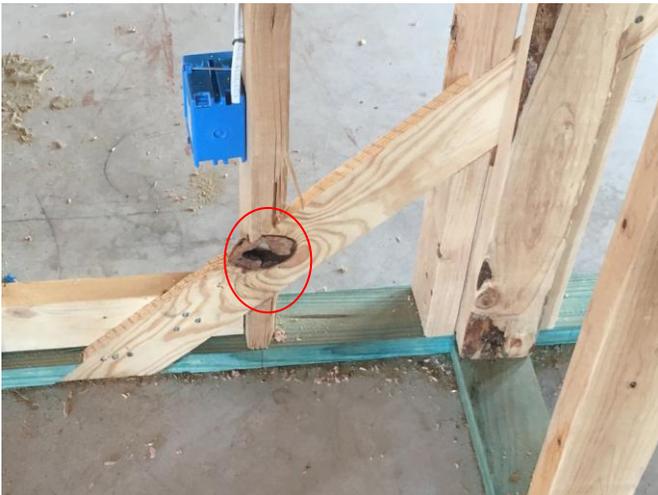
25. Lateral wind bracing cut into the wall studs should be secured at each stud with two fasteners. Fasteners observed missing at the following locations: left master bedroom right wall, left master bedroom bathroom front wall, left master bedroom closet front wall.

Fasteners missing lateral brace left master wall

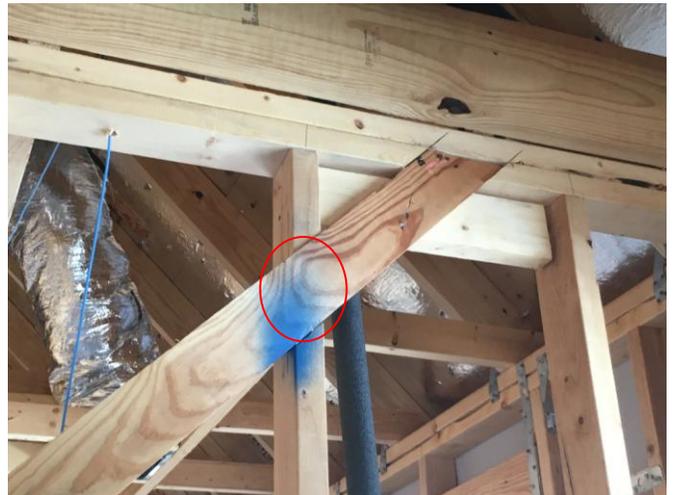
Fasteners missing lateral brace left master closet

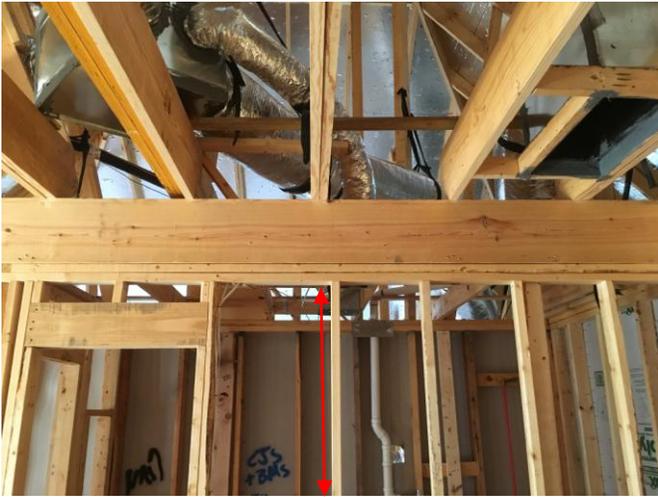
Studs missing under game room beams

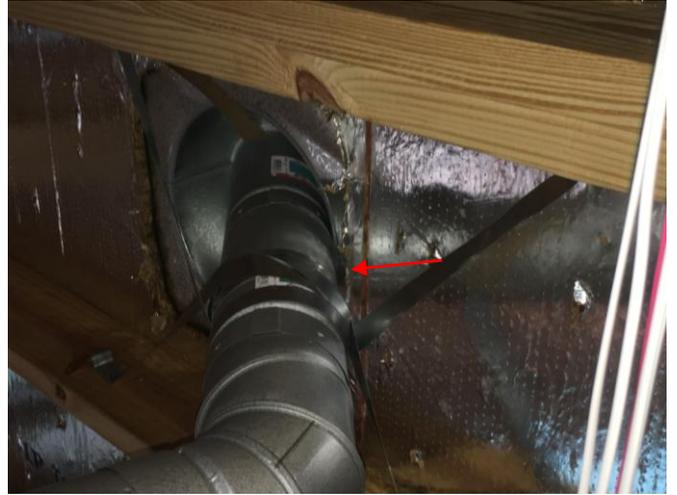
31. Proper clearance from wood or combustible materials is not installed at furnace and left water heater flue vent pipes. Minimum 1" clearance required for Type B vent pipe.

Improper clearance left water heater vent pipe

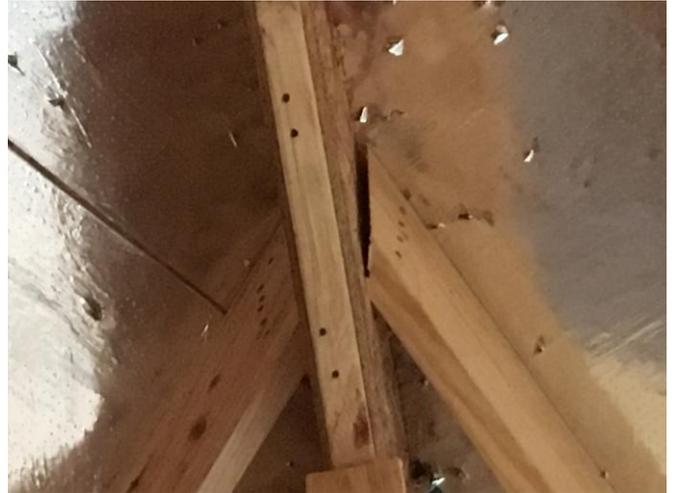
32. The hip jack roof rafter cuts are not flush at the second story roof hip beams at the following locations: right rear hip, left rear hip.
33. Vapor barrier at the exterior walls not installed over the roof step flashing at the following locations: front exterior at the garage left roof slope, front second wall at the right roof slope, rear second story wall at the right roof slope.

Second floor hip jacks not flush at hip beams

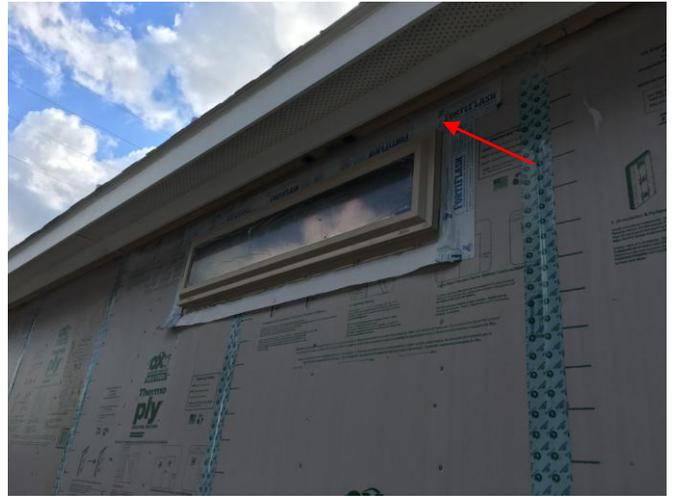
35. Box framing observed missing at the left exterior windows at the left master shower and bedroom 3 windows.

Window box frame missing at bedroom 3

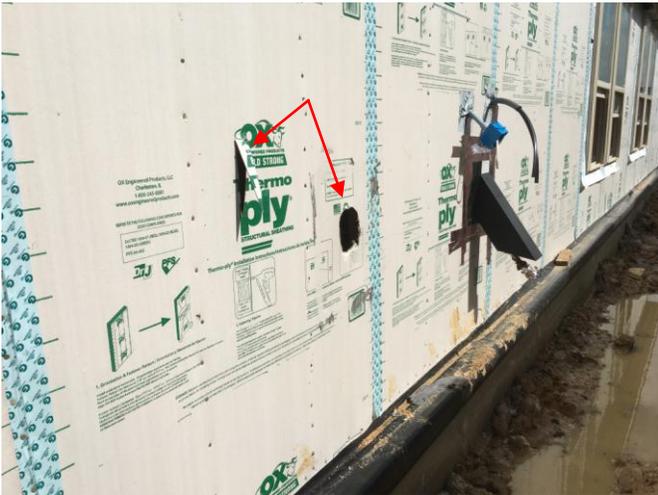
Damaged poly right breakfast room

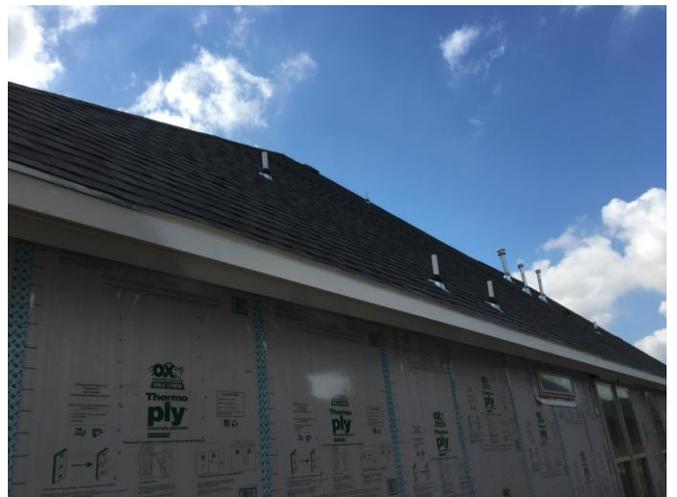
Vapor barrier not covering roof step flash
