A+ HOME INSPECTIONS

1234 Anywhere Street
Houston, TX 77000

Date: 02/13/2023

Re: Pre-pour foundation inspection at 1234 Anywhere Street

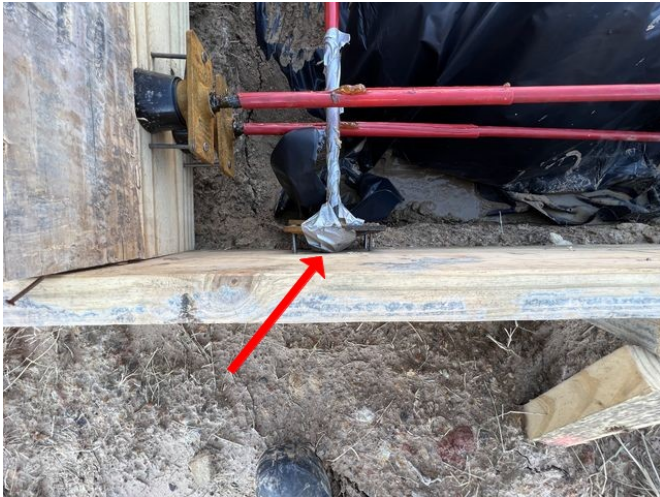
- Improper clearance post tension cable buckles observed at the following locations: front form board, left form board.
- Cable contact with the pad observed at the rear patio.

Buckle clearance at front perimeter form boards

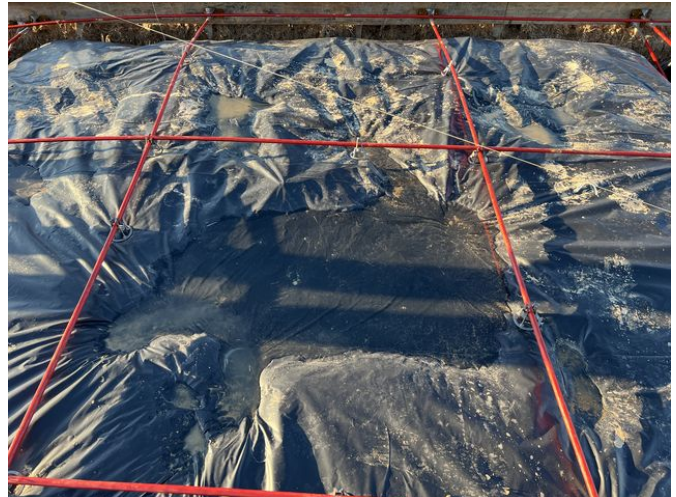
- Standing water observed on several of the interior pads. Remove all water prior to pouring concrete to avoid dilution of the cement mix.
- Cat heads missing at the post tension cables at the perimeter form boards.

Excessive water standing at several pads

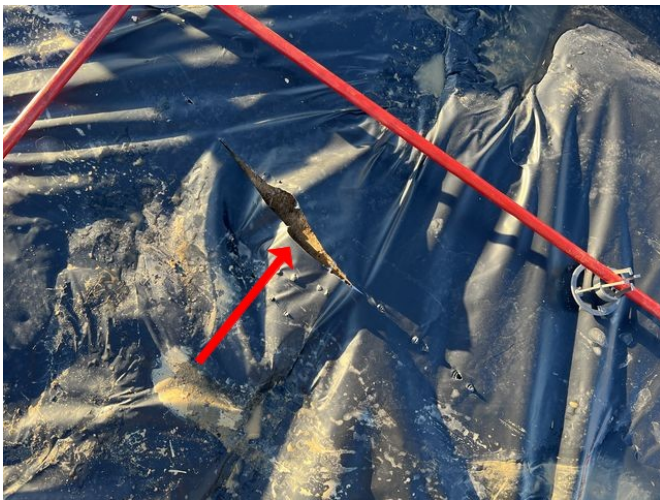
- Holes in the vapor barrier observed at the following locations: interior pad adjacent to the front porch, rear patio right interior beam.
- Vapor barrier overlap seam not taped at the interior beam running front the front to rear of the dwelling.

Tear vapor barrier interior pad near front porch

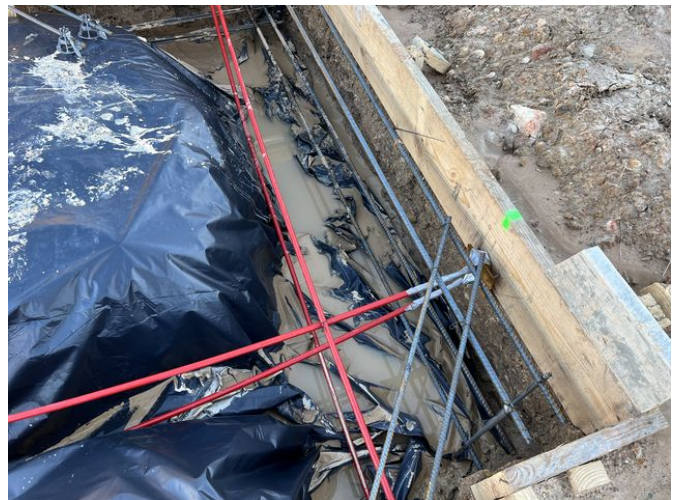
- Re-entrant rebar missing at the interior corner of the rear patio form.
- Standing water observed at the bottom of the footings at several locations. Remove all water prior to pouring concrete to avoid dilution of the cement mix.

Excessive water standing at perimeter beams

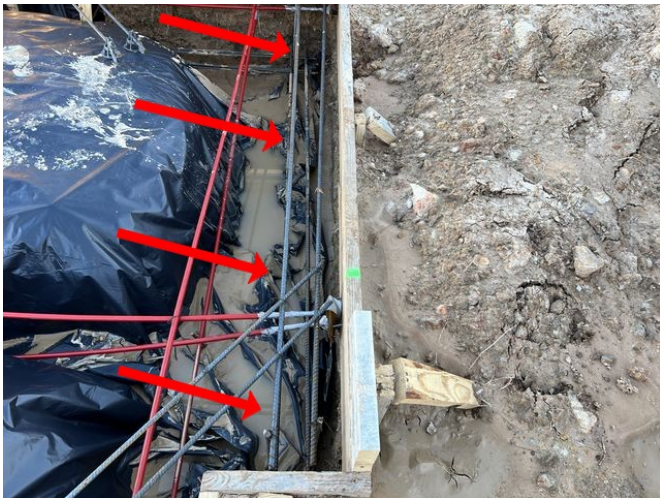
- Rebar beams not installed with stirrups at the front porch and rear patio.
- Remove construction debris from the footings prior to concrete installation.

Stirrups missing at front porch rebar beams

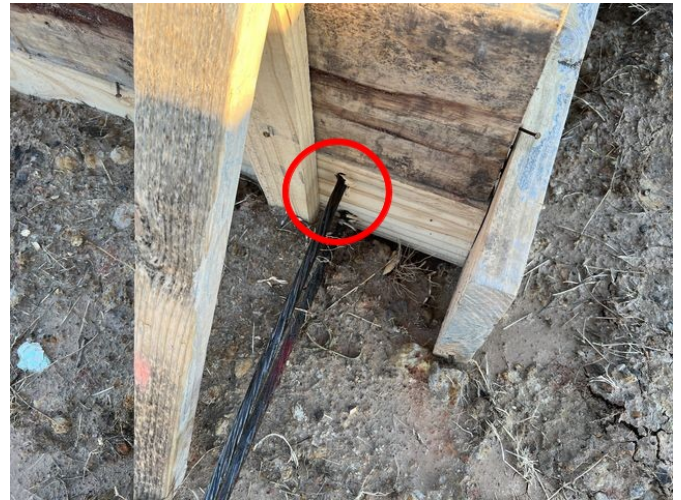
Cat heads missing at post tension cables at perimeter

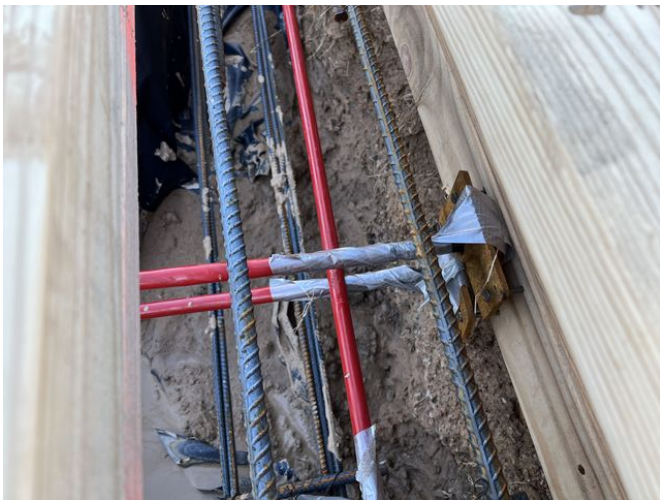
- Cave-in's and or erosion observed at the perimeter beams at the following locations: right perimeter beam, left perimeter beam, front perimeter beam, rear perimeter beam. Builder should verify that the engineer specified footing depth is obtained once cave in dirt is removed prior to pouring of the concrete.

Cave-in/erosion at front perimeter beam

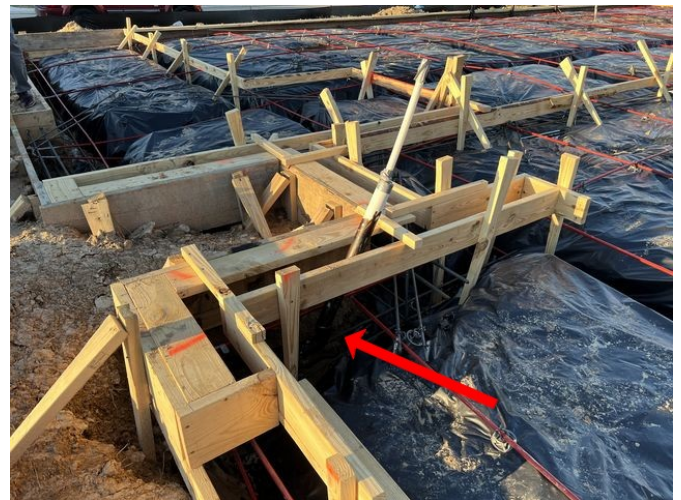
- Water pipe conduit detached at the 90 degree fitting at the left garage wall.
- Cable contact at the PVC plumbing vents/drains at the following locations: right perimeter beam front drain, interior pad rear of the garage, left perimeter beam rear drain.

Waterline conduit detached left garage wall

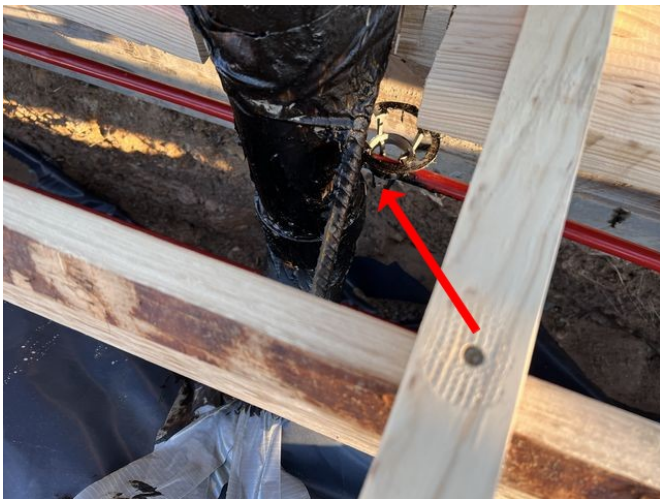
Cable clearance at the right drain pipe at garage

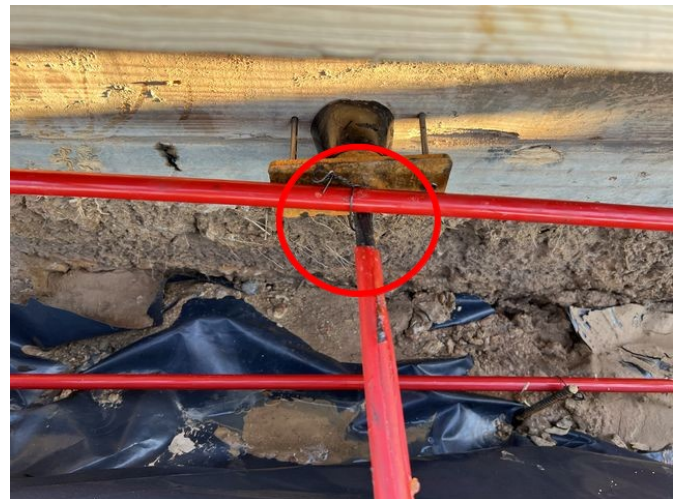
- Adjust sleeves where the cables are exposed at the port side at the following locations: right and rear form boards at multiple locations.
- Rebar contact observed at the side of the rear patio pad.

Cables not properly covered at the perimeter ports

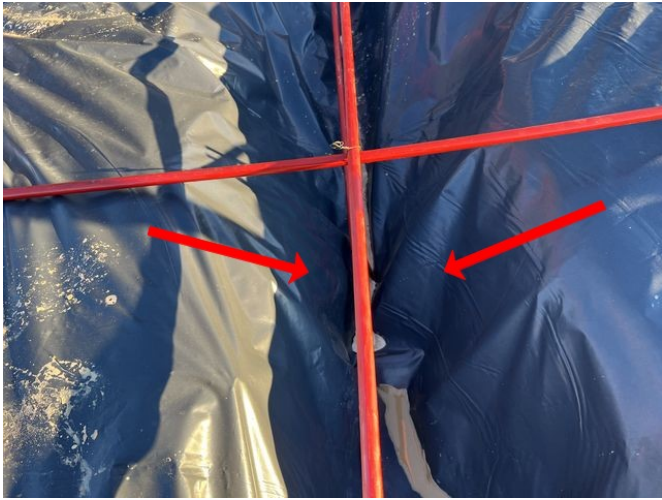
- Vapor barrier is not installed with enough poly to cover the bottom of the garage interior beam running left to right.
- Damaged cable chairs observed at the following locations: garage interior pad, rear patio pad.

Poly not covering the bottom of the garage interior beam

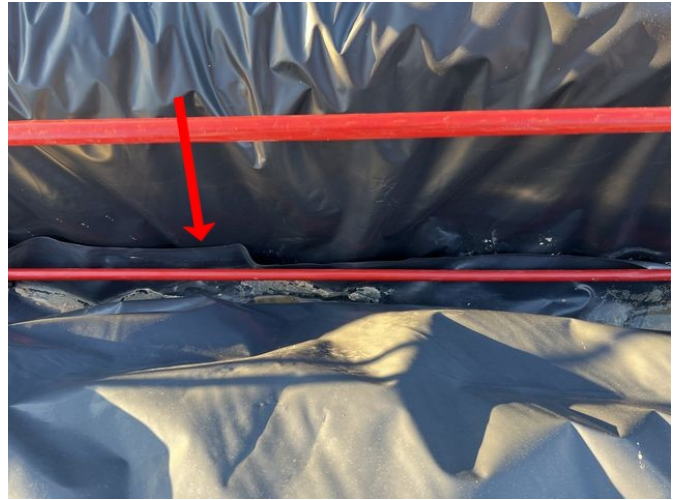
Poly overlap seam not taped at the interior beam

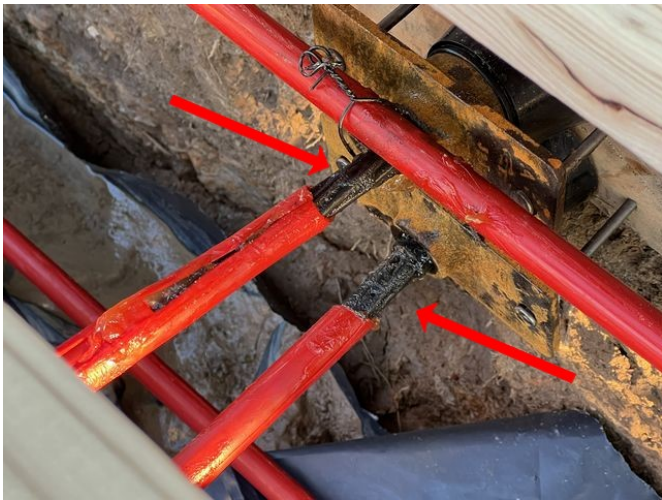
Cables not properly covered at the perimeter ports

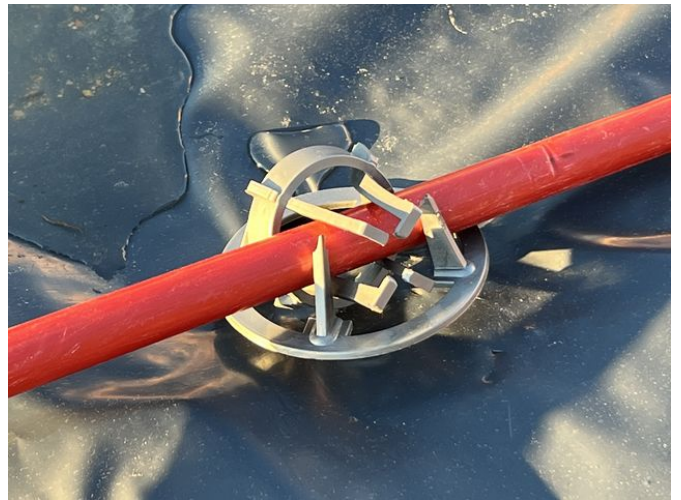
Damaged chair at garage interior pad

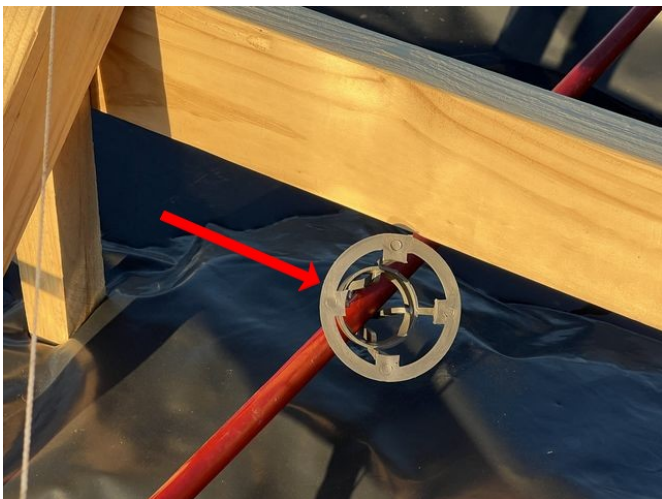
- Cable chairs shifted and not providing the proper space between the cables and pads at several locations.
- Capped PVC drain or vent pipe not removed at the right perimeter beam. This reduces the amount of concreted at the perimeter beam.

Several cable chairs shifted at the interior pads

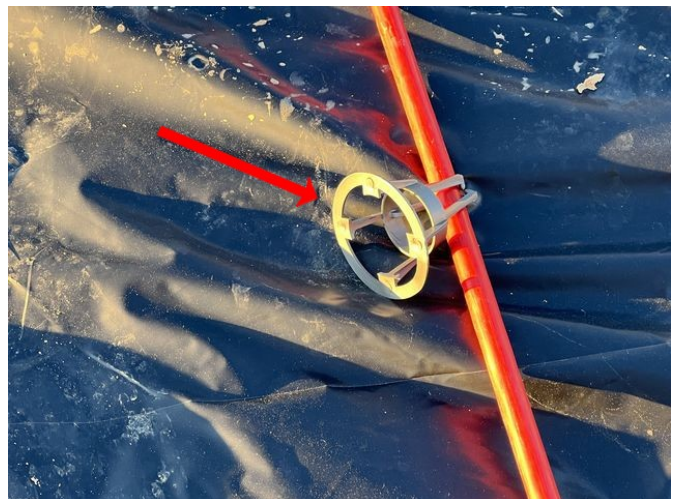
Several cable chairs shifted at the interior pads

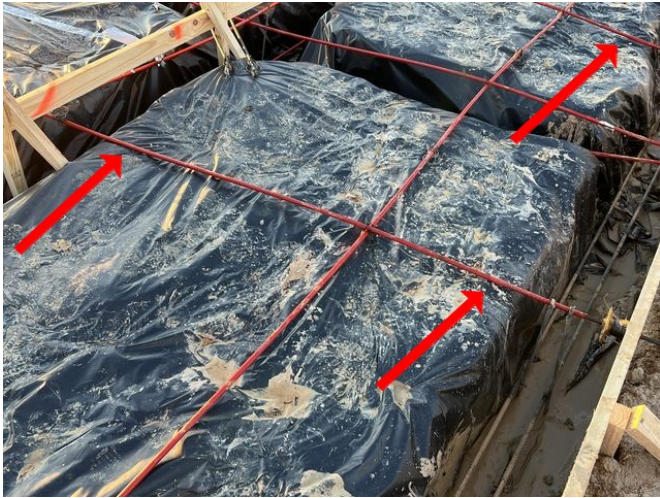
- Cable chairs missing at the rear patio pad. Cables not properly elevated above the pad.
- Rebar contact with the interior pad side wall observed at the rear patio rear perimeter beam.

Cable chairs missing rear patio pads

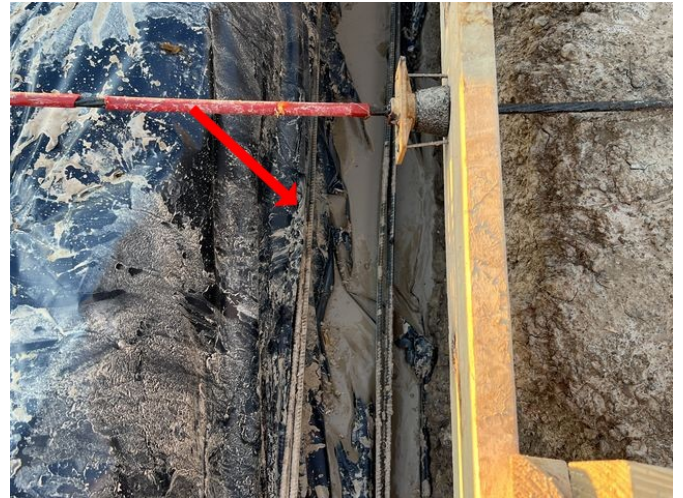
Rebar contact at rear patio pad at perimeter beam

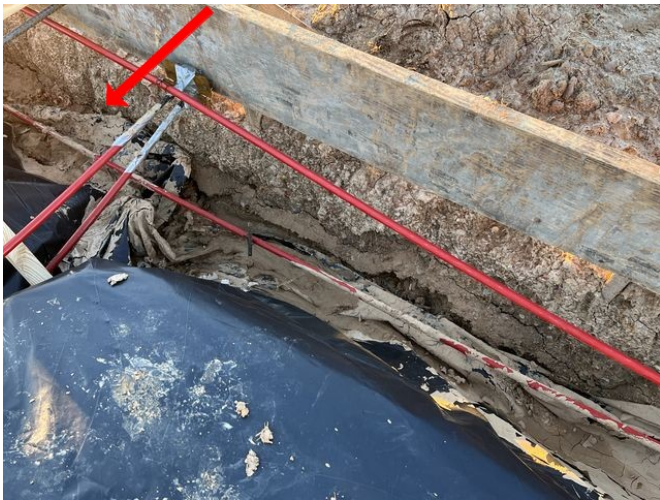
Cave-in/erosion at left perimeter beam

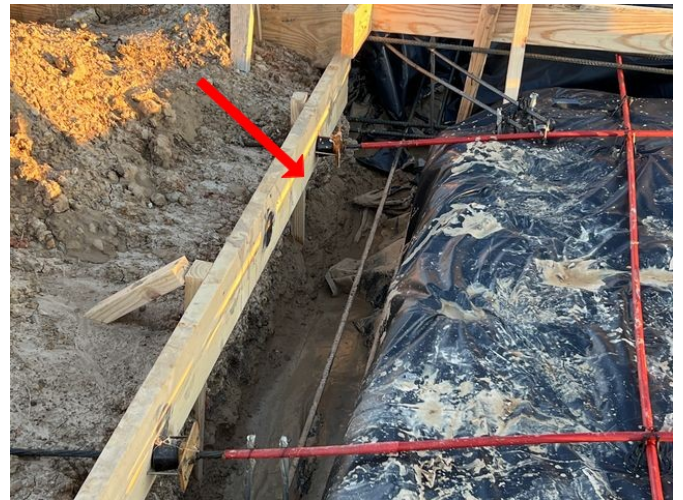
Cave-in/erosion at rear perimeter beam

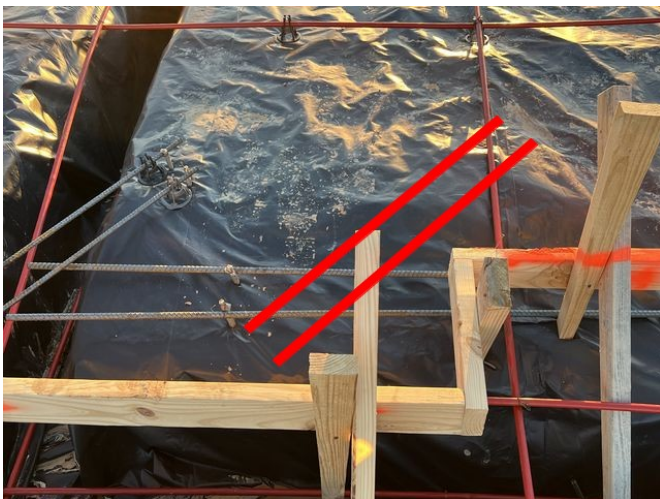
Re-entrant rebar missing interior corner rear patio

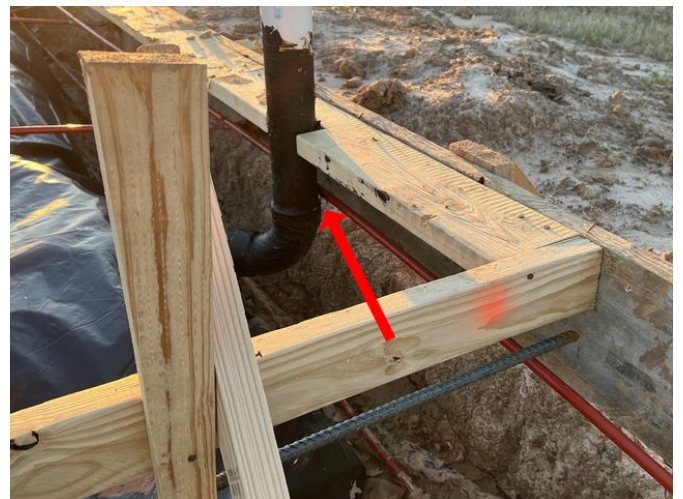
Cable contact drain left perimeter beam

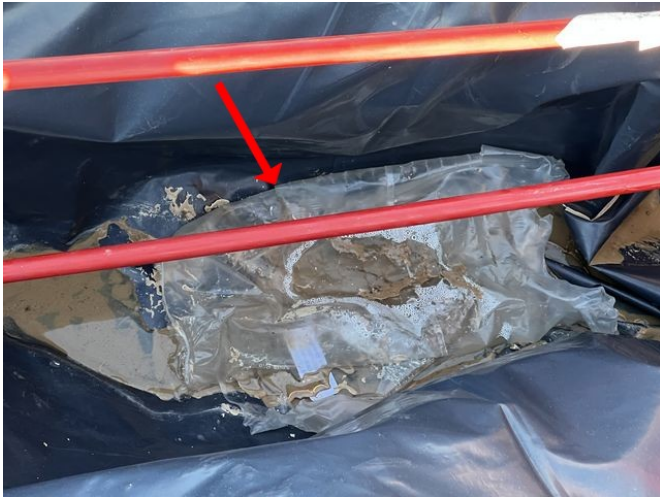
Remove construction debris from footings

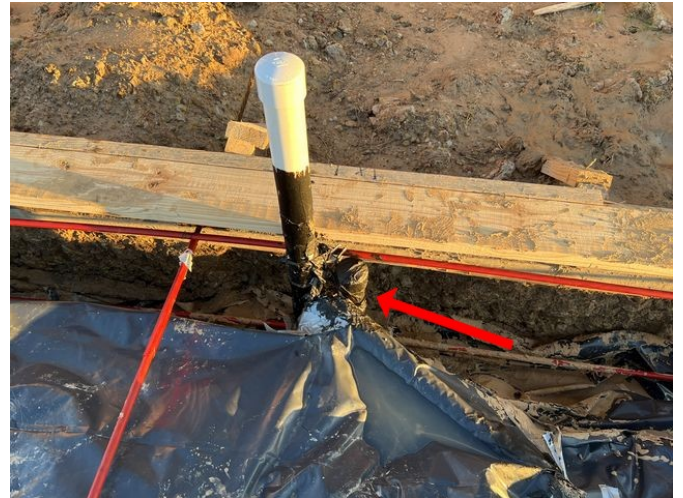
Capped drain pipe at right perimeter beam

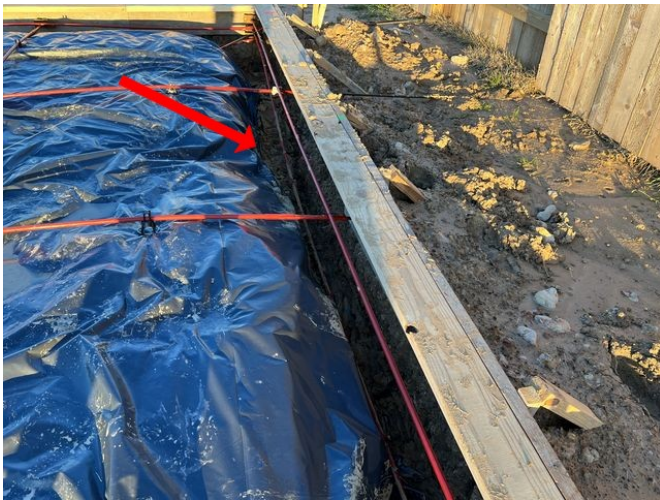
Cave-in/erosion at right perimeter beam

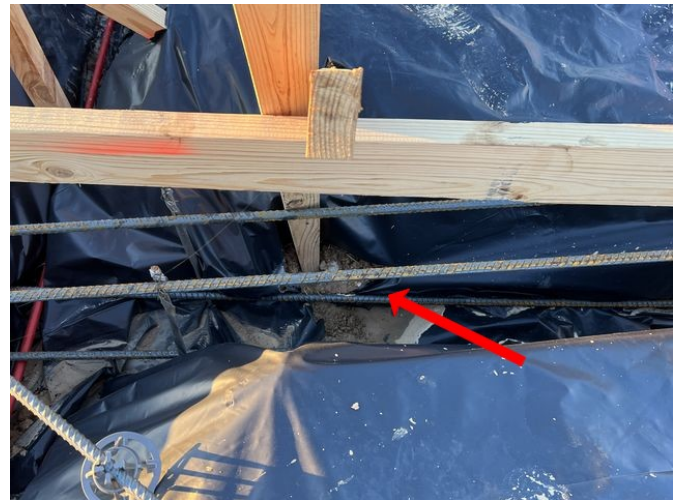
Tear poly right beam rear patio

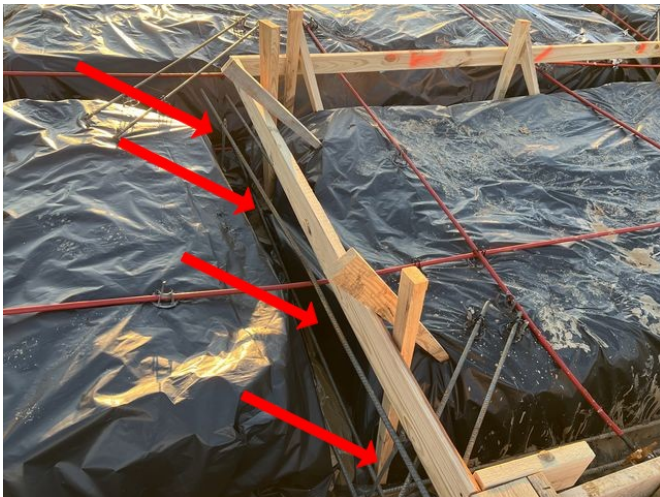
Stirrups missing rear patio rebar beam

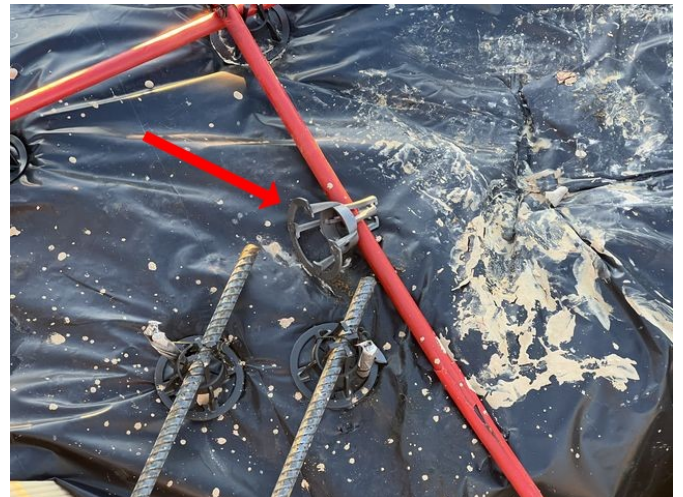
Damaged cable chair rear patio pad

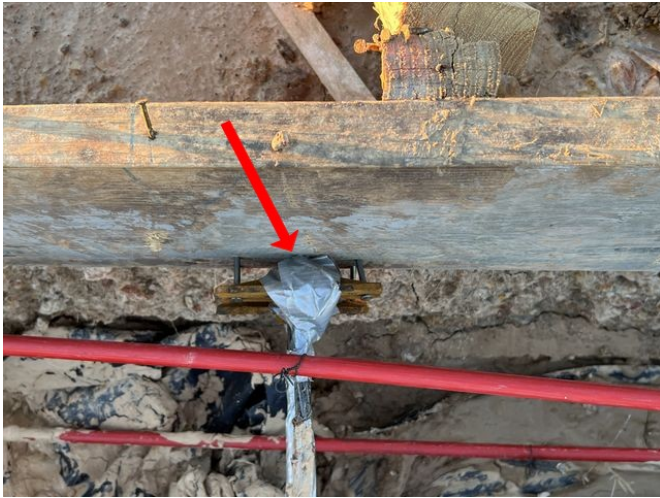
Buckle clearance at left perimeter form boards

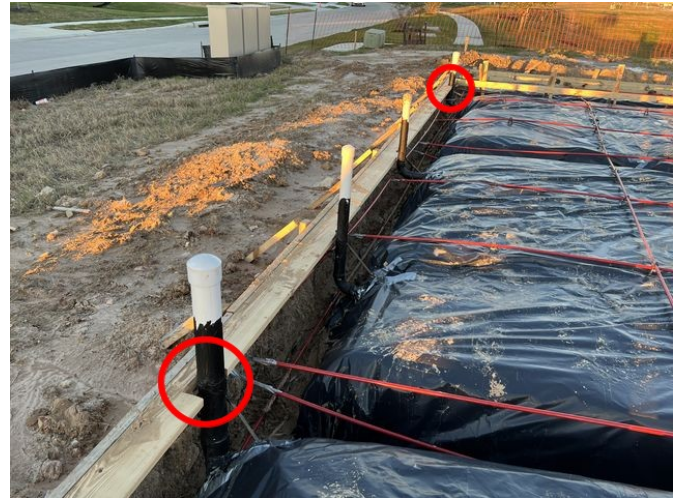
- PVC drains and or vents encroach the brick ledge at the left perimeter beam at two locations. The drains and or vents should be located with the proposed wall framing. This will interfere with the brick veneer installation.

PVC drains encroach brick ledge left perimeter

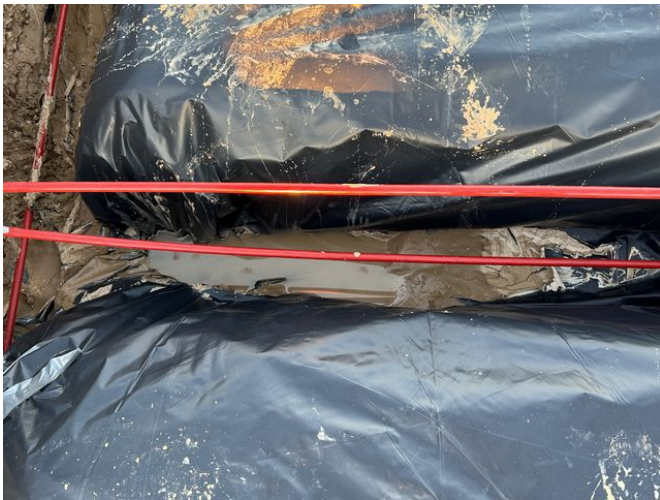
Standing water at footings

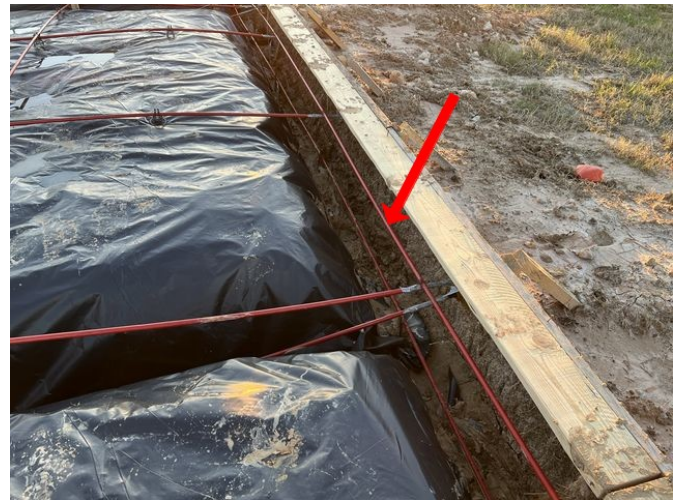
Cave-in/erosion at left perimeter beam

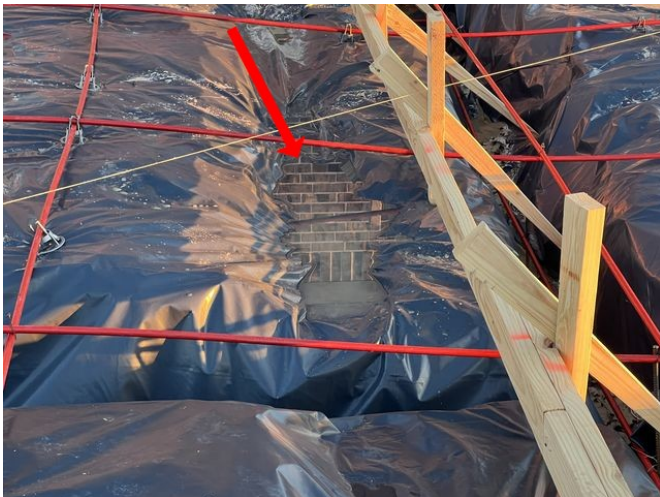
Standing water interior pads

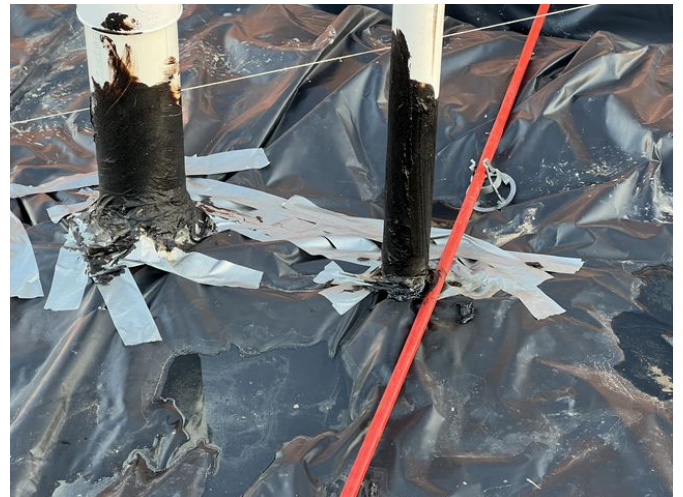
Cable contact drain pipe at interior pad rear garage

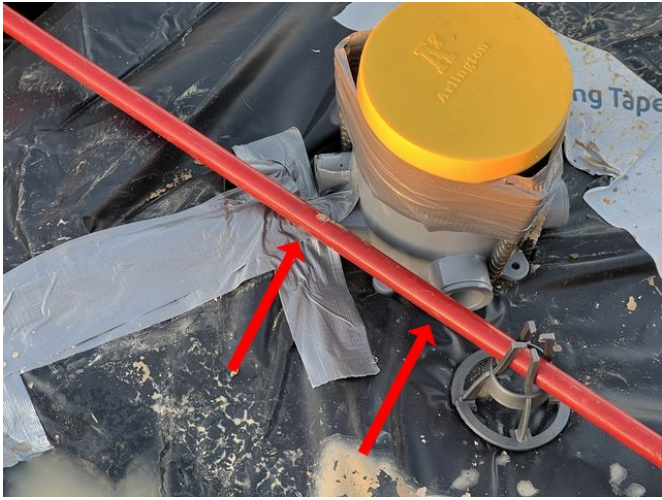
- Cable contact observed at the proposed floor plug housing and conduit at the rear of the dwelling.
- Rebar clearance left perimeter beam at rear patio.

Cable contact floor plug housing and conduit

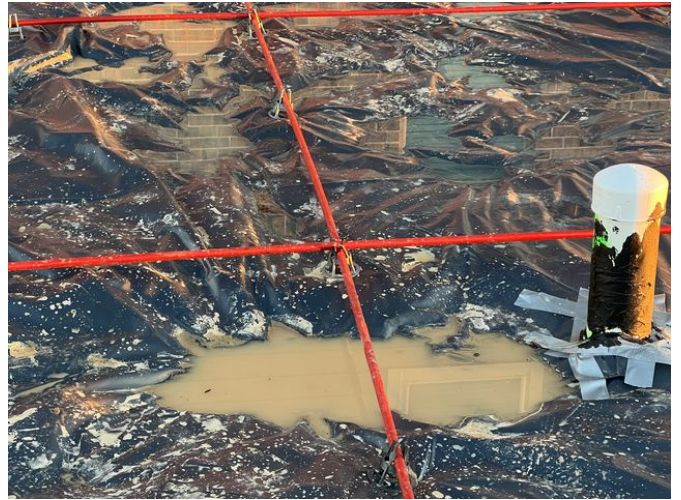
Standing water interior pads

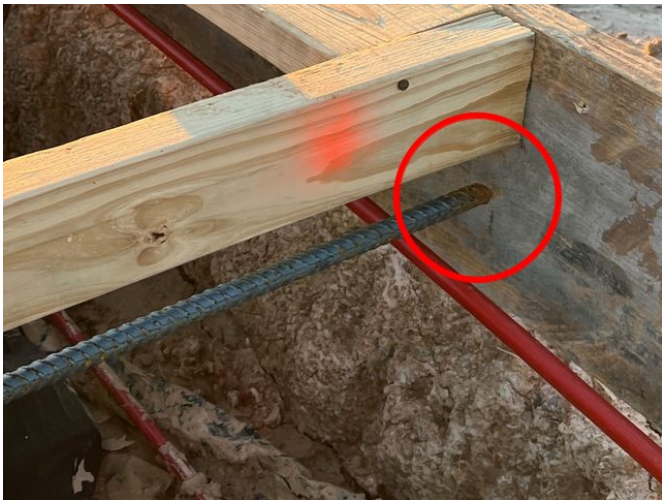
Rebar clearance left perimeter form at rear patio
