A+ HOME INSPECTIONS

Structural & Mechanical

1234 Anywhere Street
Houston, TX 77000

Re: Pre-Drywall inspection at 1234 Anywhere Street

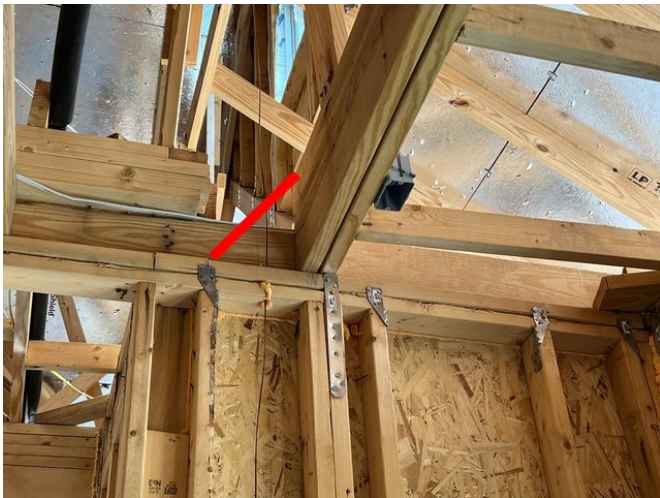
Ceiling beam not braced above left front bedroom

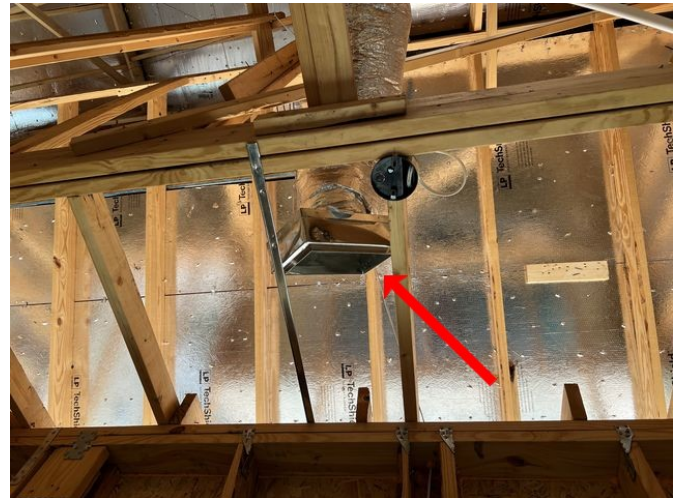
Air supply register not secured left front bedroom

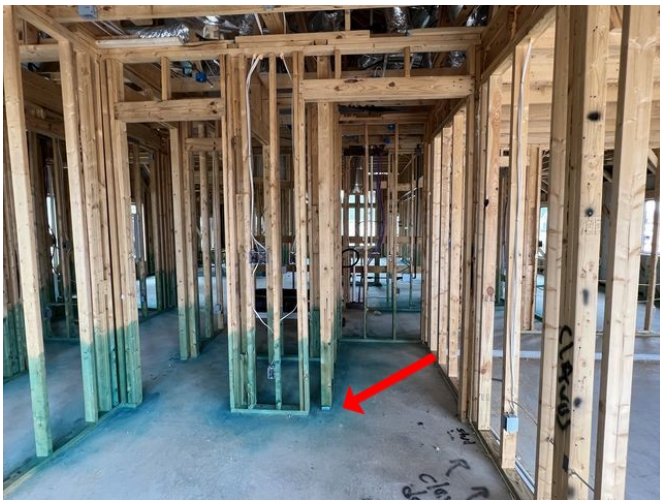
Wall corner not framed right front bedroom

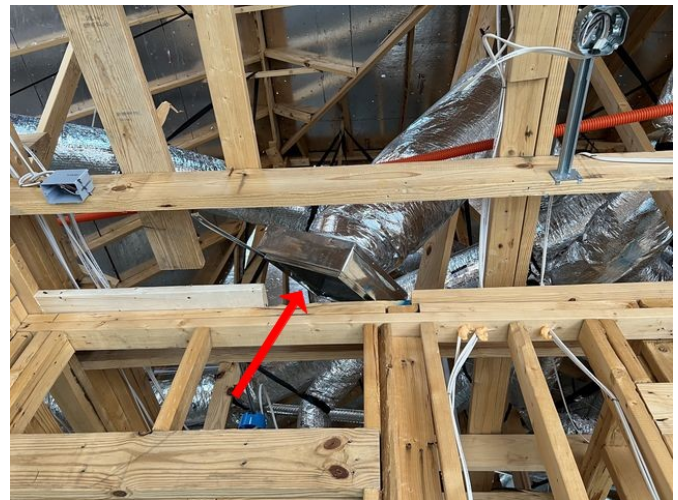
Return air box not secured right front bedroom

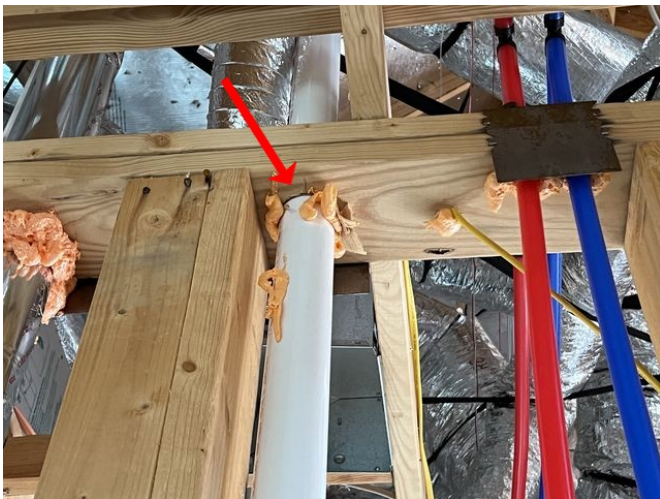
Seal plumbing penetration right front bathroom

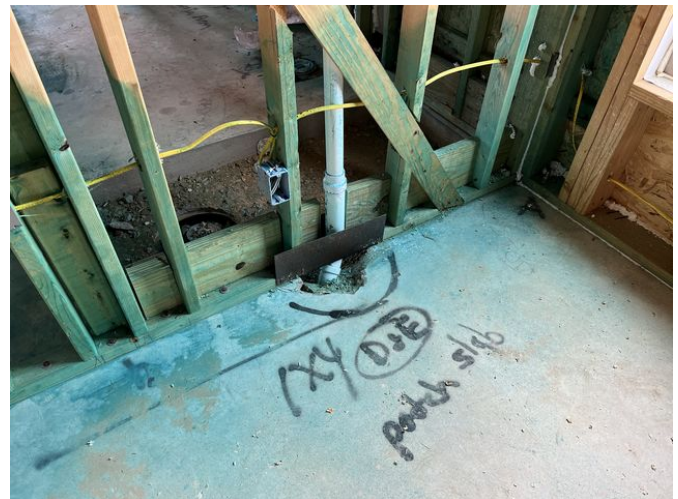
Slab not patched at dining room floor

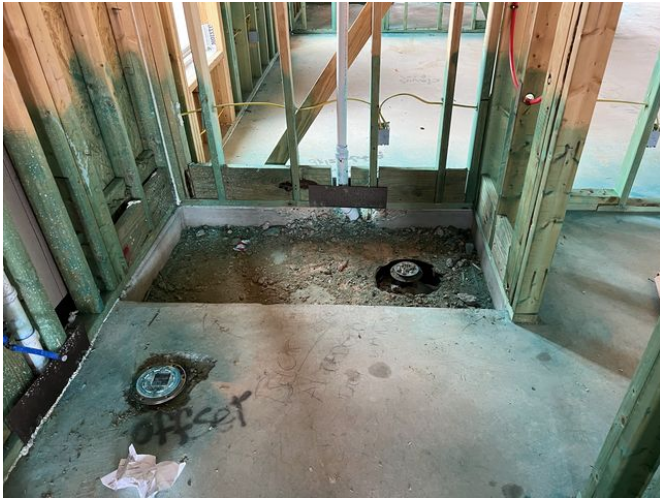
Shower liner not installed at left front bathroom

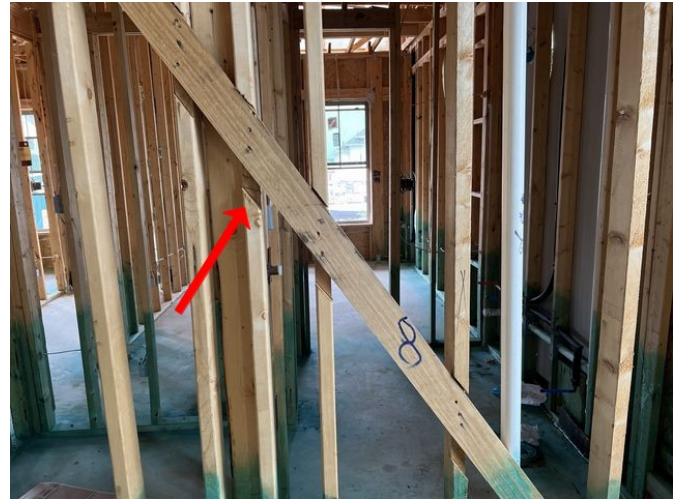
Studs over notched at LIB left front bedroom

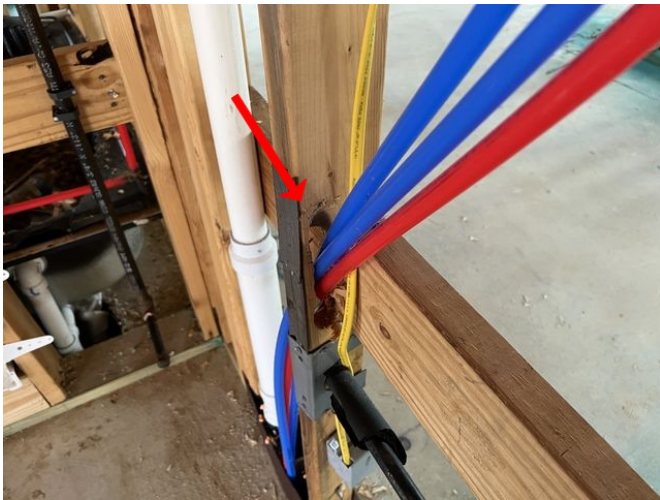
Stud boring excessive utility room rear wall

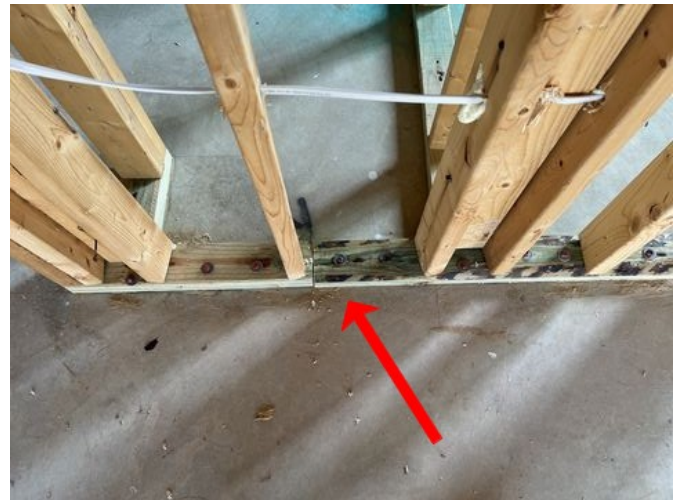
Joint not blocked garage rear wall toe plate

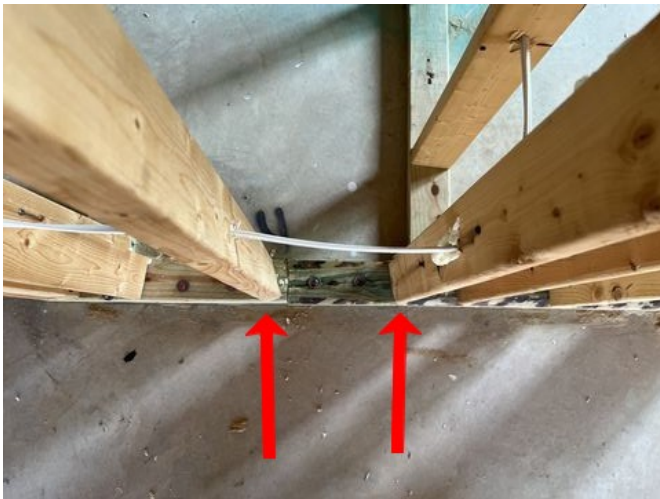
Studs twisted base rear garage wall

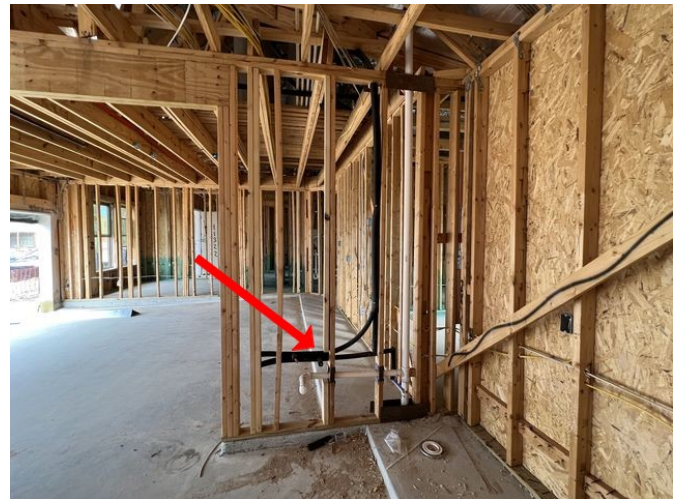
- Studs observed twisted at the toe plate at the garage rear wall.
- Double wall stud cut at the garage sink drain. The double wall stud is supporting at ceiling beam at the garage attic.

Double stud not continuous at garage sink drain

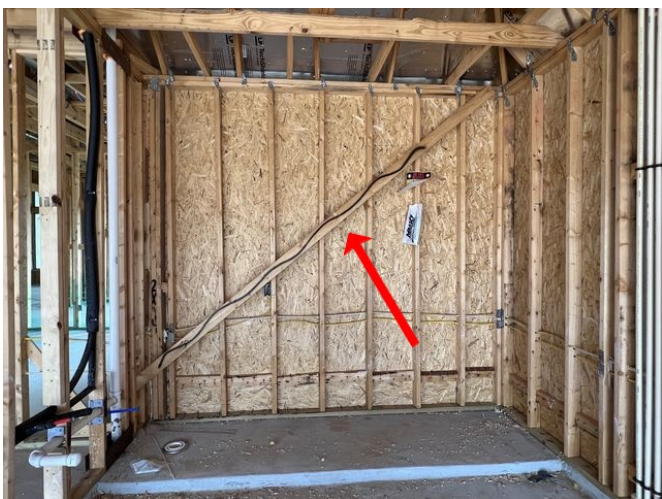
Temporary brace not removed rear garage wall

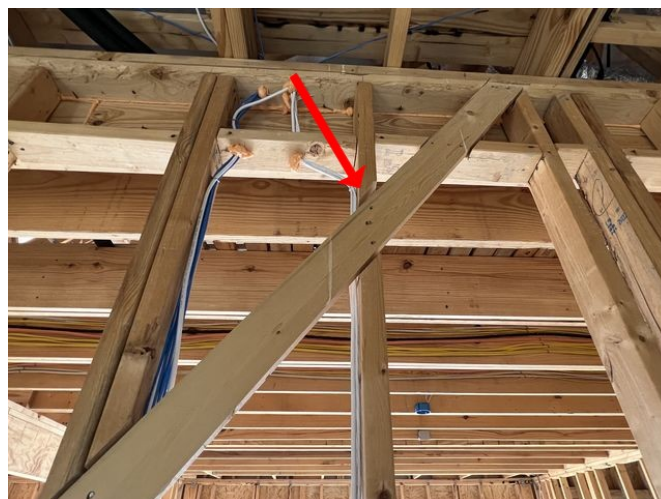
Studs over notched at LIB at rear garage wall

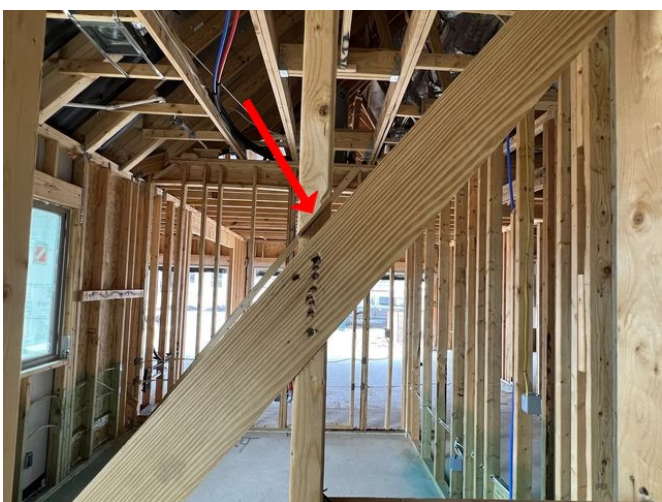
Studs over notched at LIB at front office wall

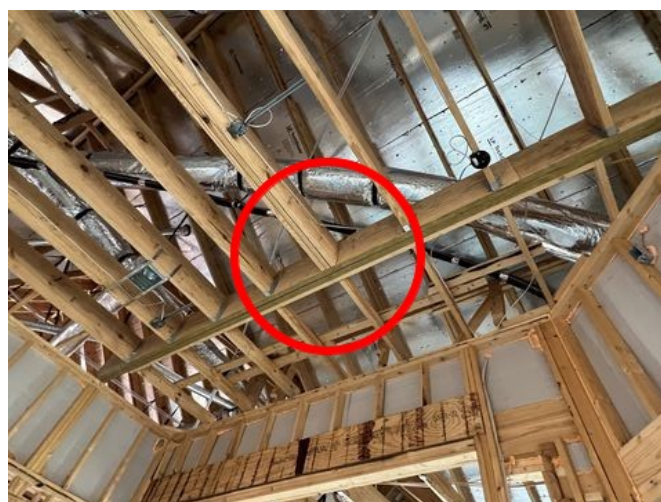
Joist hanger missing above kitchen at beam intersection

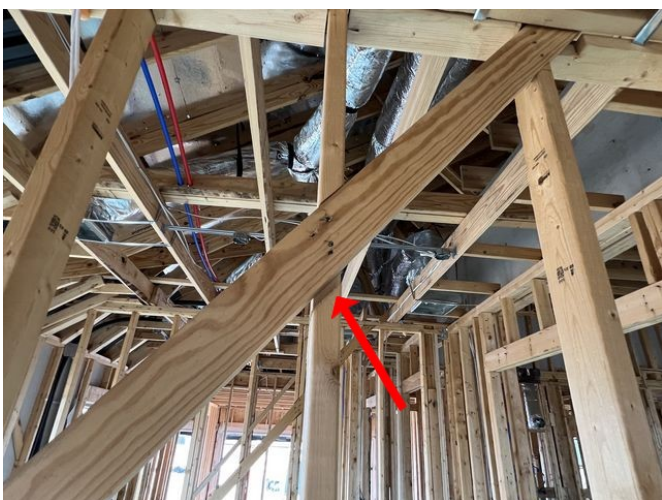
Studs over notched at LIB at right middle bed wall

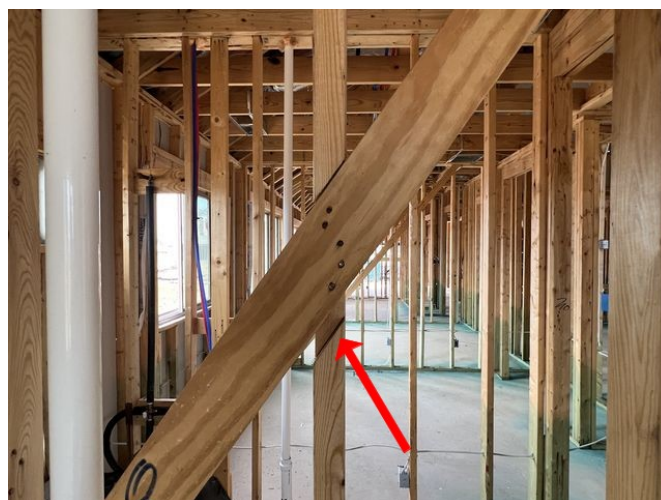
Studs over notched at LIB at right rear bed wall

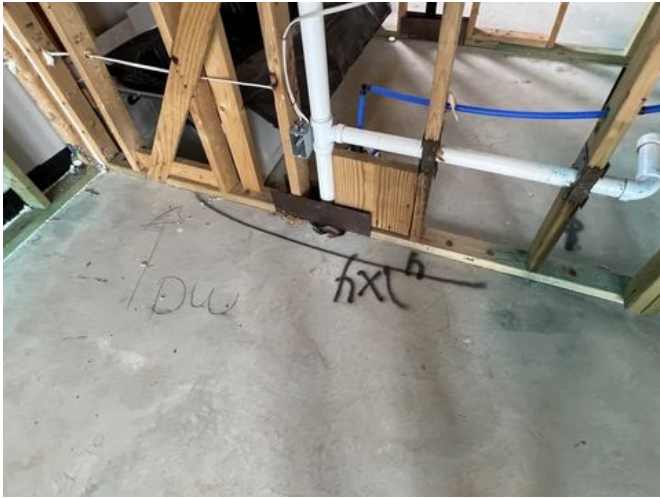
Slab not patched at right rear bedroom floor

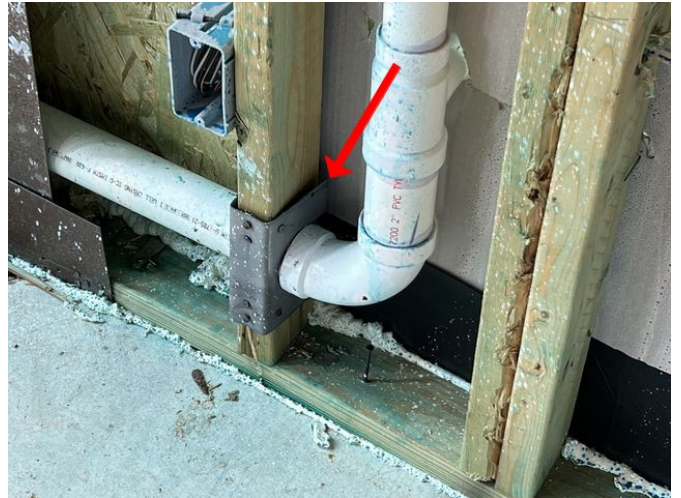
Nails missing at stud boot master bedroom right wall

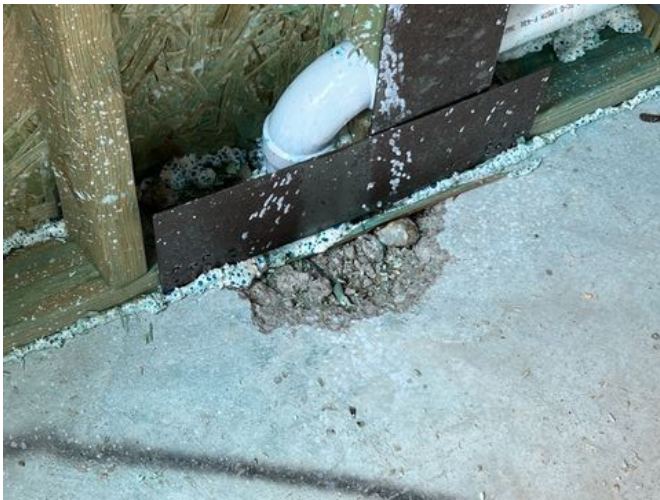
Slab not patched at master bedroom right wall

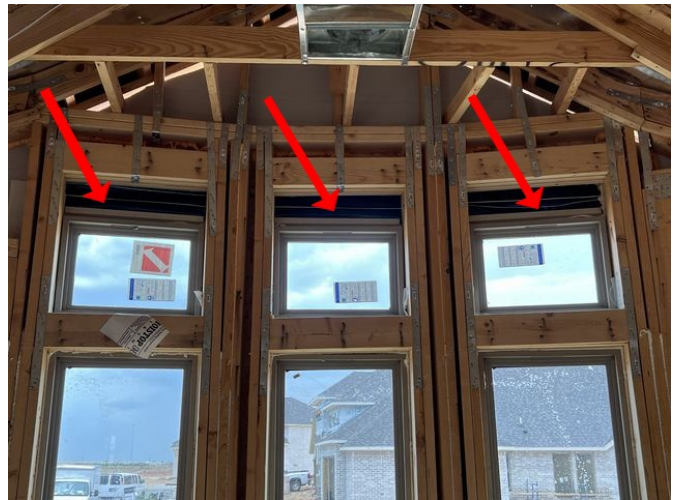
Master bedroom clearstory windows not poly sealed

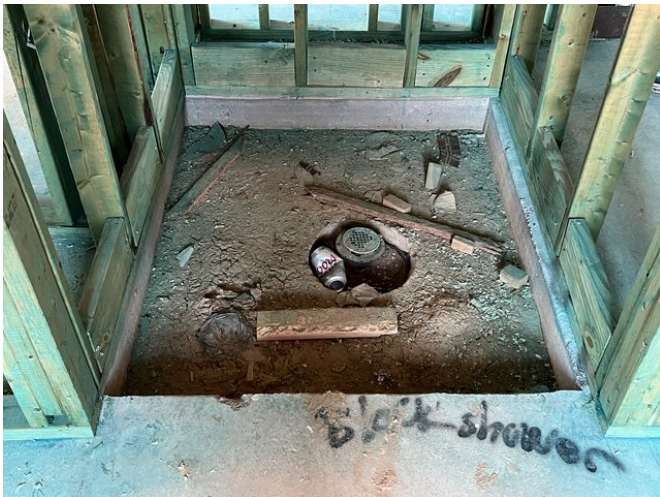
Shower liner missing at master bathroom

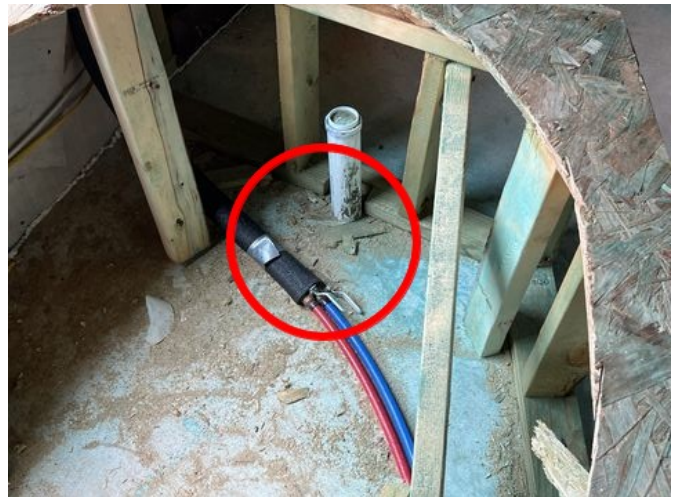
No drain well present at master tub

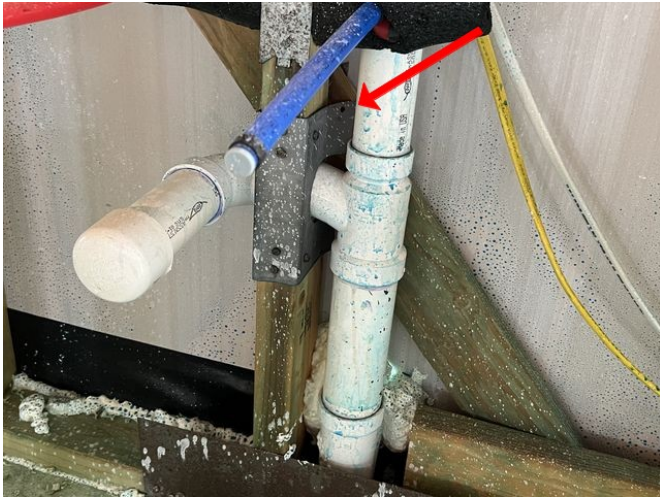
Nails missing at stud boot left master bathroom sink

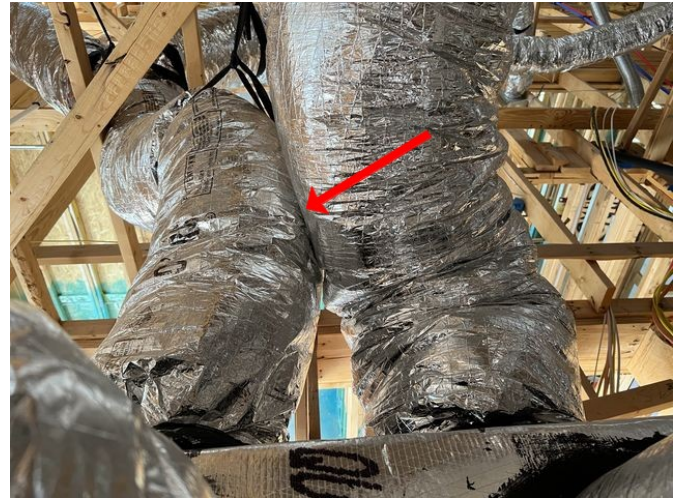
- Separate ductwork where touching at the attic to prevent thermal bridging. Thermal bridging causes condensation to form on the exterior of the ductwork that can drip in the attic.

Separate ductwork where touching at attic

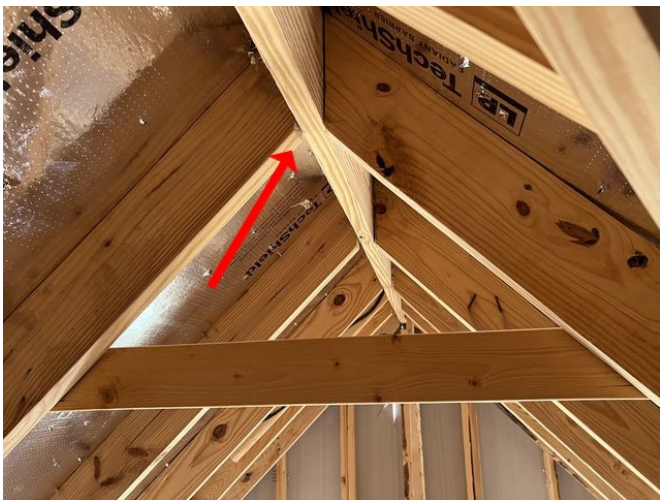
Ridge brace undersized at garage gable

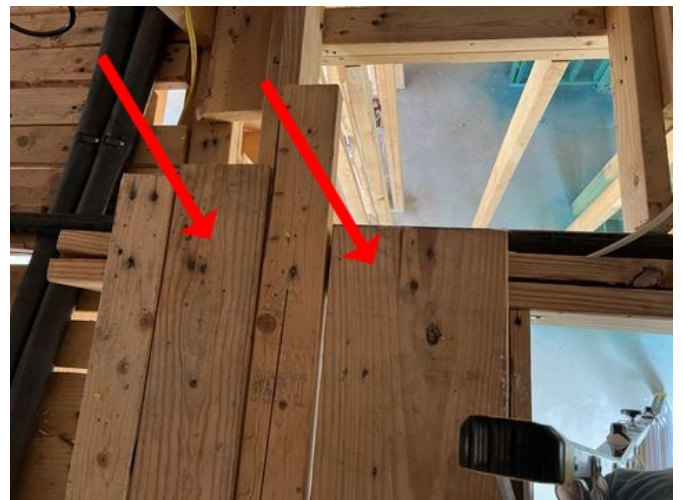
Nails missing decking top ladder access opening

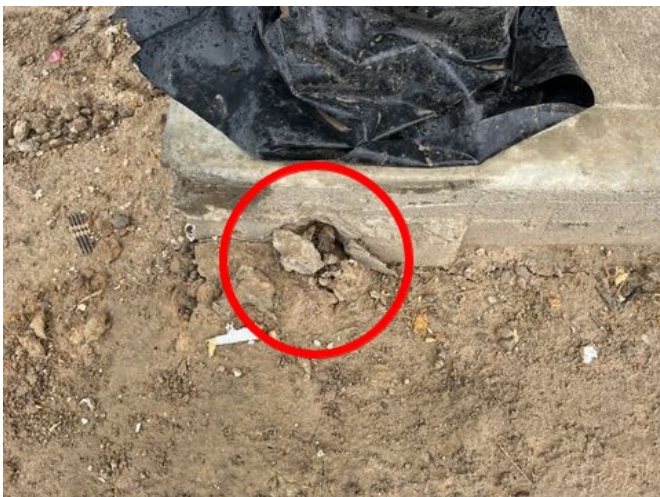
Post tension cable blow out left front dwelling

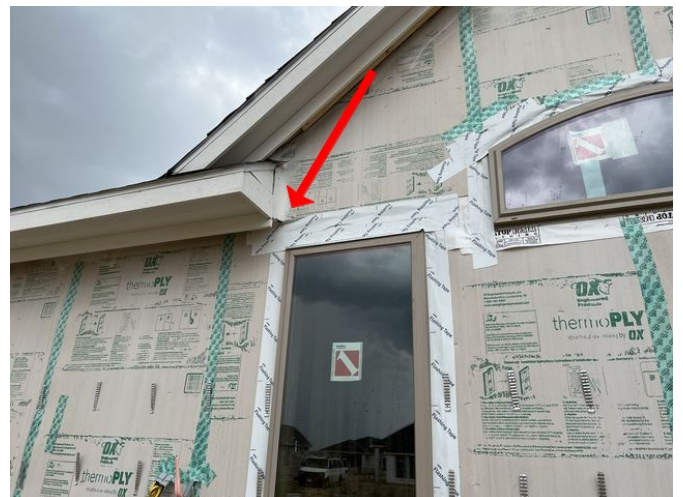
Loose flashing tape above dining room window

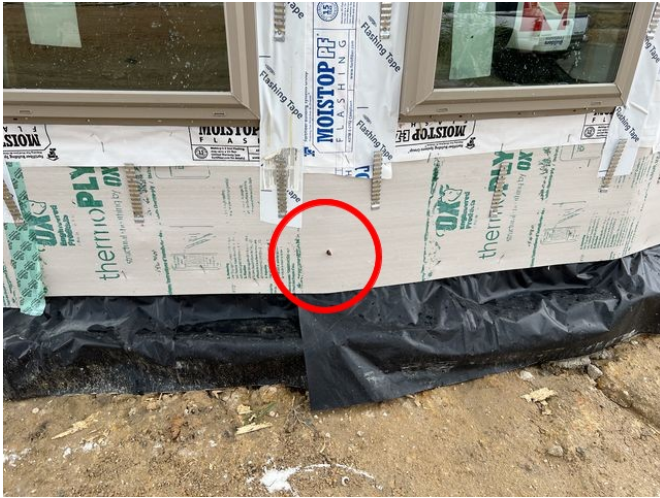
Hole T-ply rear master bedroom wall

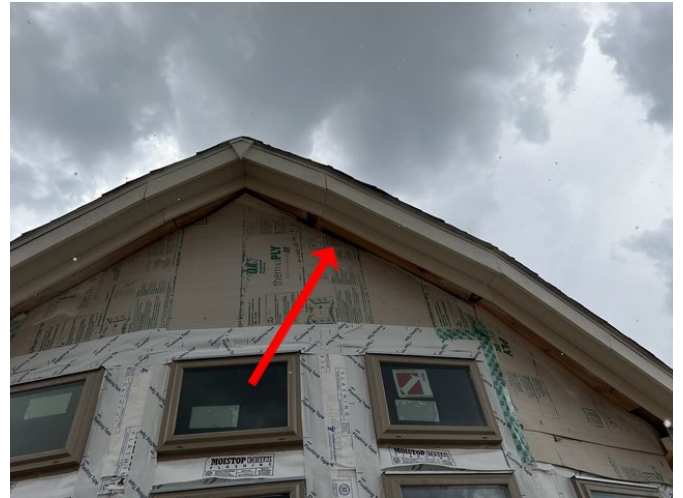
Gap in the T-ply rear master gable

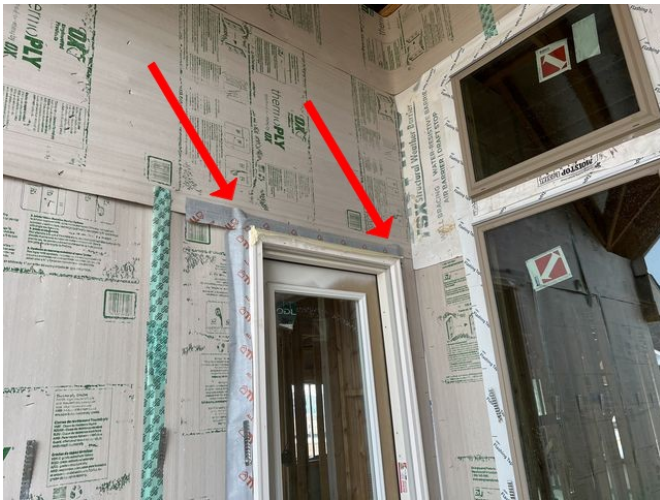
Loose flashing tape above rear patio door

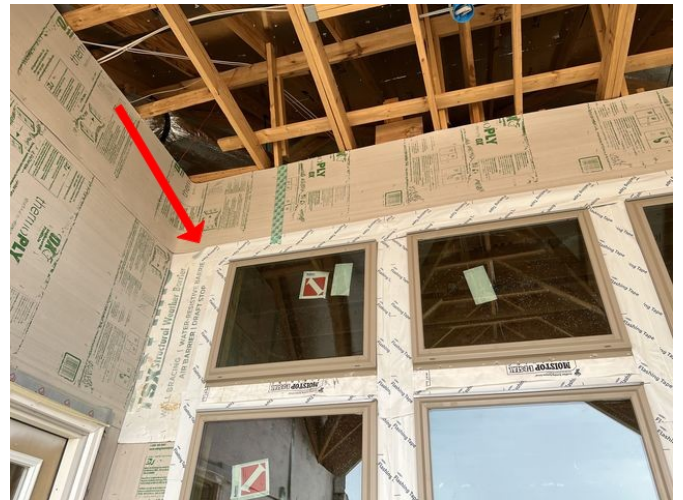
Loose flashing tape above family room window

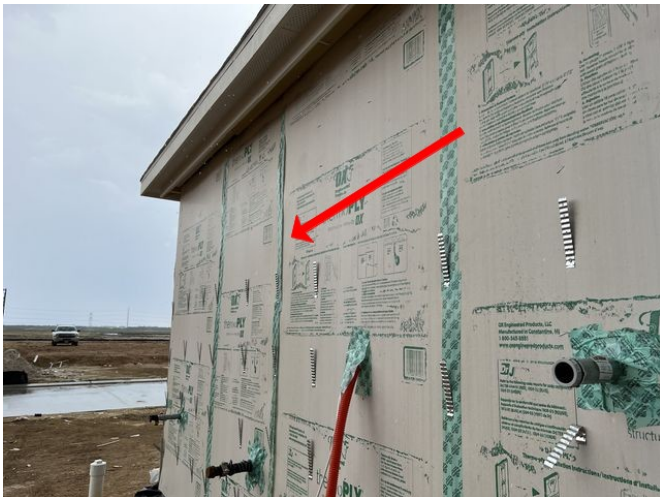
Loose T-ply flashing tape right garage wall

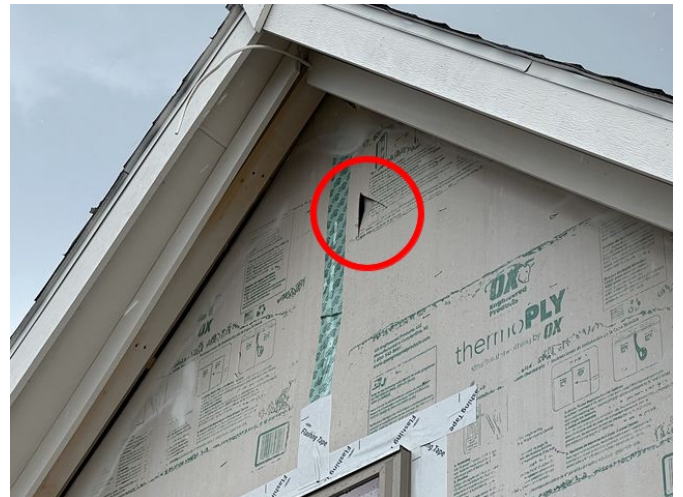
Hole T-ply at garage gable

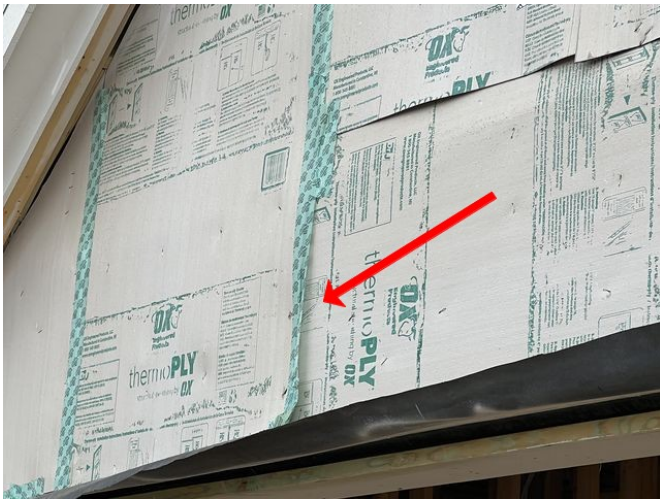
Loose flashing tape above the garage double door

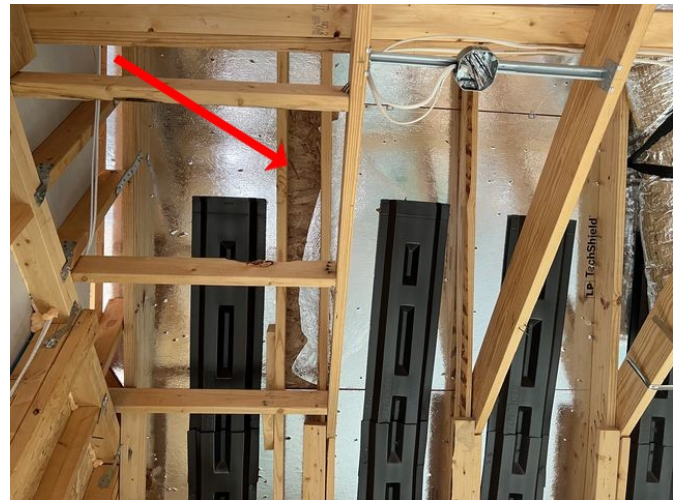
Damaged radiant barrier above right rear bedroom

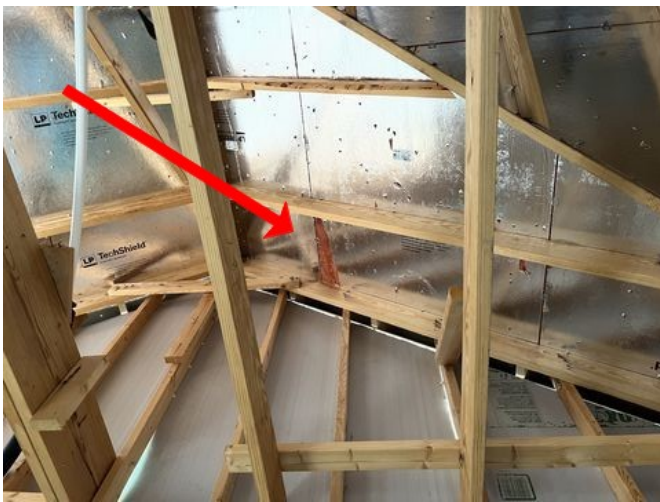
Damaged radiant barrier above left front bedroom
