# A+ HOME INSPECTIONS

1234 Anywhere Street  
Houston, TX 77000

Date: 02/13/2023

Re: Commercial inspection at 1234 Anywhere Street

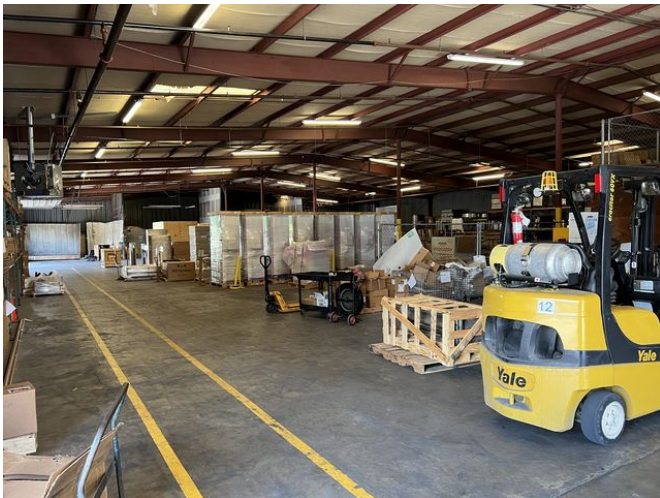
The building is a steel frame construction with a corrugated steel wall exterior. The foundation is slab on grade construction and the slab appears to be performing its intended function.

*Building is steel frame construction on slab*

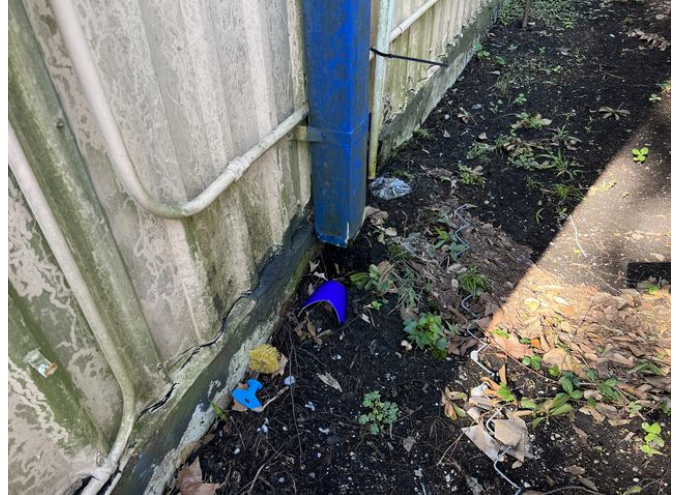
The grading is not properly sloped away from the dwelling at the right, rear and left rear corner of the dwelling. The gutter downspouts at the right exterior are not installed with directional diverters and causing erosion under the downspout.

*Downspouts missing diverters and splashblocks, erosion*

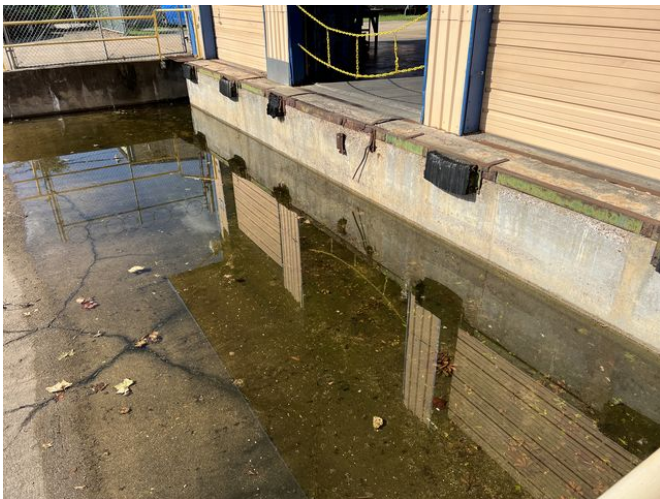
*Standing water front delivery well*

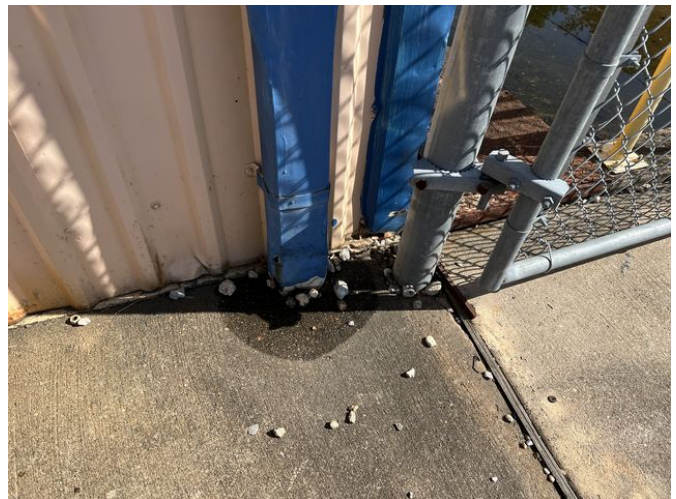
*Left front downspout leaking at drain pipe connection*

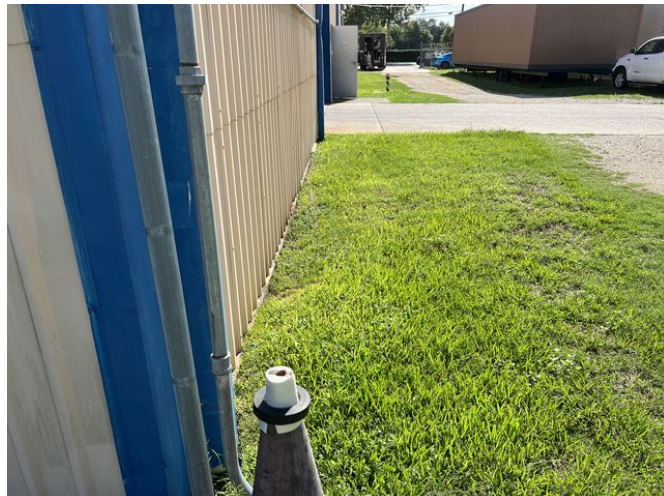
*Inadequate slope left rear building*

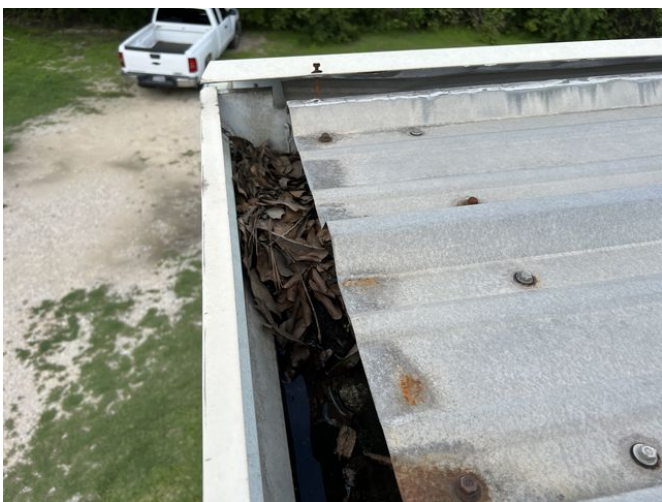
*Debris gutters*

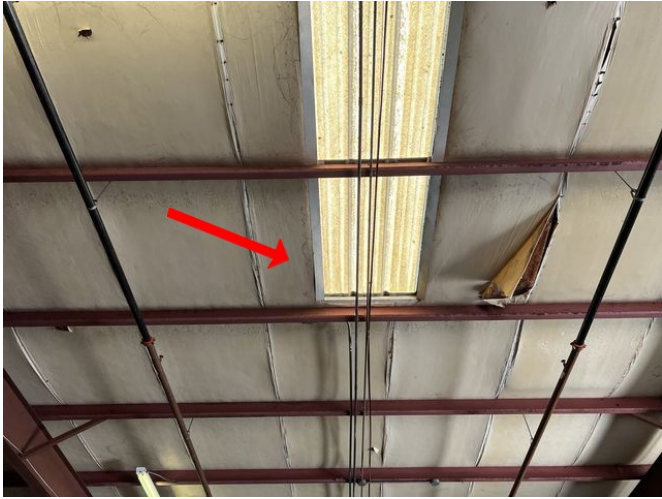
*Skylight leaking left roof slope*

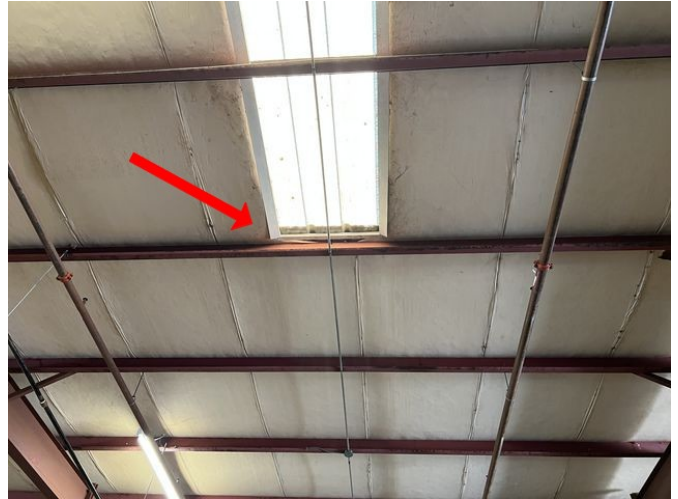
*Skylight leaking left roof slope*

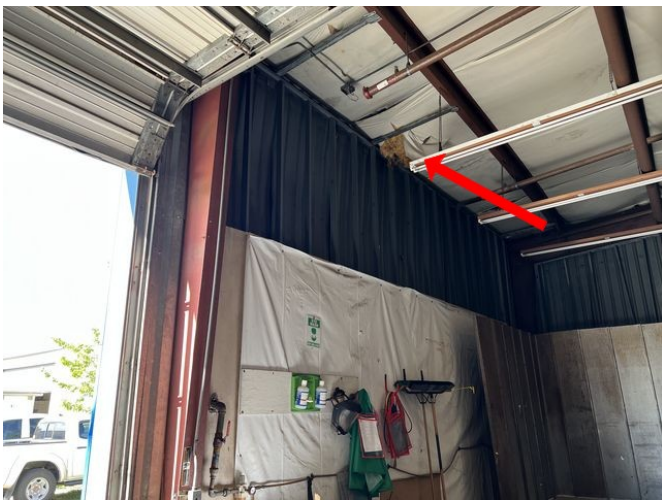
*Leak at left rear corner warehouse*

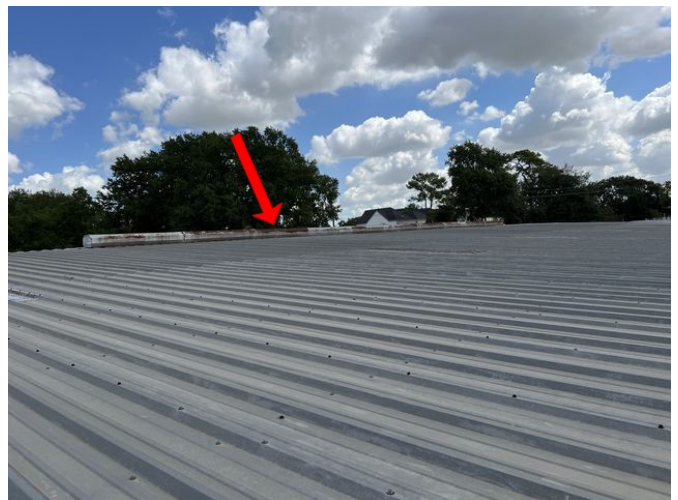
*Rust along the ridge cap*

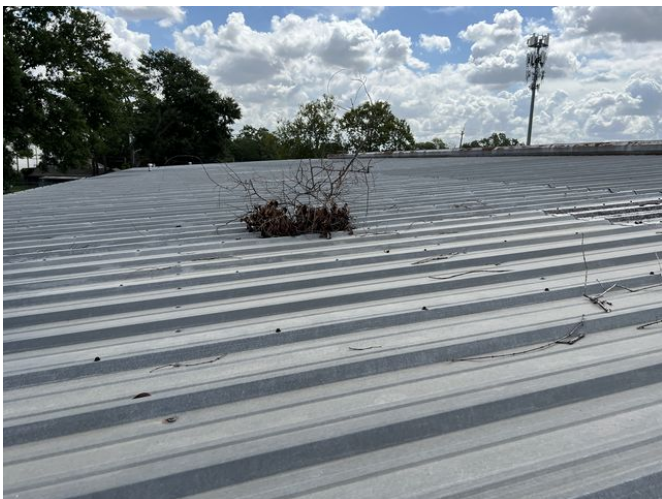
*Debris right roof slope*

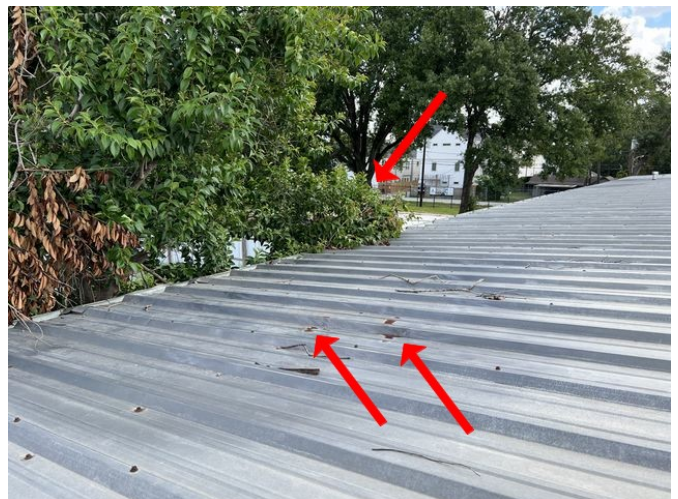
*Rust at roof covering, vegetation contact right slope*

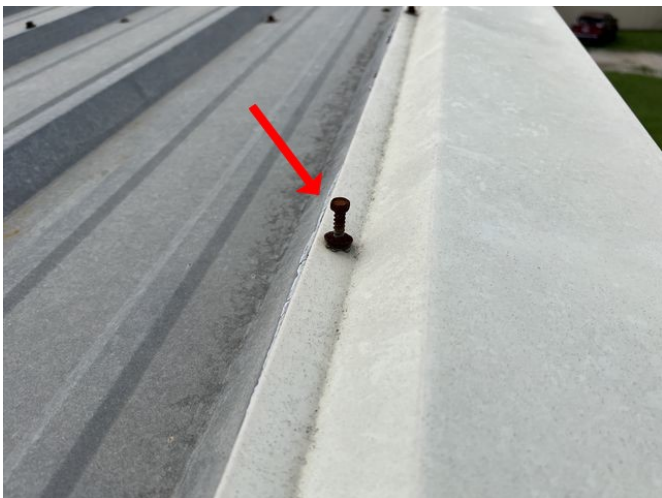
*Loose fasteners at roof covering*

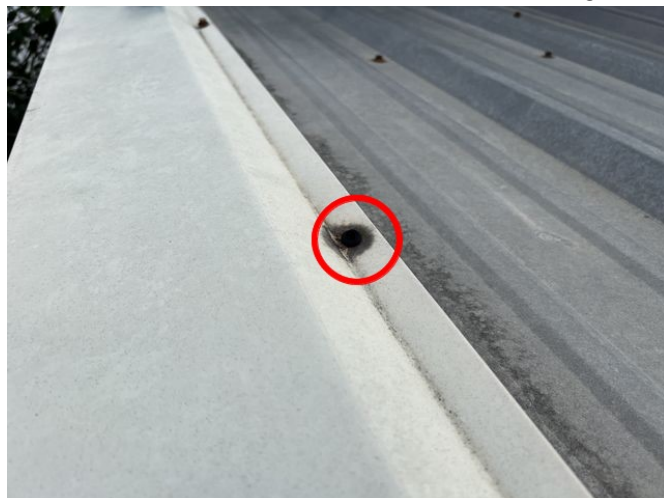
*Missing fasteners at roof covering*

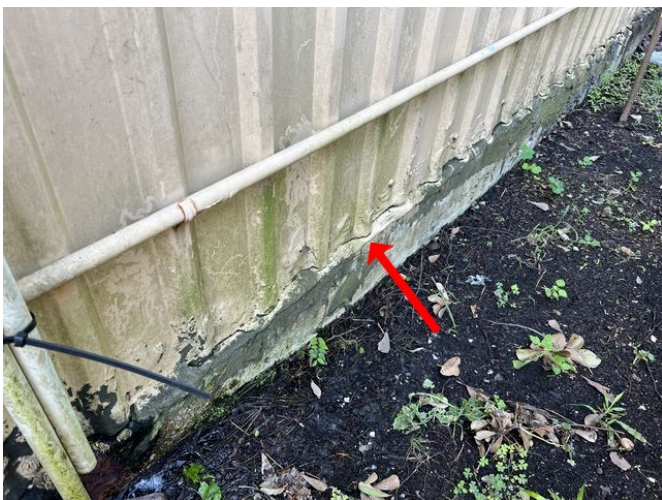
*Siding not flashed at the slab, tar applied in places*

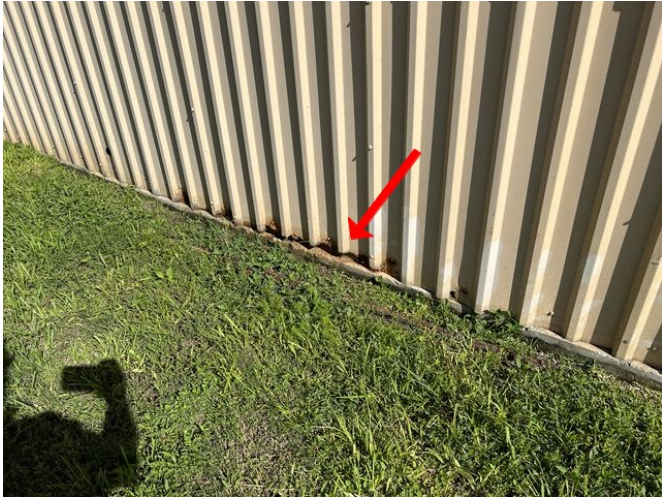
*Rust at the base of the walls at several locations*

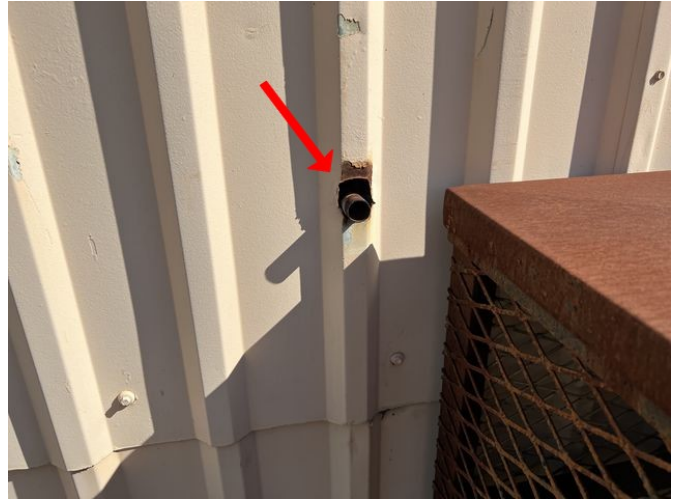
*Penetrations not sealed several locations*

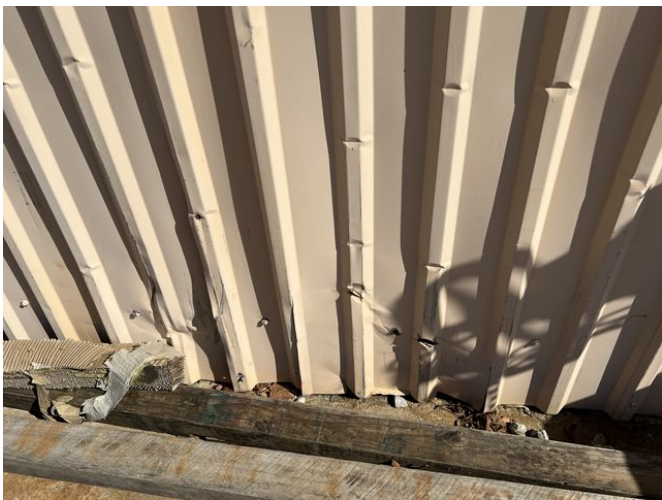
*Damaged siding from equipment contact*

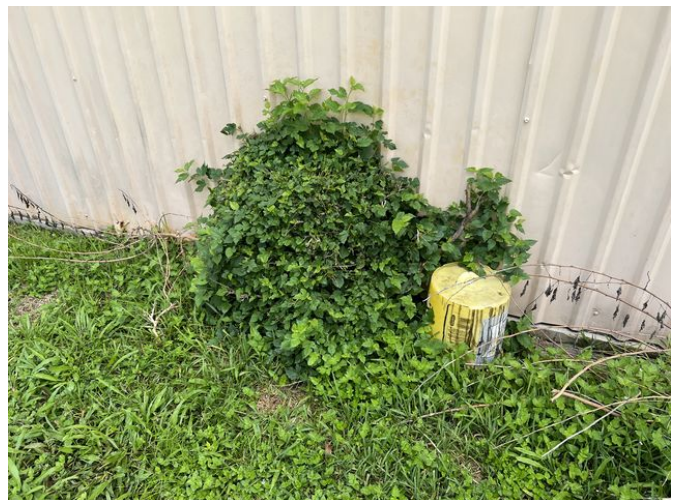
*Vegetation contact siding rear dwelling*

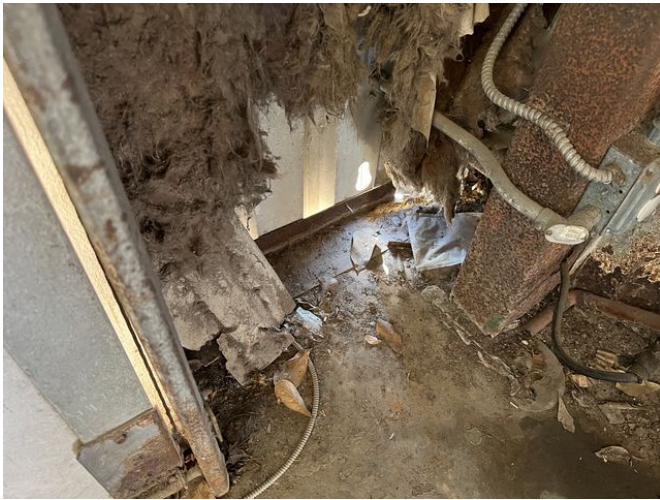
*Hole siding front building, insulation missing*

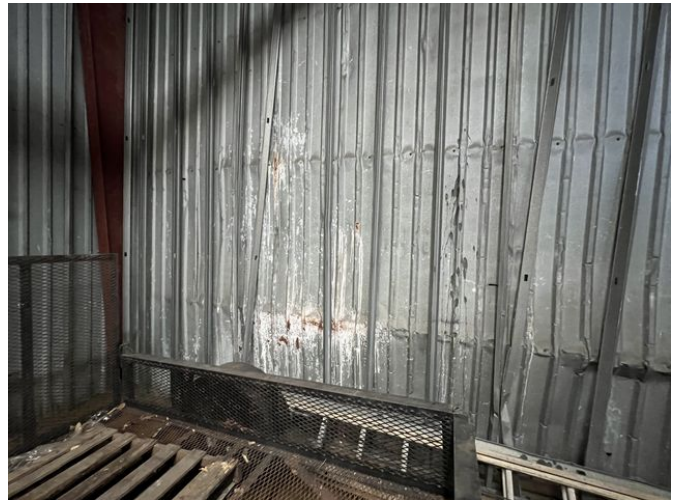
*Metal stud damage right warehouse wall, siding rusted*

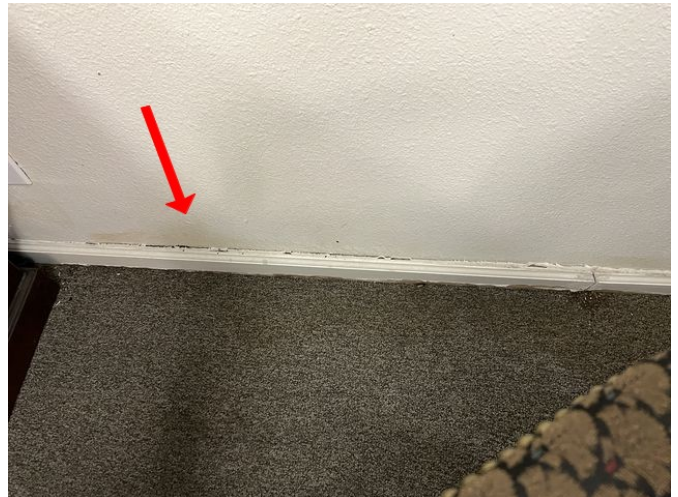
*Moisture stains right front office base wall*

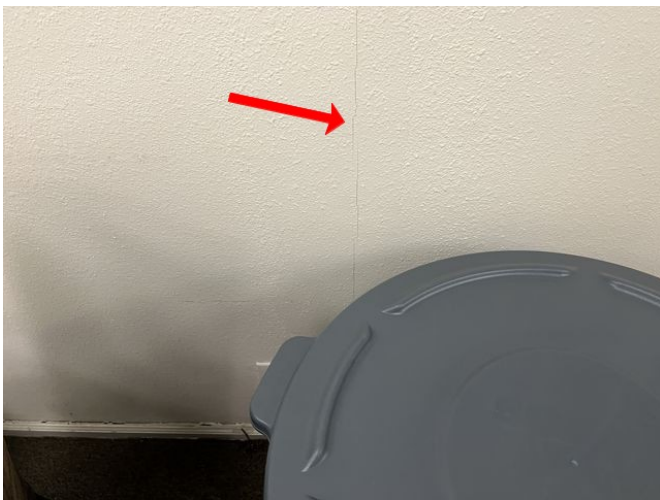
*Drywall crack right front office right wall*

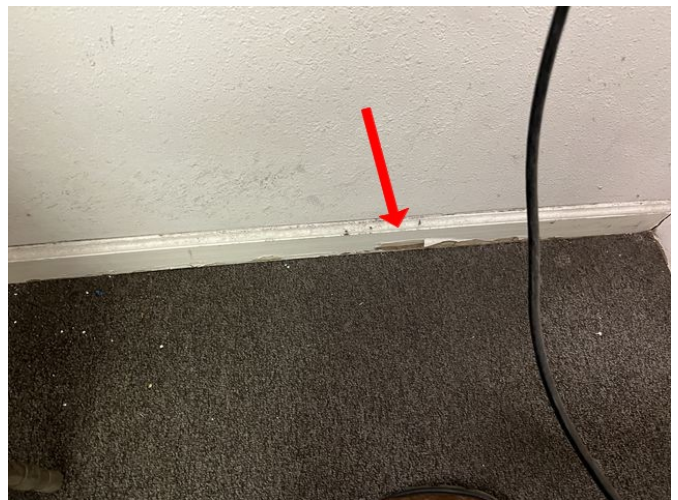
*Moisture stains receptionist room front wall*

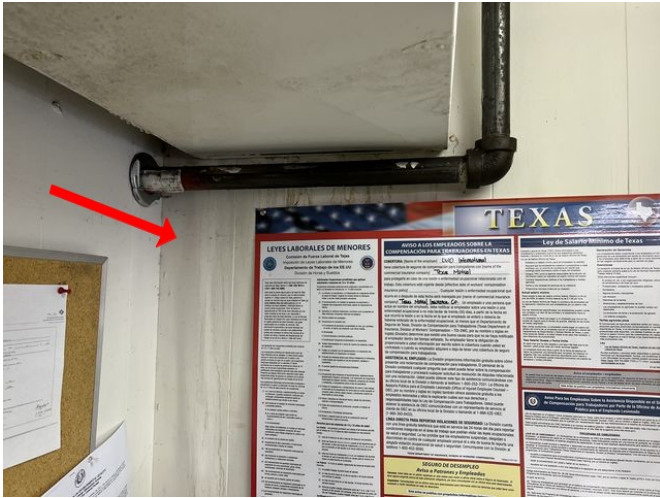
*Moisture stains receiving room front wall*

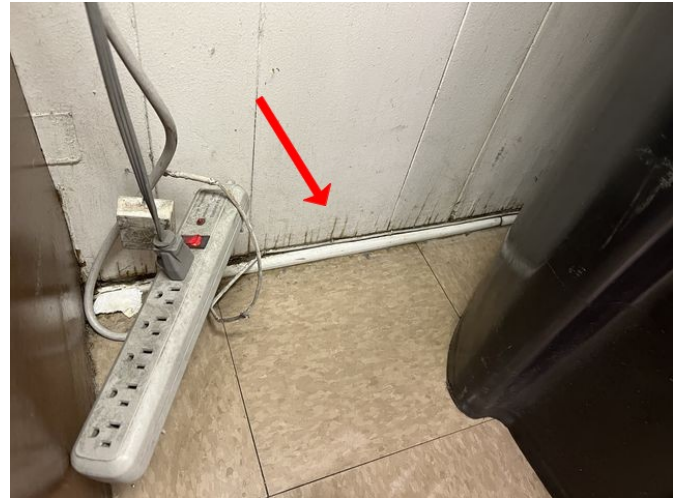
*Moisture stains receiving room front wall*

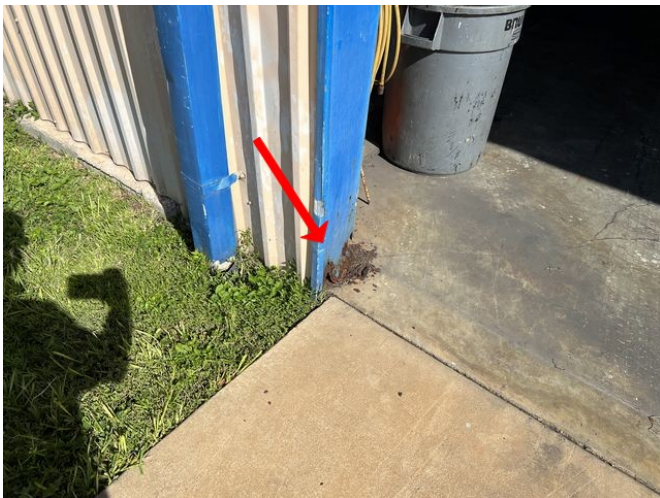
*Deteriorated jamb warehouse garage door*

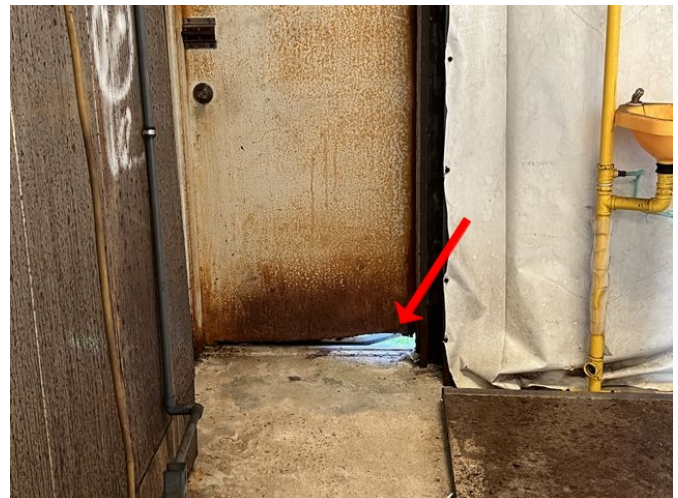
*Rear warehouse door deteriorated*

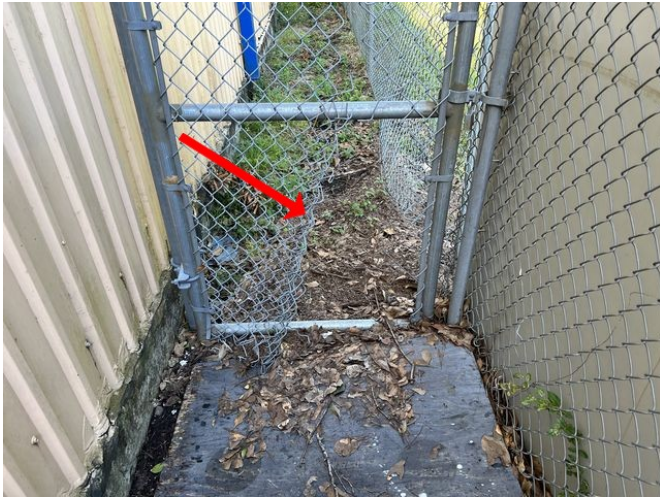
*Gate damaged right side building*

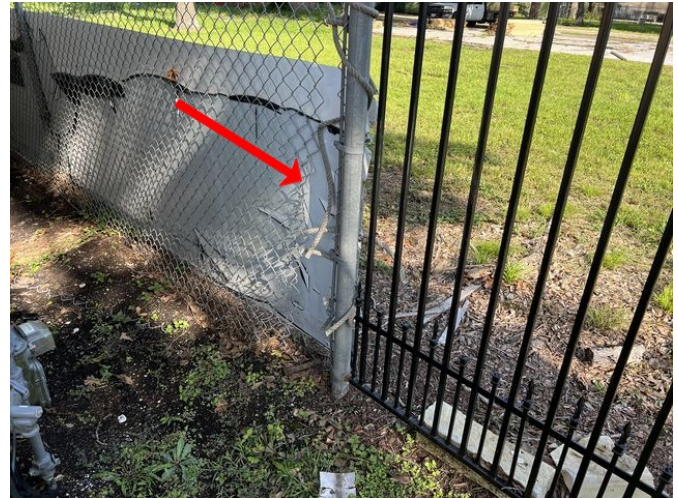
*Right property line fencing damaged*

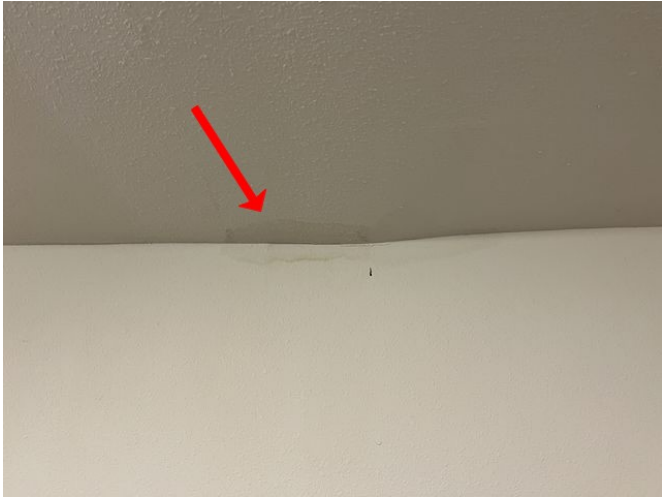
*Moisture stain right office ceiling*

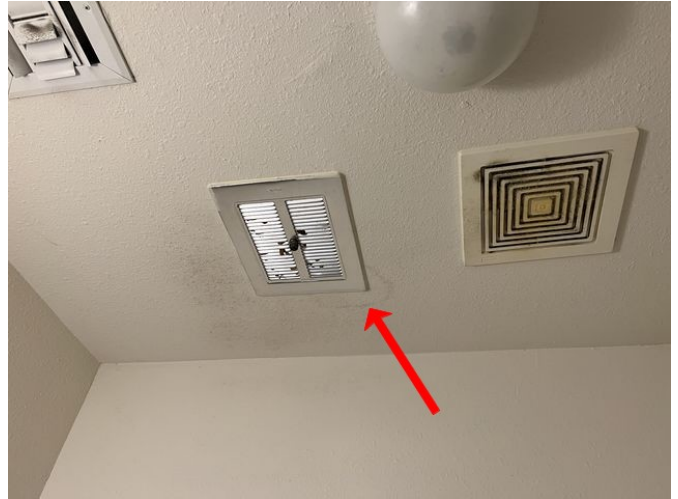
*Moisture stain women's bathroom ceiling*

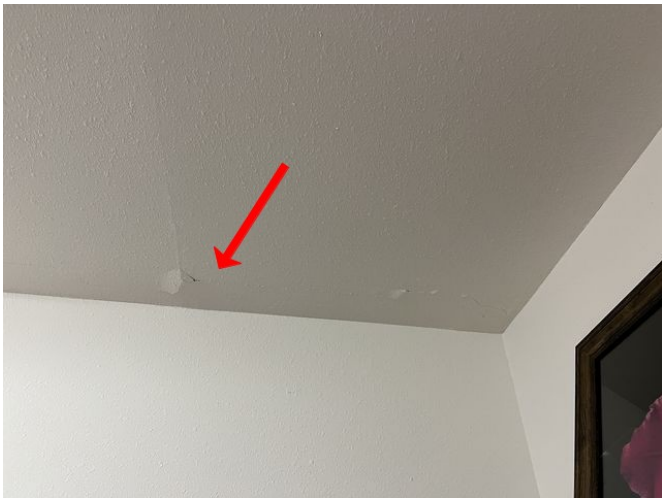
*Drywall cracked rear office ceiling*

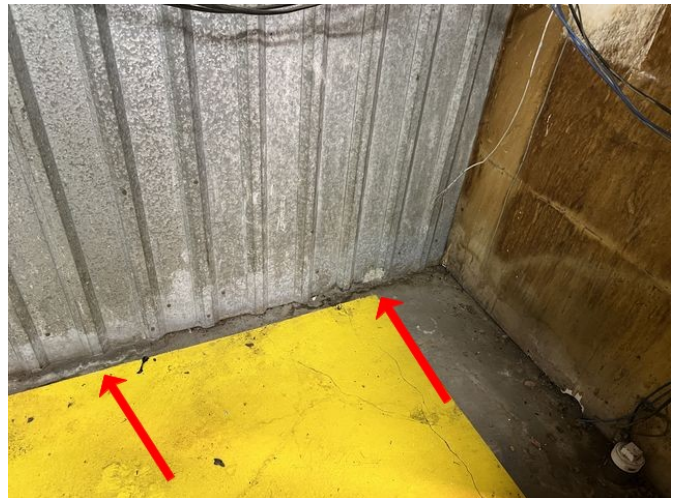
*Moisture stains storage room floor at right wall*

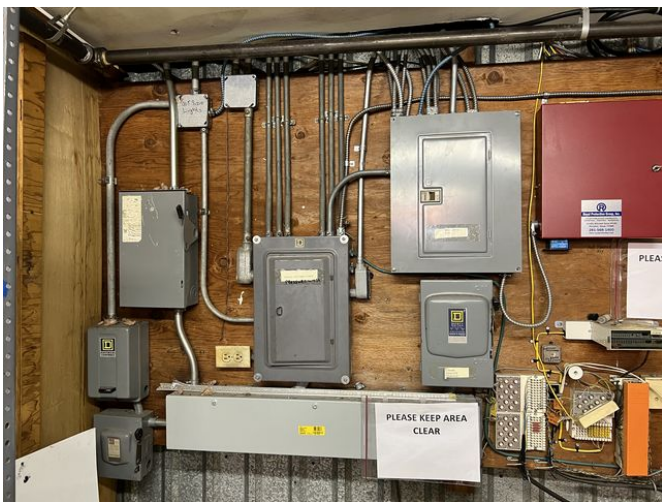
Building electrical service at the storage roof

Moisture observed at the interior of the gutter cabinet. No bonding bushing at the service conduit. Several conductors observed double lugged at the terminals.

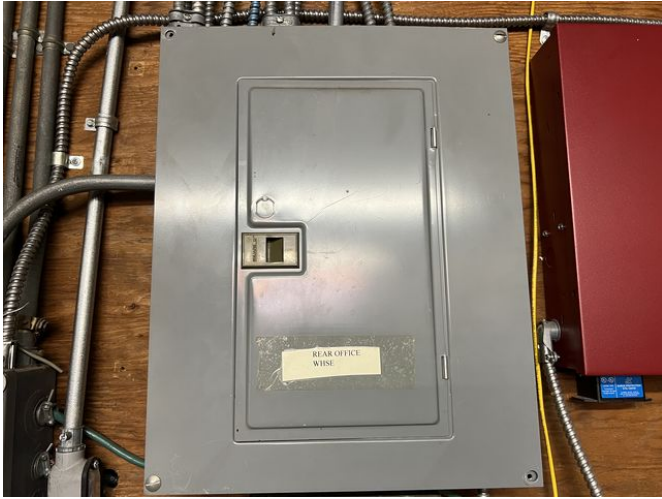
Right panelboard, Square D

The branch circuit distribution panelboard is missing labels, 2 set screws are missing, neutrals are double terminated, neutrals and grounds are in common and not properly separated, no grounding conduction installed between the panelboards, the black sheathed service neutral is not marked white, trip ties missing at the circuit breakers that have a shared neutral, the panelboard is not properly bonded.

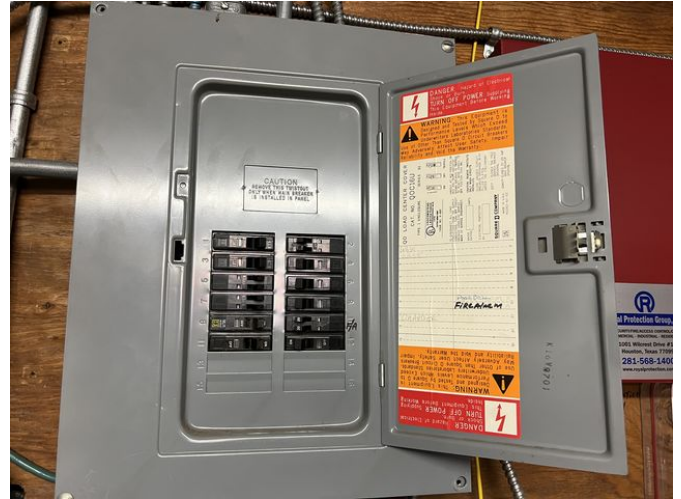
Labels missing at the dead front cover

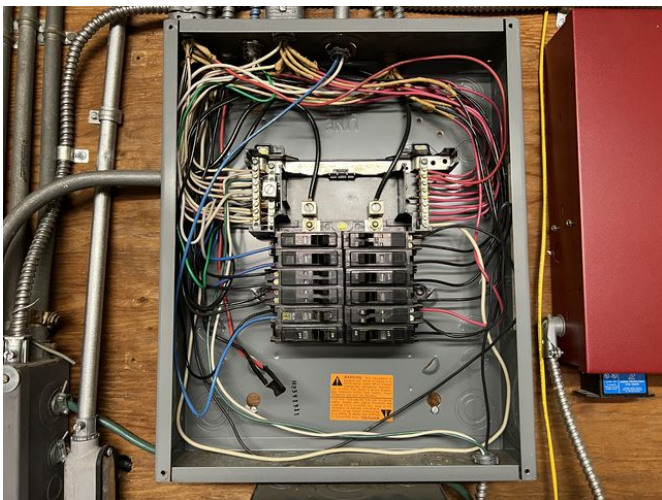
Neutrals and ground in common, no ground from panel

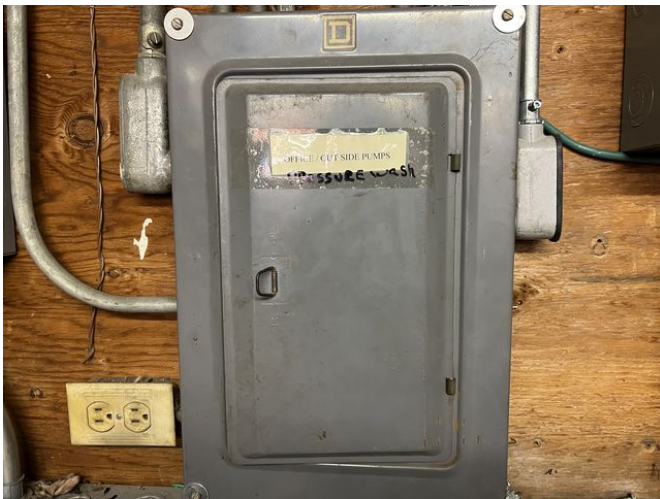
*Left panelboard, Square D*

The branch circuit distribution panelboard is missing labels, improper set screws installed at the dead front cover, knockouts are not covered at the bottom of the panelboard, the neutral and grounds are in common and not properly separated, black sheathed ground is not marked green, panelboard is not properly bonded.

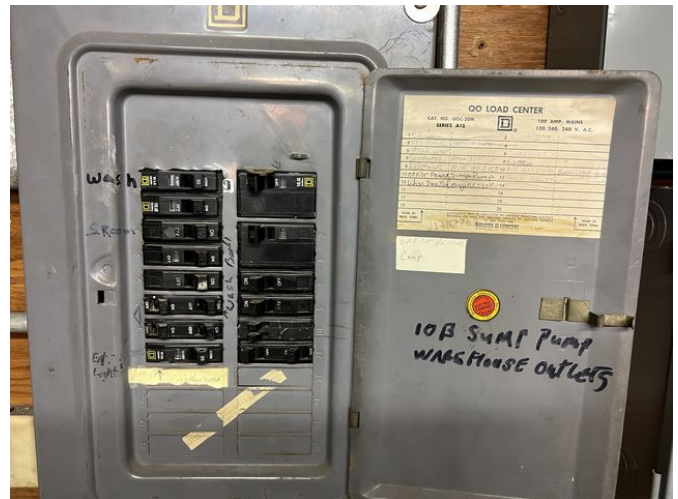
*Labels missing at dead front cover*

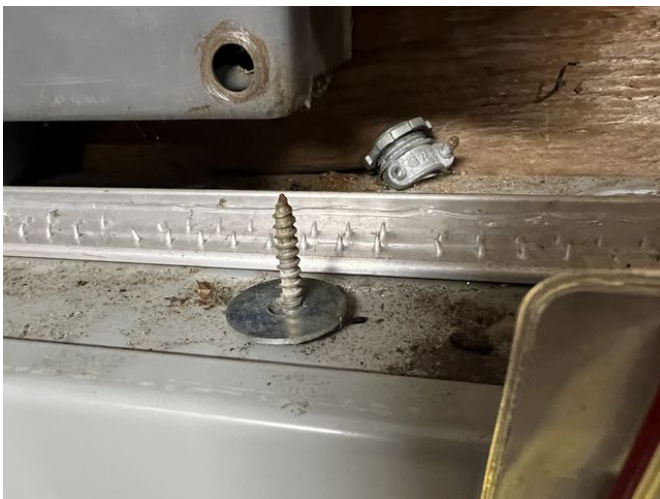
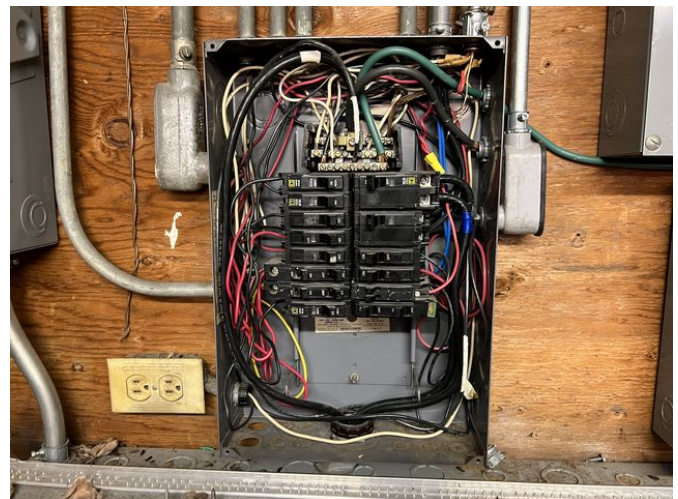
*Improper set screws dead front cover*

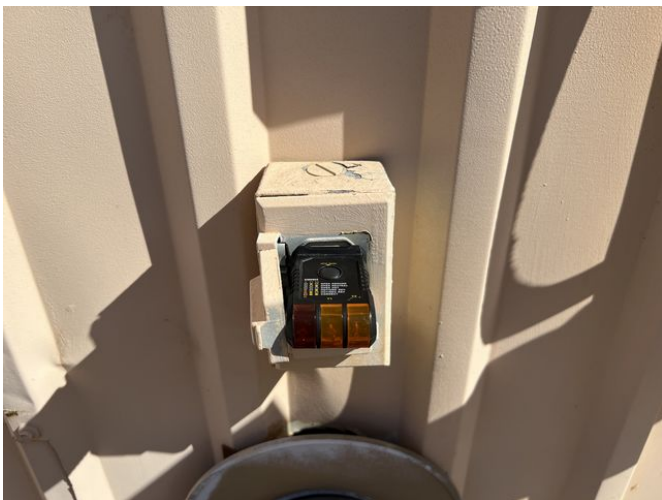
*No GFCI receptacles at the exterior*

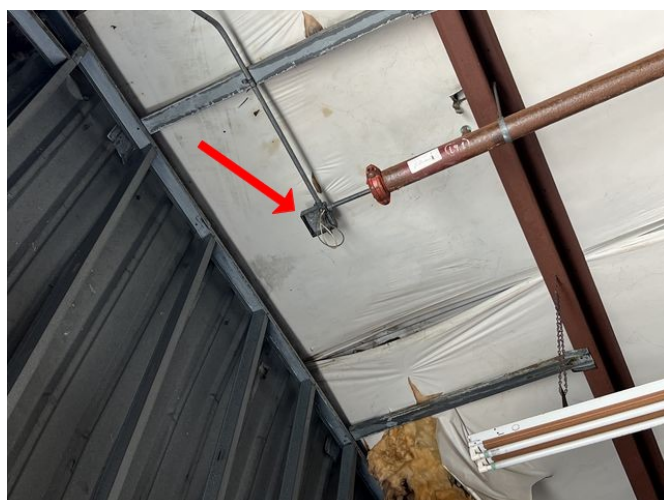
*Junction box coverplate missing at warehouse ceiling*

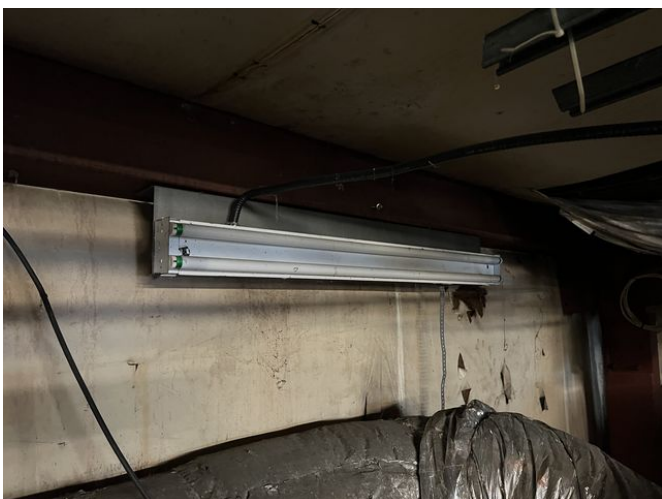
*Attic light at the right wall not working*

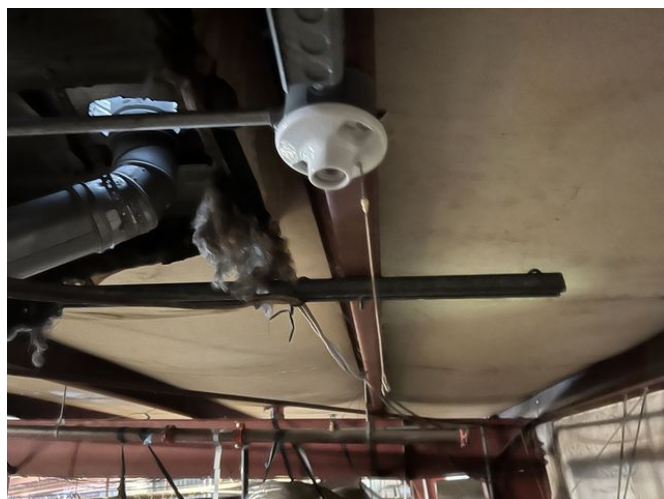
*Bulb missing at the attic light fixture*

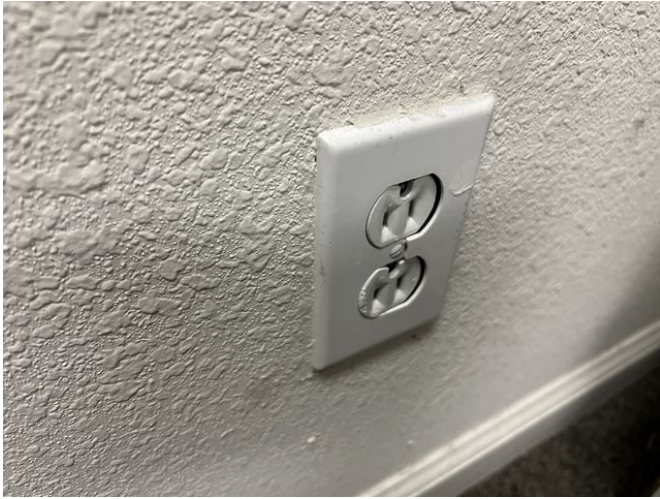
*Several of the coverplates are cracked in the offices*

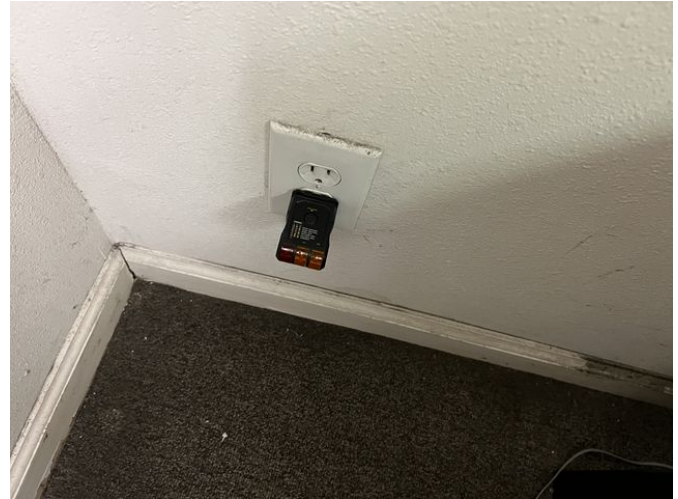
*No power reception left wall receptacle*

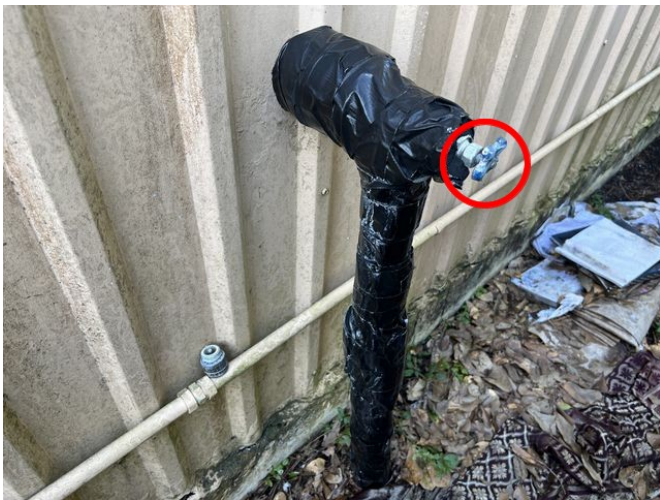
*Broken wheel handle right hose bib*

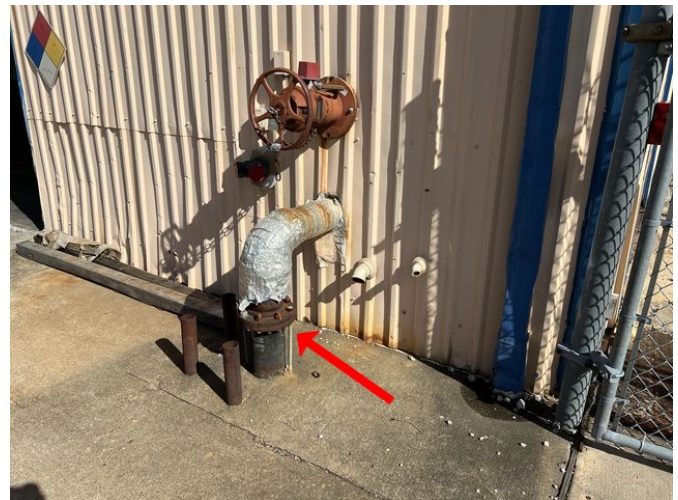
*Insulation missing at sprinkler main waterline*

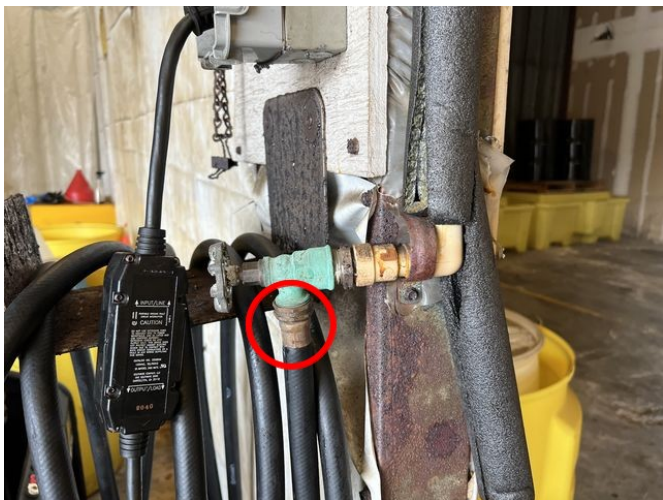
*Anti-siphon devices missing at hose bibs*

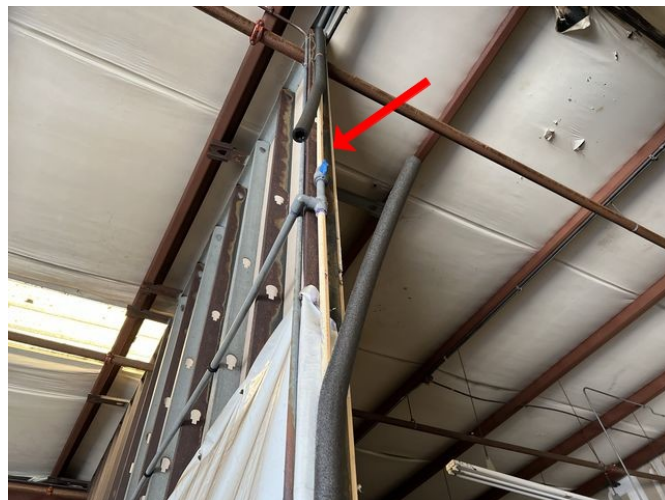
*Waterlines not properly insulated at warehouse*

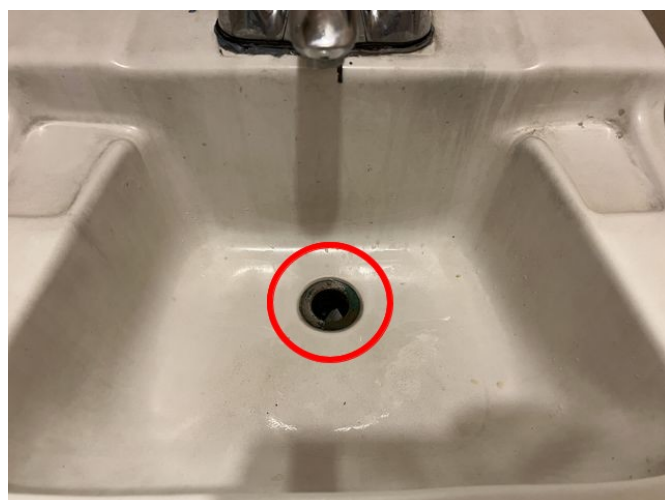
*Sink stopper missing storage room bathroom*

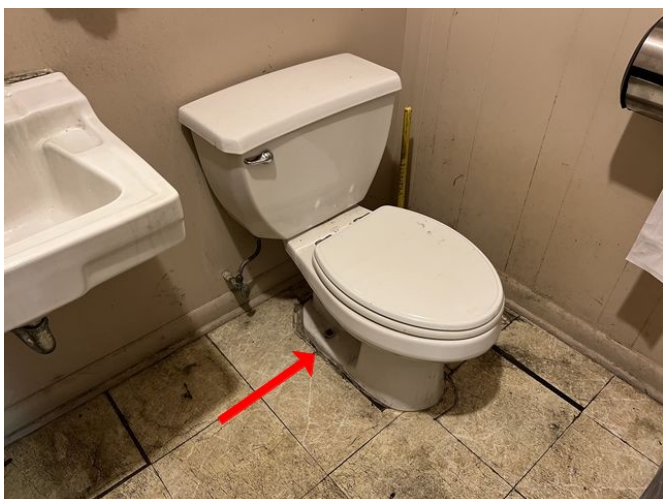
*Commode loose at floor storage room bathroom*

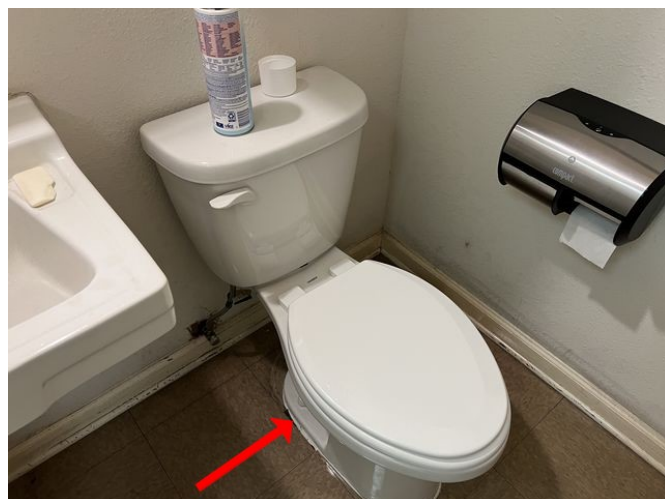
*Commode loose at floor women's bathroom*

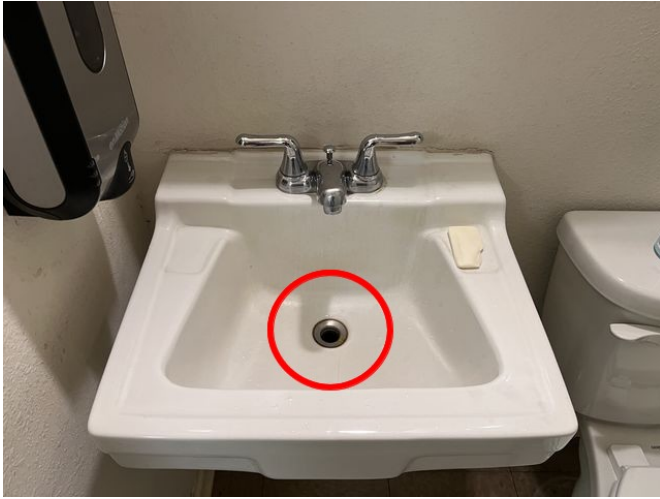
*Sink stopper missing women's bathroom*

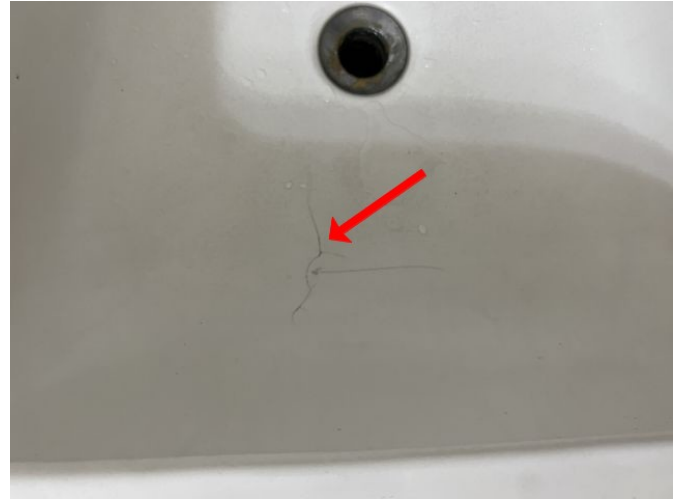
*Sink bowl cracked men's bathroom*

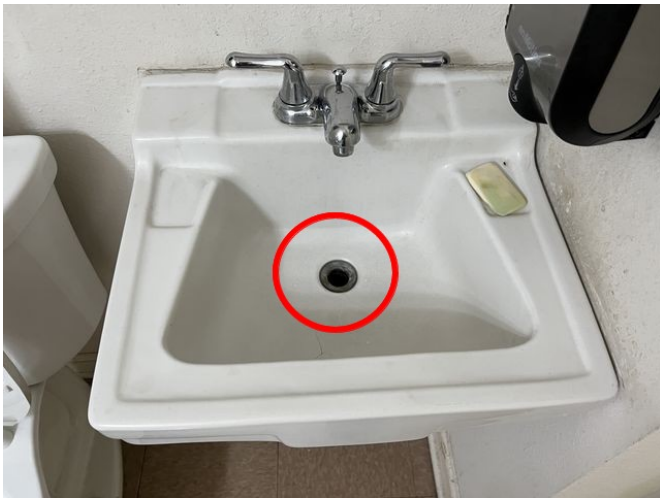
*Sink stopper missing men's bathroom*

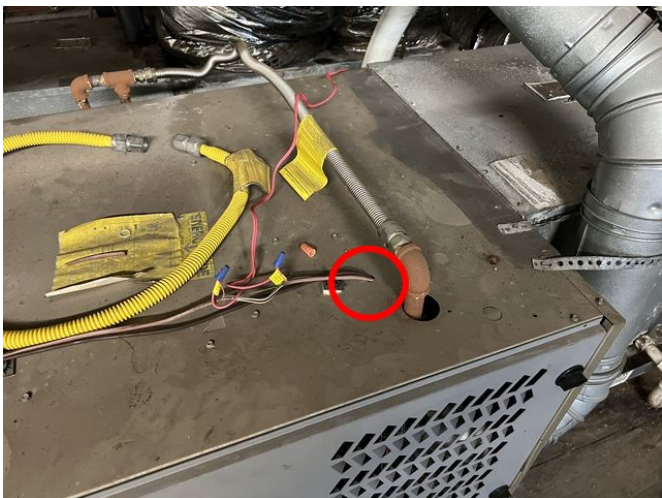
*Thermostat wires not sleeved at office furnace*

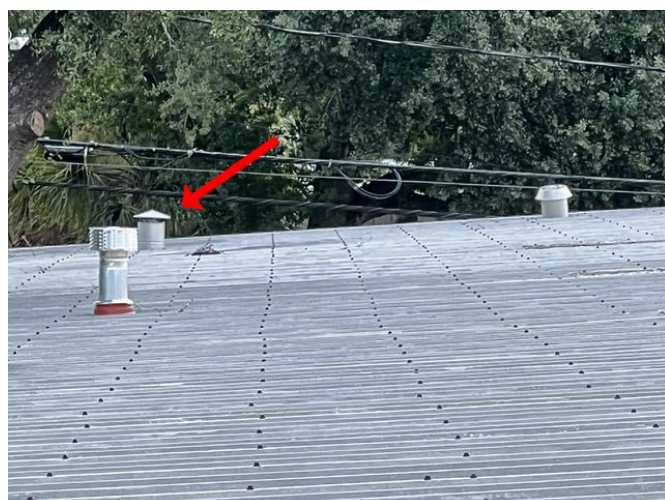
The furnaces were performing at the time of inspection. The thermostat wires are not sleeved at both furnace cabinets. The office furnace gas shut off is located too far from the equipment. Both furnaces are not properly vented to the exterior of the building. The furnace vents should extend the proper distance above the roof and be terminated with a cap and collar.

*both furnace are not properly vented to the exterior*

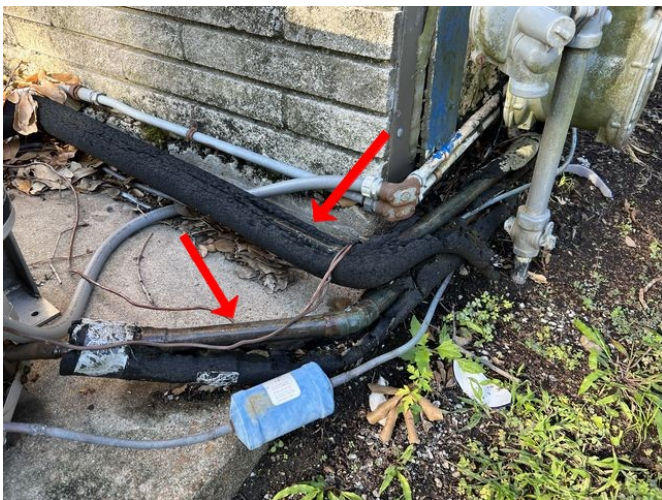
Deteriorated suction line insulation at exterior

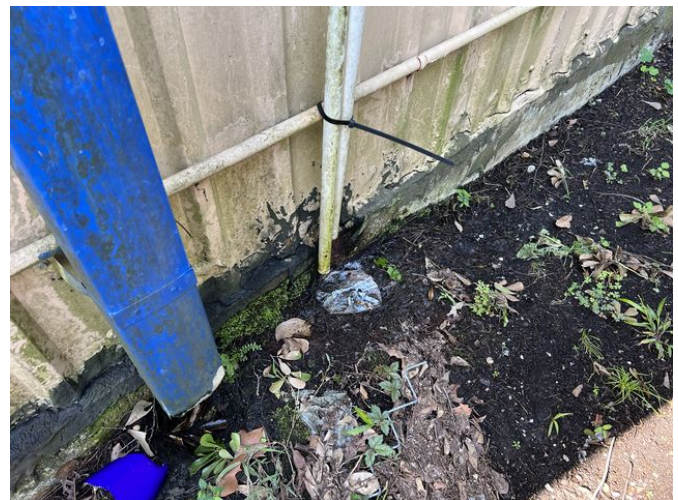
A/C drain lines deposit right side building

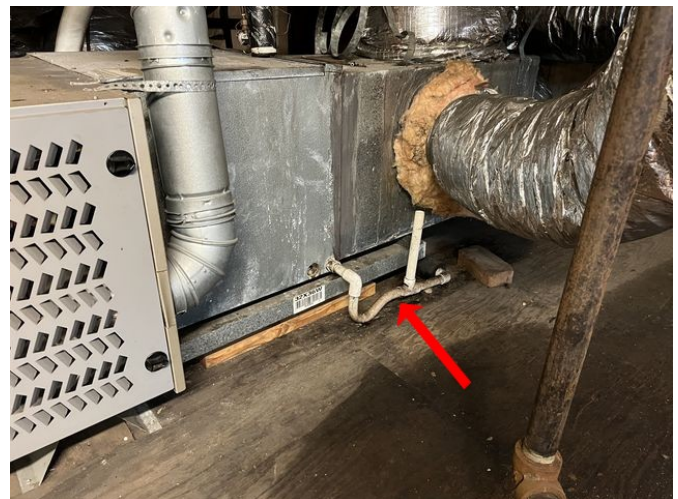
Insulation missing office A/C primary drain line

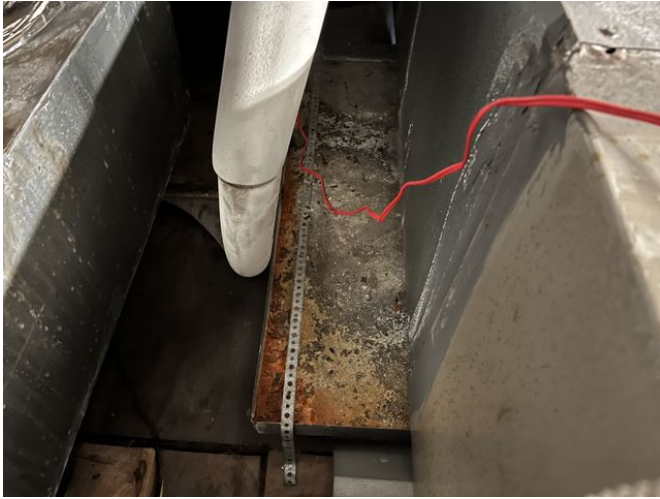
*Office A/C drain pan rusted, monitor*

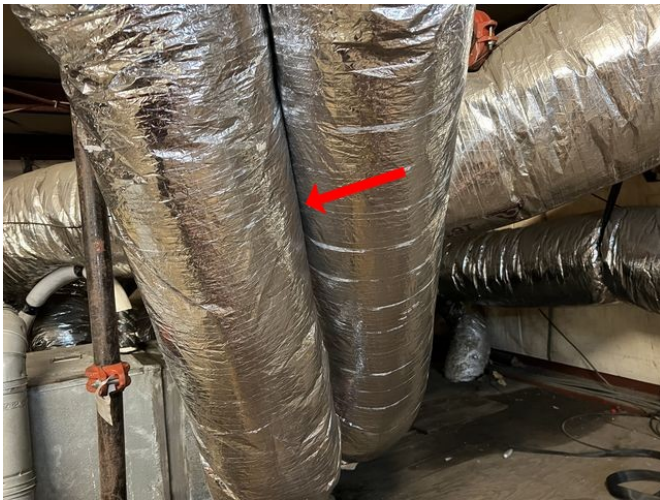
*Separate ductwork where touching at attic*

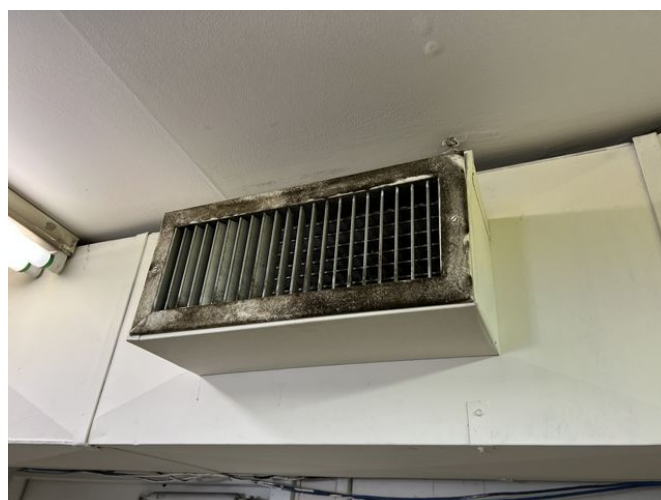
*Organic stains observed at receiving room register*
