# A+ HOME INSPECTIONS

1234 Anywhere Street  
Houston, TX 77000

Date: 02/13/2023

Re: Commercial inspection at 1234 Anywhere Street

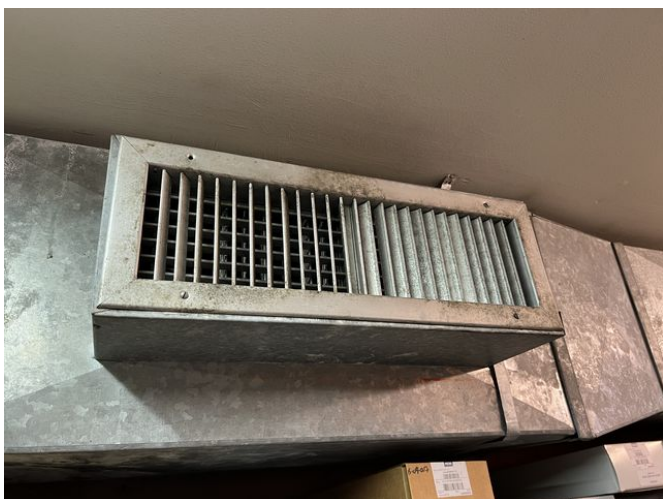
*Organic stains observed at storage room registers*
