A+ HOME INSPECTIONS

12345 Anywhere Street
Houston, TX 77000

Date: 9/13/2016

Re: Pre-Drywall inspection at 12345 Anywhere Street

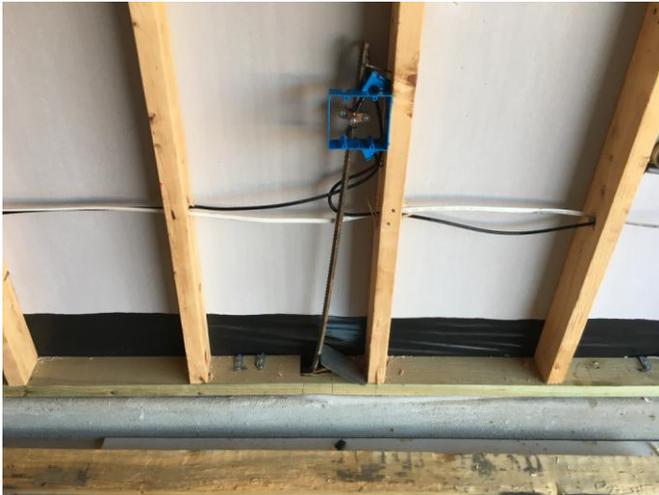
1. The exposed rebar (Ufer ground) at the right garage wall does not properly establish a concrete encased electrode as defined by the Nation Electric Code (NEC). Connecting a grounding conductor to a concrete encased electrode will bond the slab to the electrical system when a vapor barrier is installed between any of the slab and grade. Recent electrical publications have indicated that bonding of a slab to the electrical system does not meet the intent of the NEC and is not recommended if a vapor barrier is installed between any of the slab and grade. The NEC code requires two means of grounding for residential dwellings and only on grounding electrode was identified.

Ufer ground garage right wall

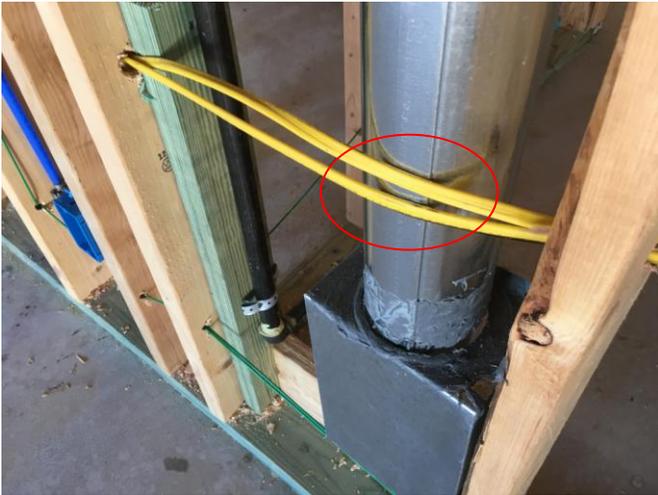
4. Romex wiring not installed with spacers where in contact with the dryer vent pipe at the utility room front wall.
5. Holes in the vapor barrier not covered at the following locations: garage right wall, bedroom 3 closet left wall.

Romex contact dryer vent pipe utility room

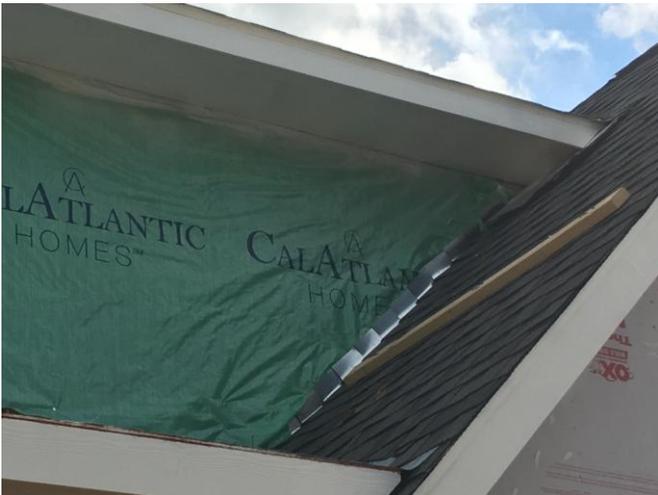
Vapor barrier not cover step flash front exterior
