# A+ HOME INSPECTIONS

1234 Anywhere Street  
Houston, TX 77000

Date: 02/13/2023

Re: Commercial inspection at 1234 Anywhere Street

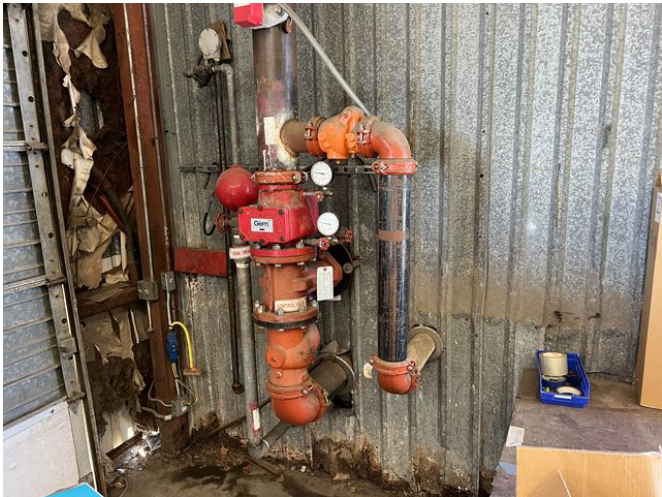
Fire sprinkler controls at warehouse

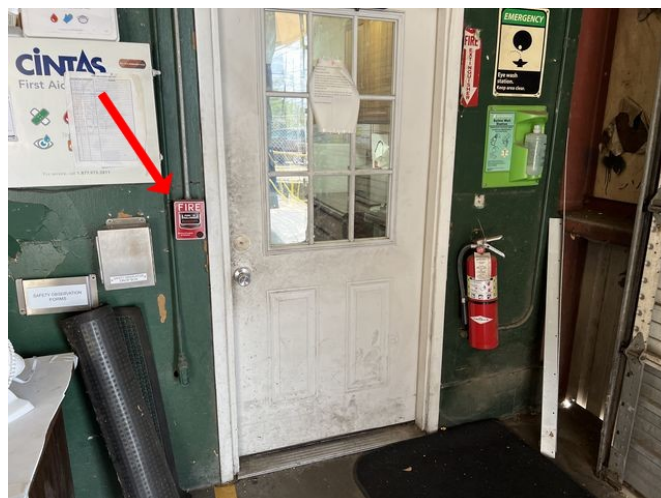
Manual fire alarm lever at receiving door

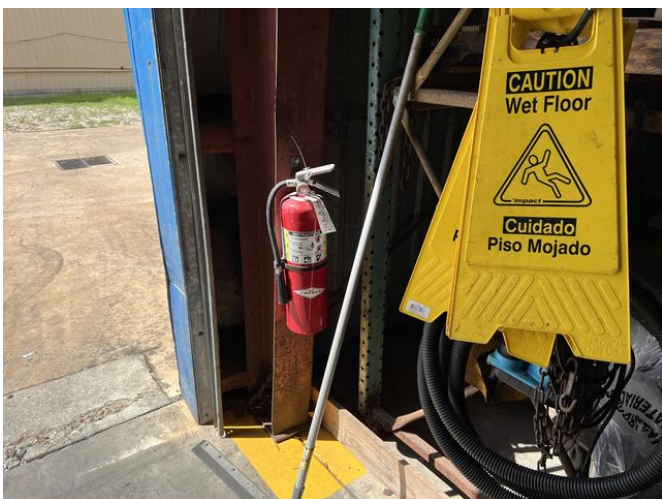
Fire extinguishers located at the exterior doors

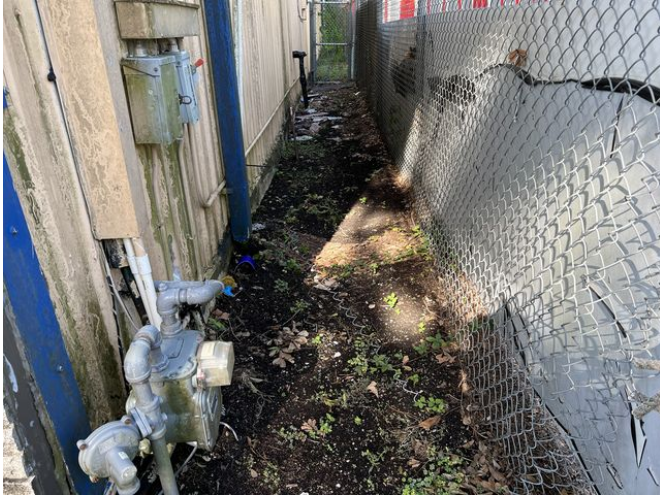
The grading is not properly sloped away from the dwelling at the right, rear and left rear corner of the dwelling. The gutter downspouts at the right exterior are not installed with directional diverters and causing erosion under the downspout.

*Improper grading right building*

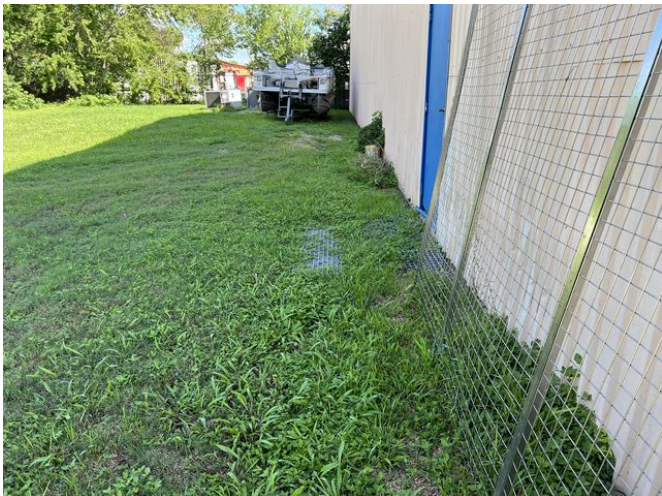
*Inadequate slope rear building*

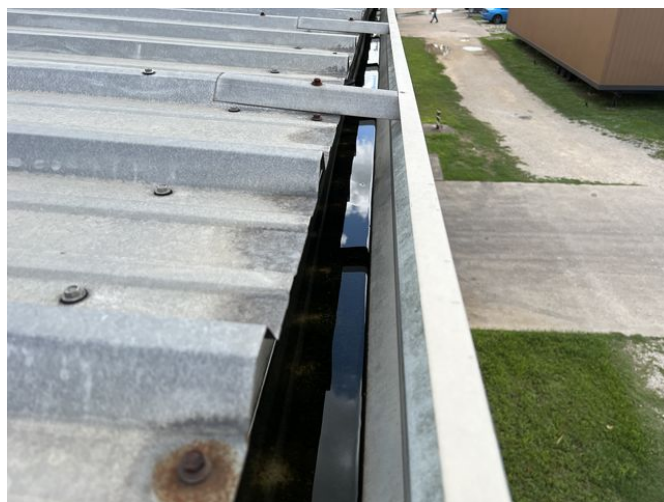
*Standing water gutters*

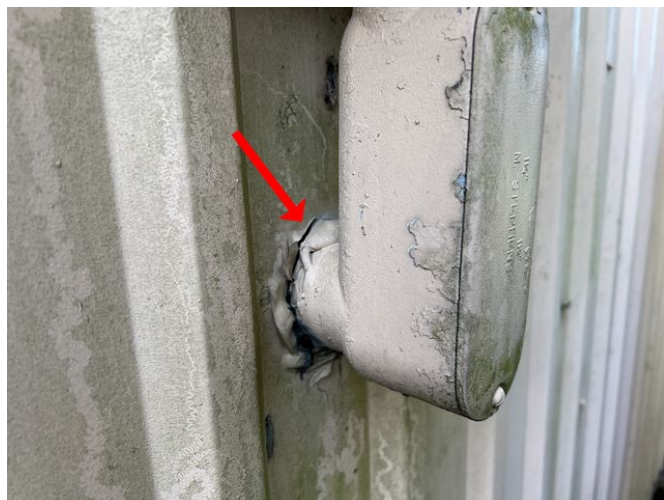
*Penetrations not properly sealed*

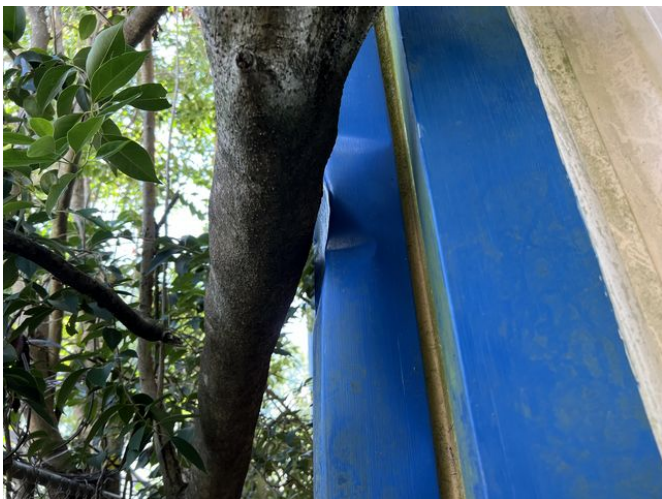
*Tree contact siding right rear building*

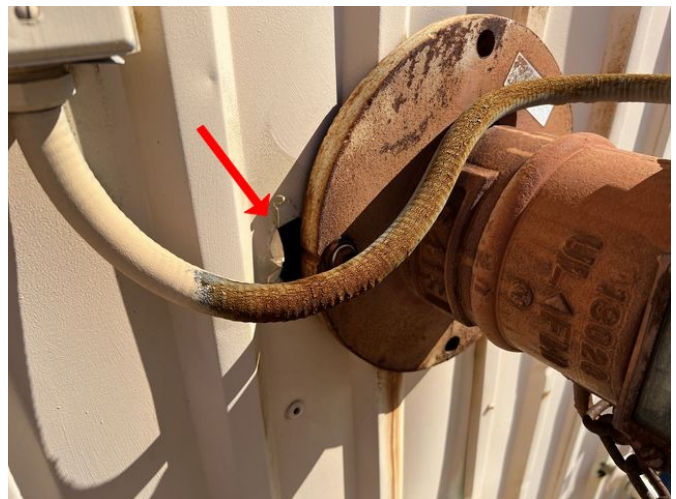
*Penetrations not sealed at siding*

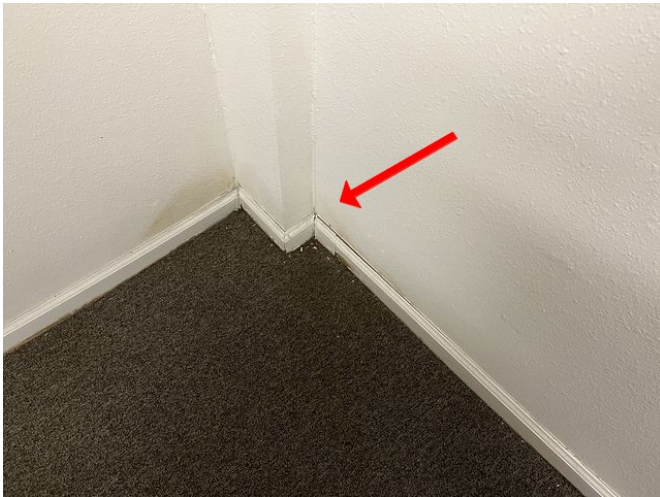
*Moisture stains right front office base wall*

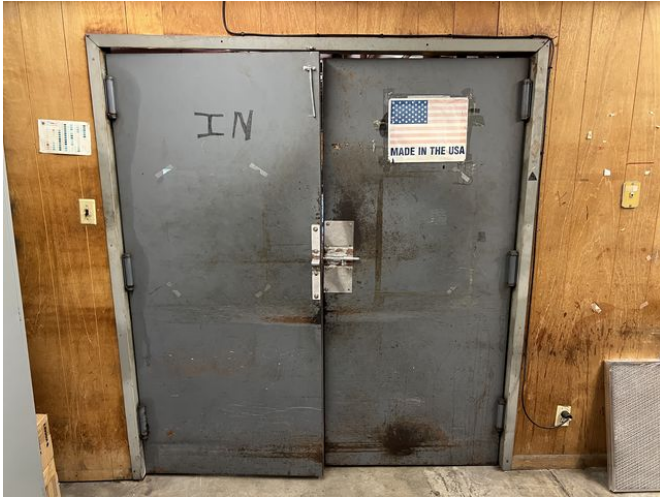
*Storage room rear double doors not weather stripped*

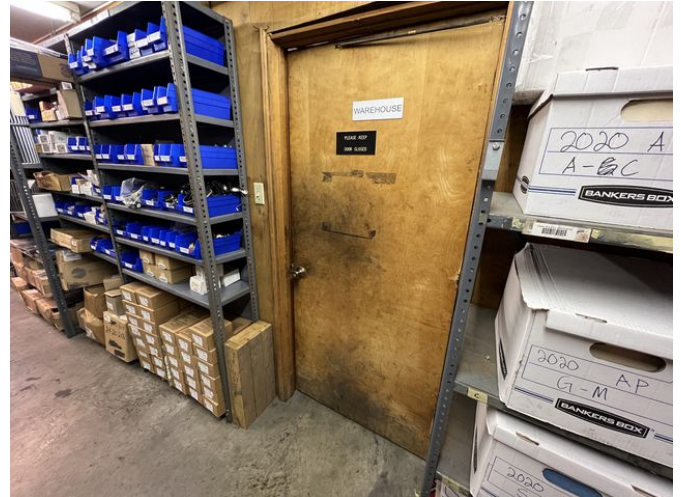
*Storage room rear door not weather stripped*

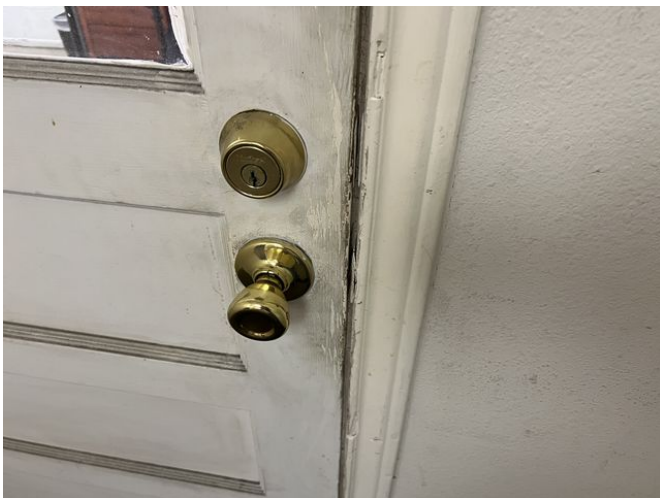
*Office hallway door at receiving room not latching*

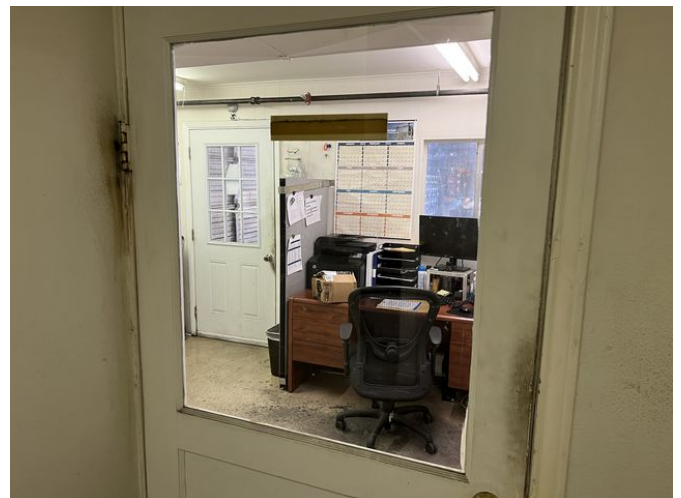
*Glass not tempered at hallway door at receiving room*

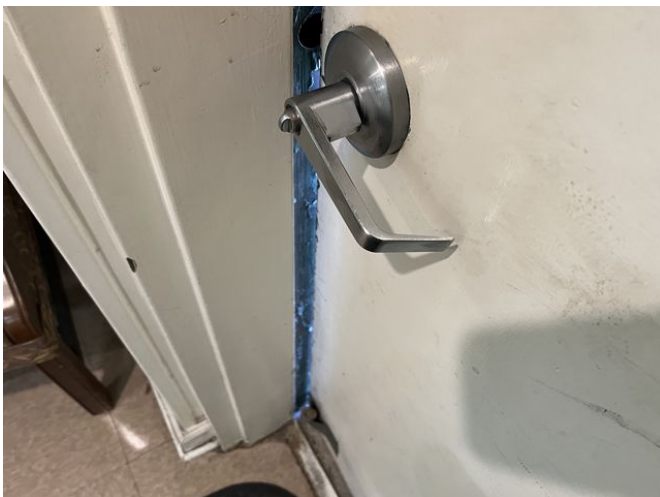
*Front entry door not weather stripped*

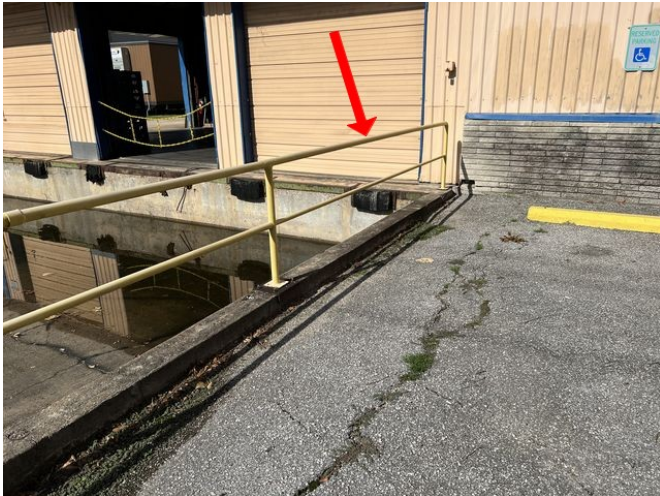
The safety guard rail at the front delivery well has openings greater than 4" wide where the pit is deeper than 30". The fence at the right property line is damaged. The gate fencing at the right side of the building is also damaged.

*Delivery well guard rail has opening wider than 4"*

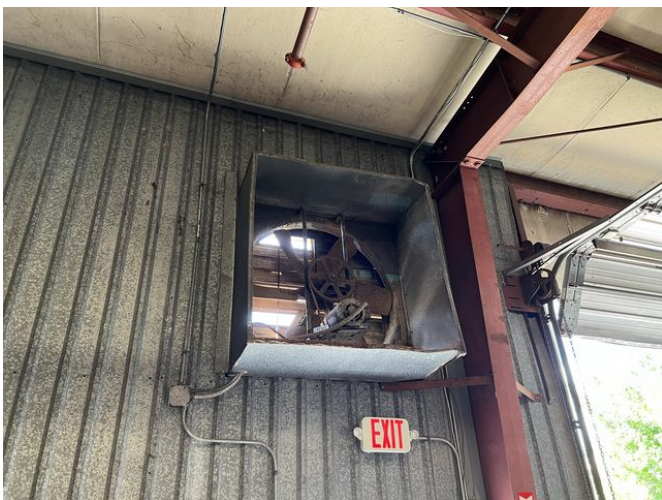
*Warehouse left wall ventilation fan not working*

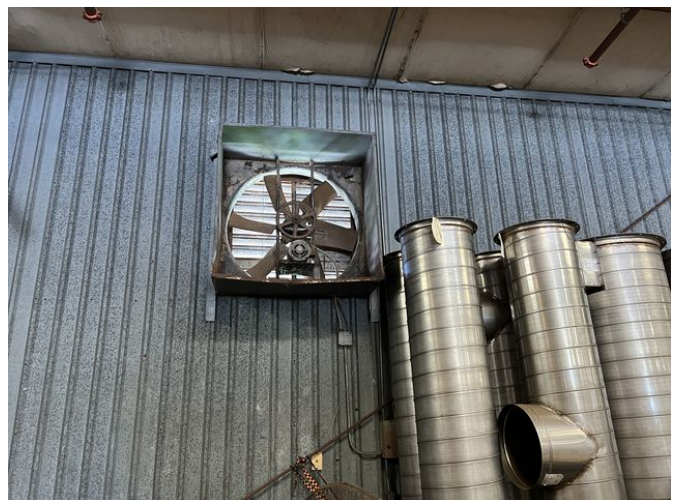
*Warehouse right wall ventilation fan not working*

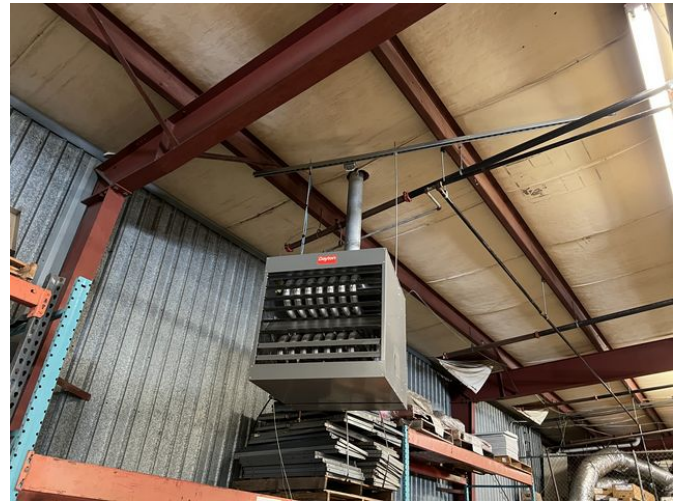
*Right warehouse heater*

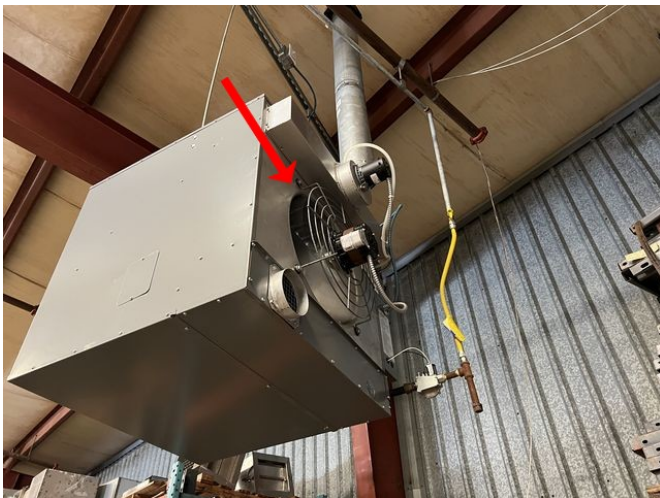
Two heaters have been installed at the warehouse to provide heat for the fire sprinkler system during freezing conditions. Both heaters were operated and working. The right heater fan had some vibration observed when operated. Further evaluation is recommended.

*Fan vibration right warehouse heater when operated*

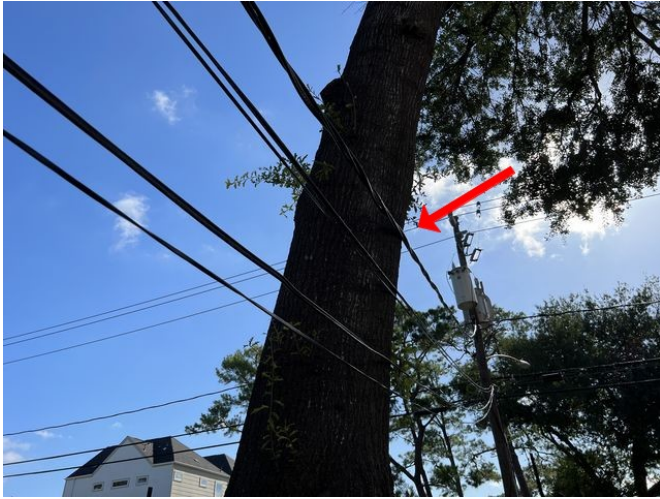
*Power lines in contact with front tree*

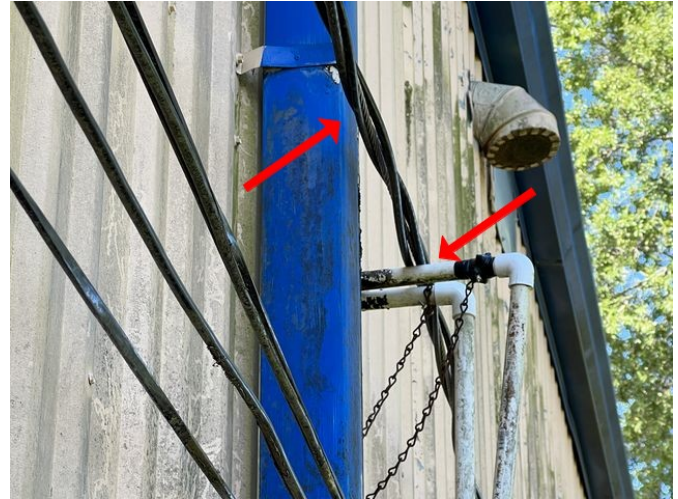
*Power lines on the A/C drain lines, clearance gutter*

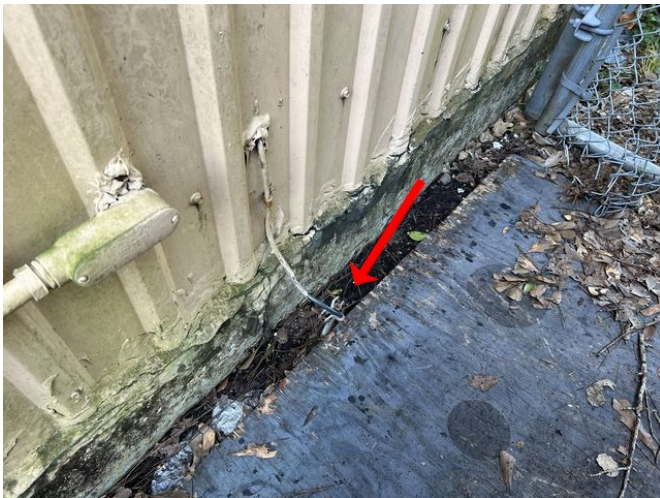
*Ground rod at right side building not driven below grade*

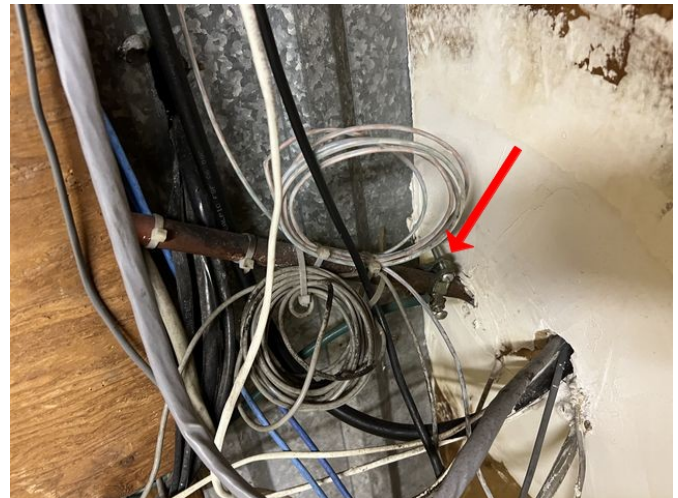
*Metal building bonding clamp at storage roof*

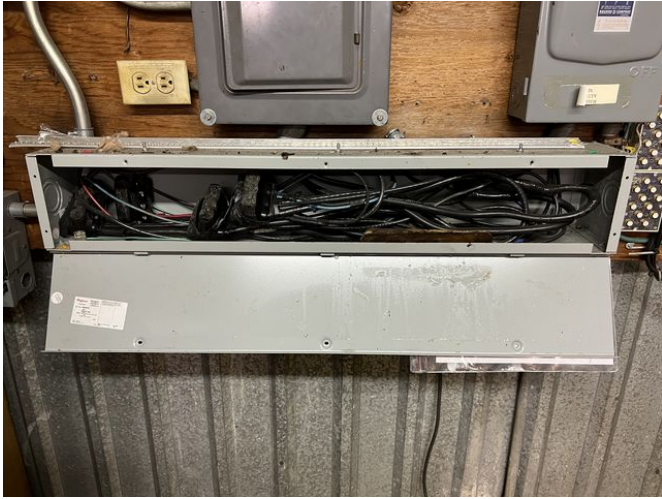
Grounding and bonding not originated at service gutter

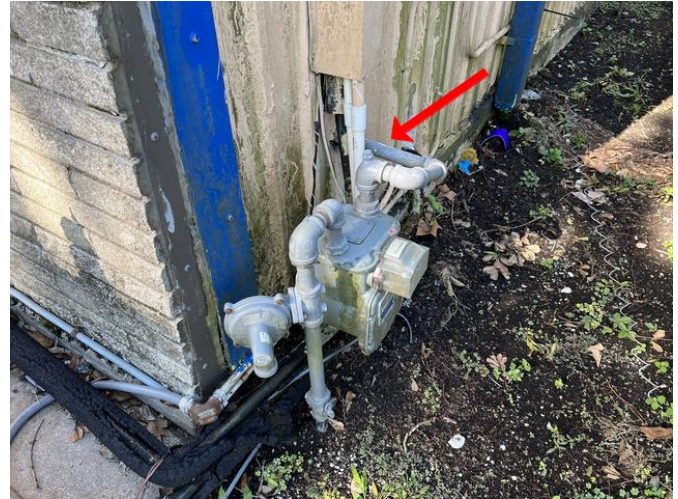
Gas pipe not bonded right side building

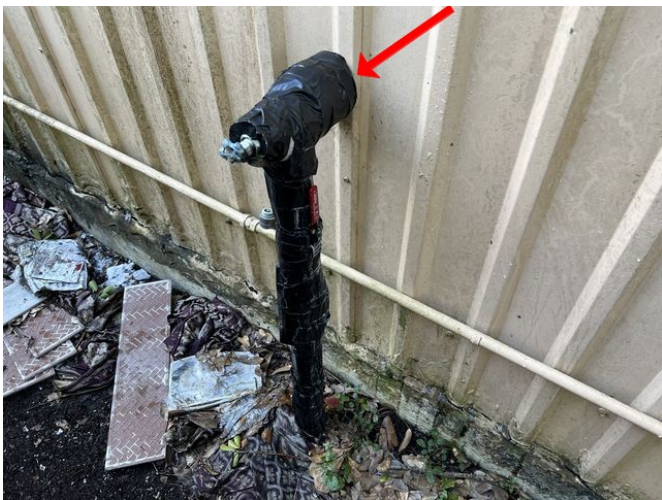
Galvanized water pipe not bonded right side building

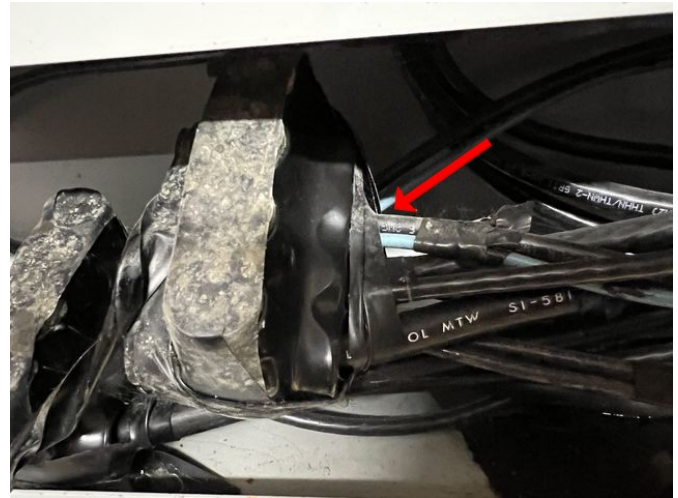
*Double lugged terminals at gutter cabinet*

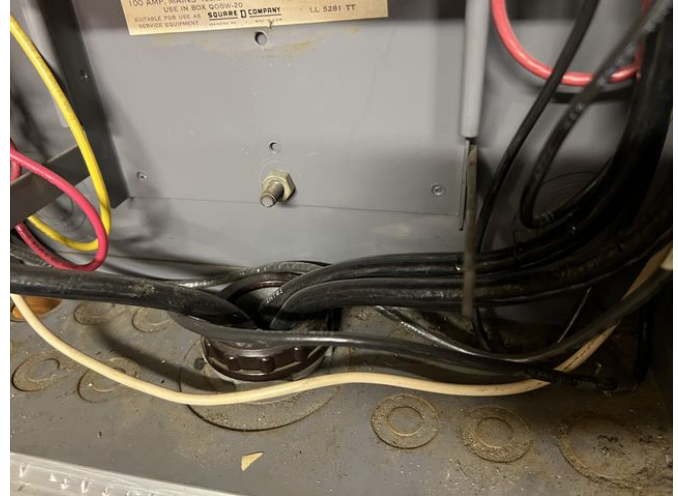
*No ground from the gutter cabinet point of service*

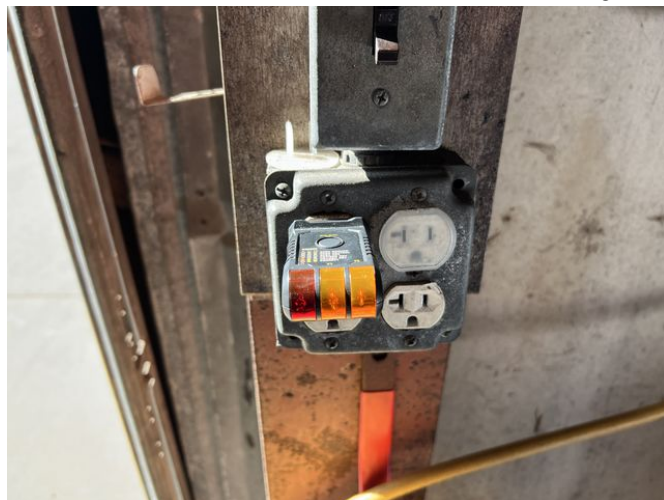
Ground fault circuit interrupter (GFCI) receptacles are not installed at the following required locations: exterior, bathroom, warehouse. The junction box is missing a coverplate at the left rear warehouse ceiling. The attic right wall light is not working. The attic ceiling light fixture is missing a bulb. Several of the receptacle coverplates are cracked in the offices. No power the reception office left wall receptacle.

*No GFCI receptacles installed in the warehouse*

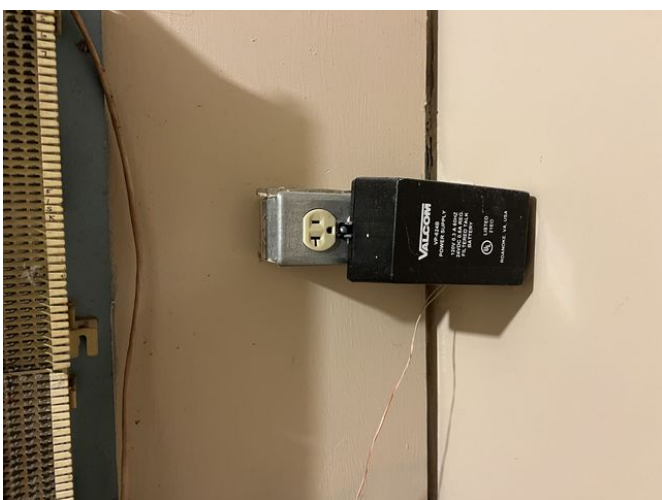
*No GFCI receptacles installed at the bathrooms*

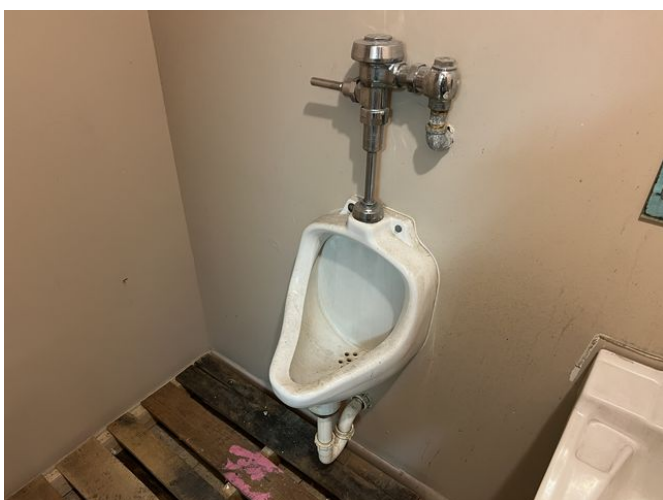
Storage room bathroom: The urinal is not working at the storage room bathroom, the sink stopper is missing, commode is loose at the floor mount.

*Urinal not working at storage room bathroom*

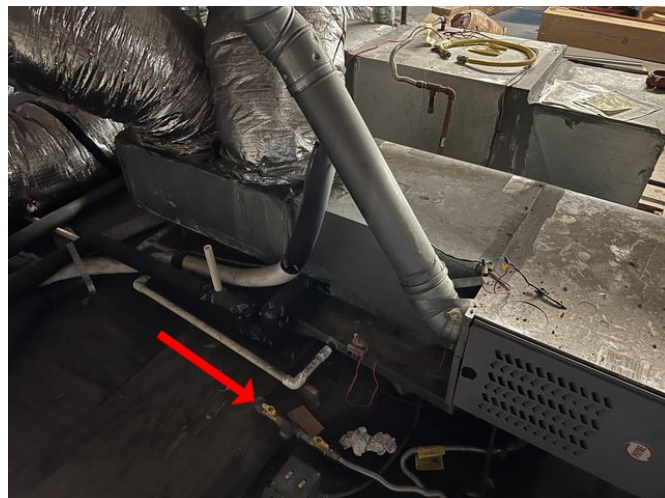
*Gas shut off valve too far from the office furnace*

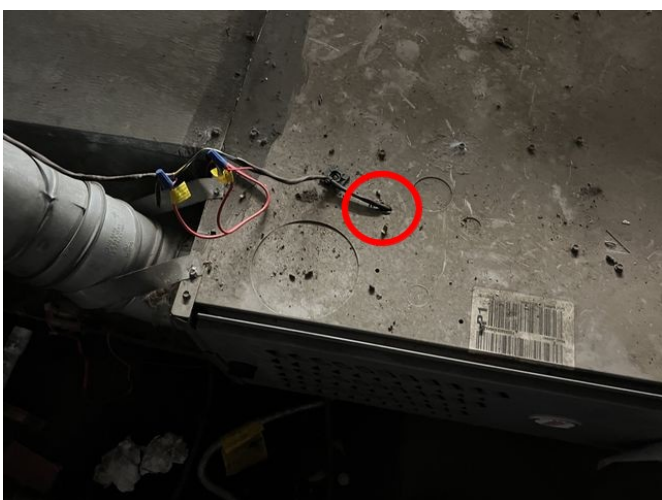
*Thermostat wires not sleeved at storage area furnace*

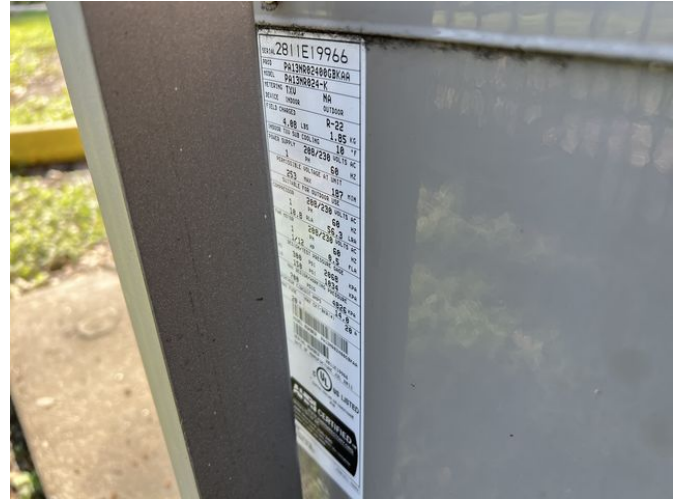
Storage area condensing unit labeling, 2 tons

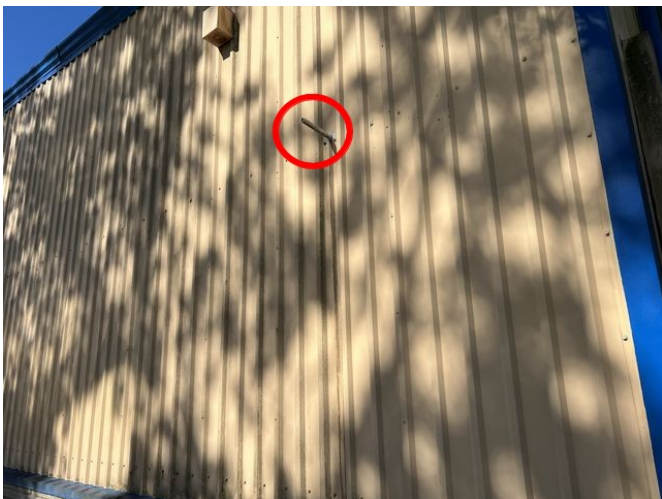
Auxiliary drain line not a conspicuous location

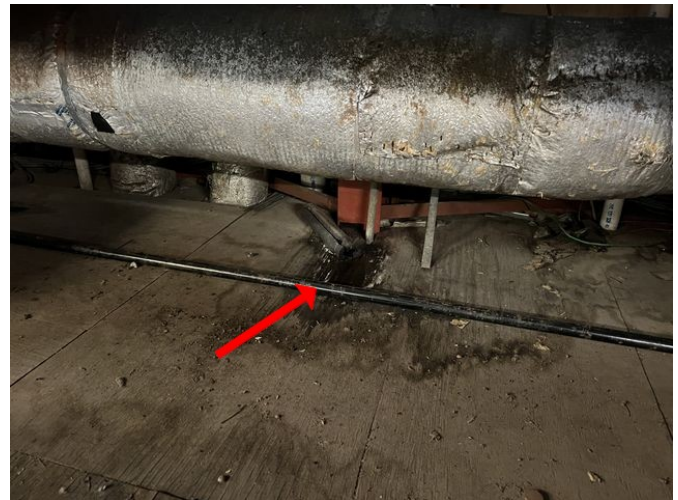
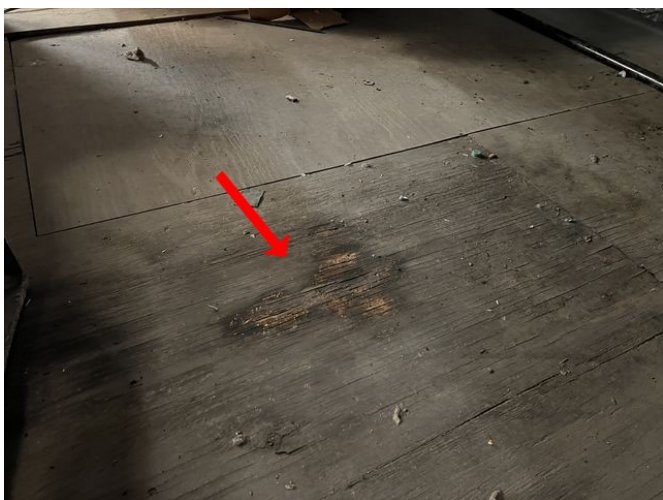
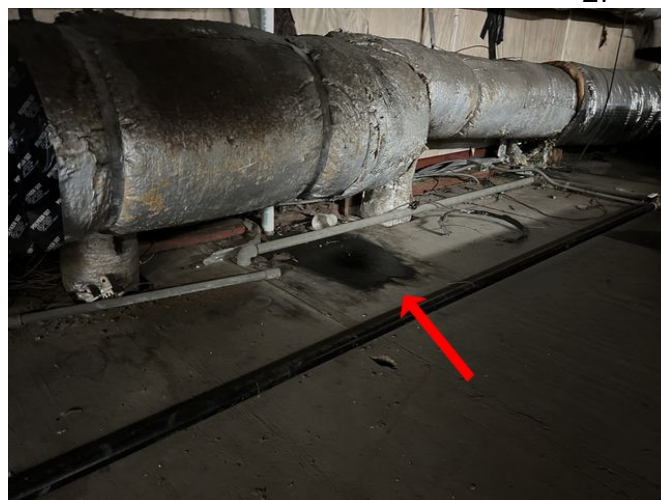
The ductwork installed is a combination of metal rigid duct and mylar flex duct. Several of the duct runs were observed to be sweating and dripping condensate. Insulation may be loose and or missing. Further evaluation is recommended. The mylar flex duct should be separated where touching to prevent thermal bridging (sweating and dripping). Organic stains was observed at the air supply registers at the receiving room and storage room.

*Ductwork sweating and dripping at attic*

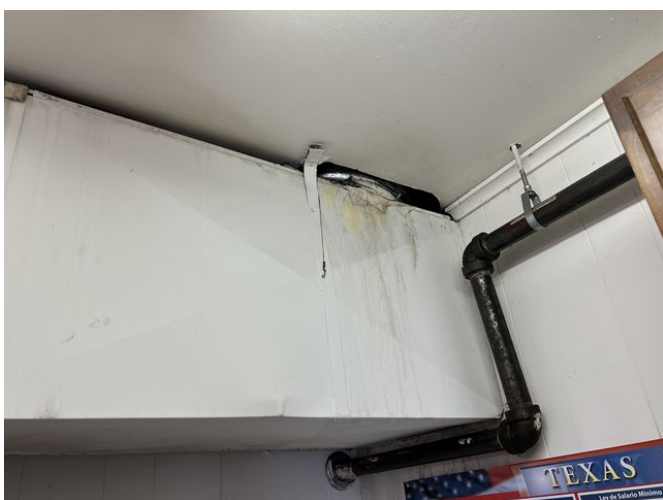
*Duct sweating at receiving room*
