# A+ HOME INSPECTIONS

1234 Anywhere Street  
Houston, TX 77000

Date: 02/13/2023

Re: Commercial inspection at 1234 Anywhere Street

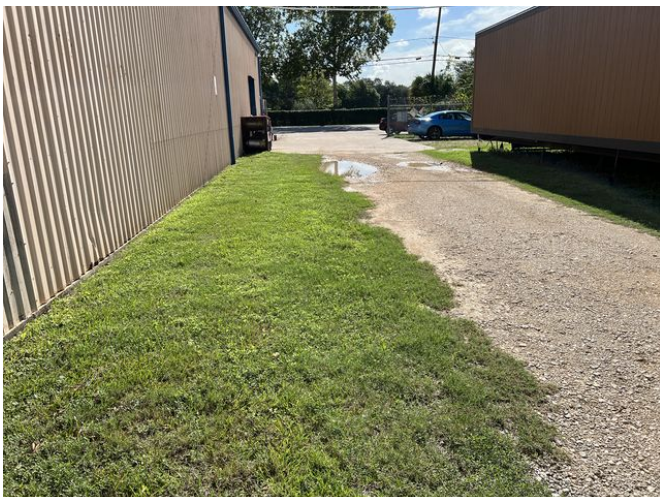
*Standing water left drive*
